# Water Resources Technical Report

State Loop 288 From IH 35W to IH 35 Denton County, Texas

CSJs: 2250-02-013, 2250-02-014

February 2020

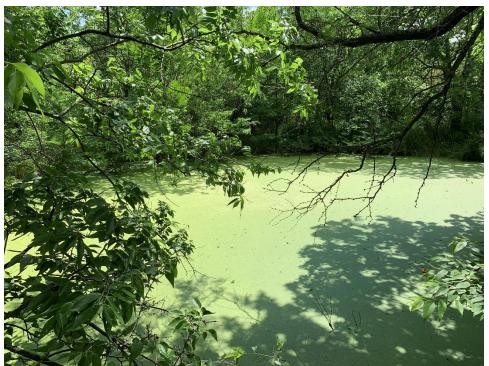
Photograph 2. View looking north at Feature 1. This feature is likely to be considered non-jurisdictional due to its lack of hydrological connectivity to any jurisdictional water.

Features 1, 10, and 14 are likely to be considered non-jurisdictional due to being located outside of the 100-year FEMA floodplain and lacking hydrological connectivity to any named or mapped water feature, as noted during field investigations.

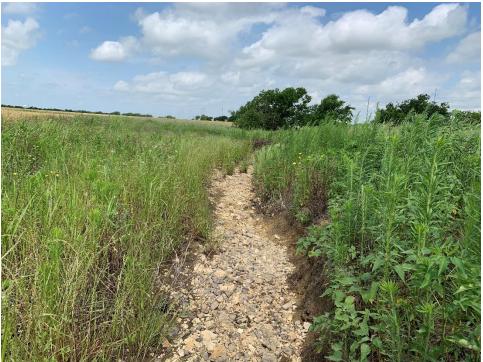
Photograph 3. View looking north from the start of Feature 2, an unnamed tributary to Hickory Creek. This feature is likely to be considered jurisdictional.

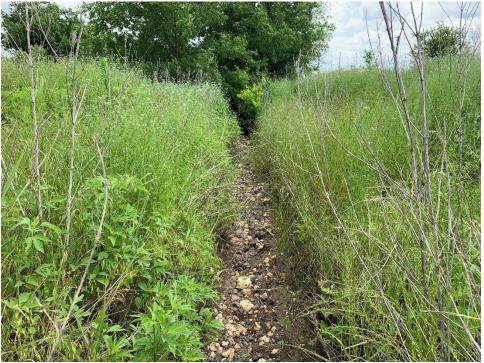
Photograph 4. View looking north at Feature 3, an unnamed tributary to Hickory Creek. This feature is likely to be considered jurisdictional.

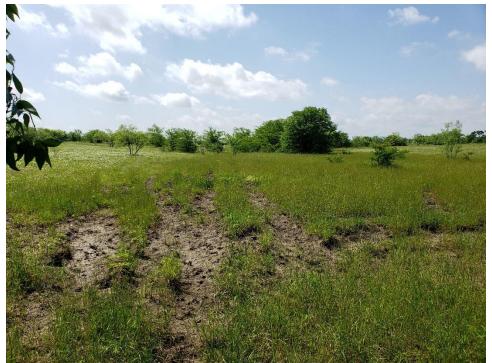
Photograph 5. View looking south at the mapped NHD line of an unnamed tributary to Hickory Creek. No OHWM or flow was exhibited on the south side of CR 2449, but an OHWM was present on the north side of the road.

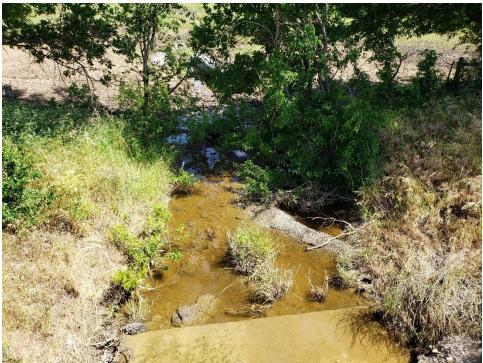
Photograph 6. View of the unnamed tributary to Hickory Creek (Feature 4) looking north. This feature would likely be considered jurisdictional.

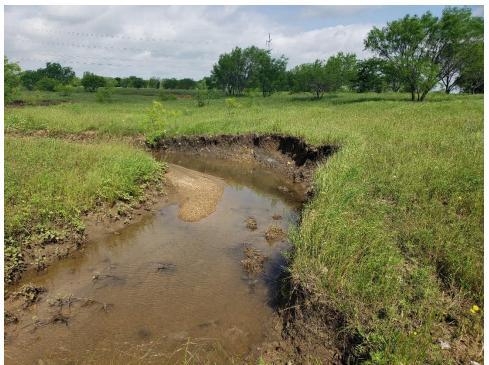
Photograph 7. View looking west at Feature 5, an unnamed tributary to Hickory Creek. This feature is likely to be considered jurisdictional.

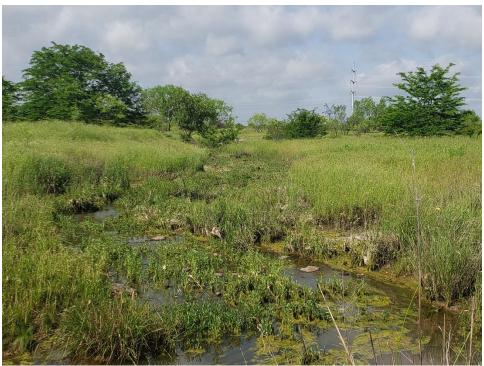
Photograph 8. View looking west at Feature 6, a mapped unnamed tributary to Hickory Creek. This feature was delineated with WP 12 (wetland point) and WP 13 (upland point). The portion of this mapped NHD-line was determined to be a wetland within the project area and would likely be considered jurisdictional.

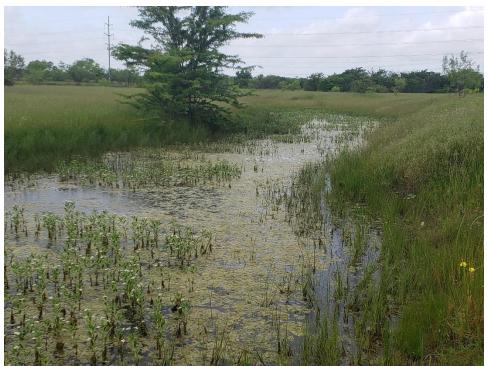
**Photograph 9.** View looking west at Feature 7, an herbaceous wetland. This feature is within the floodplain of the unnamed tributary to Hickory Branch and would likely be considered jurisdictional.

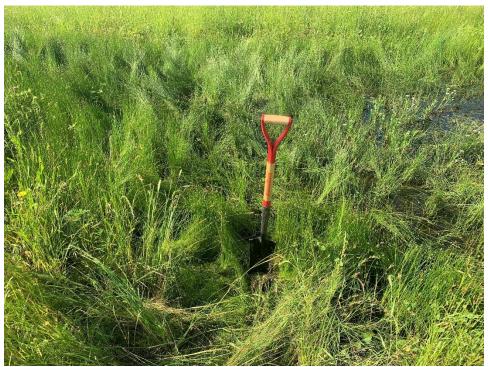
Photograph 10. View of WP 10 within Feature 7. This location met the three necessary criteria to be considered a wetland.

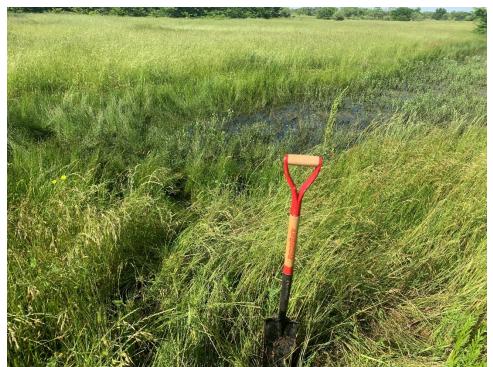
Photograph 11. View of WP 11, adjacent to Feature 7. This sample point did not meet the three necessary criteria to be considered a wetland.

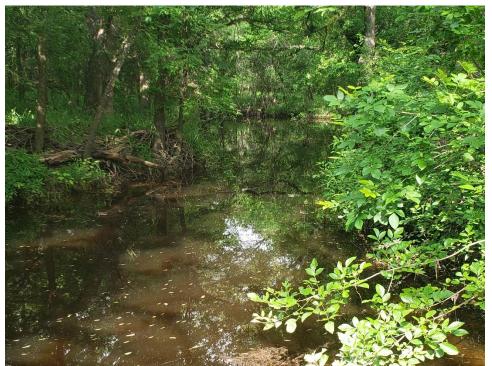
Photograph 12. View looking west at Feature 8, an impoundment. This feature is within the floodplain of Hickory Creek and would likely be considered jurisdictional.

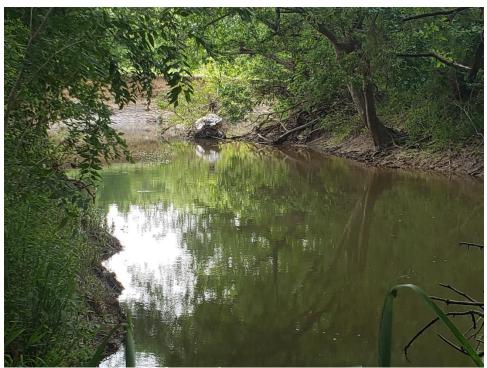
**Photograph 13.** View looking east at Feature 9, Hickory Creek. This feature is likely to be considered a jurisdictional creek.

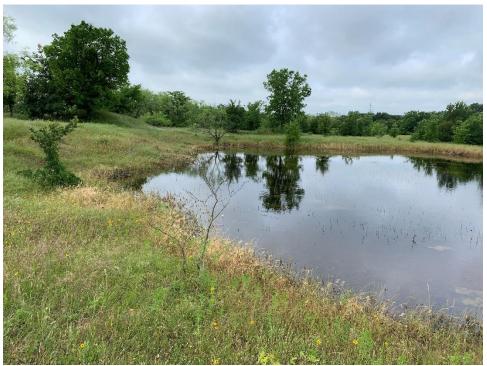
**Photograph 14.** View looking south at Feature 10, an impoundment. This feature is likely to be considered non-jurisdictional due to its lack of hydrological connectivity to any jurisdictional water.

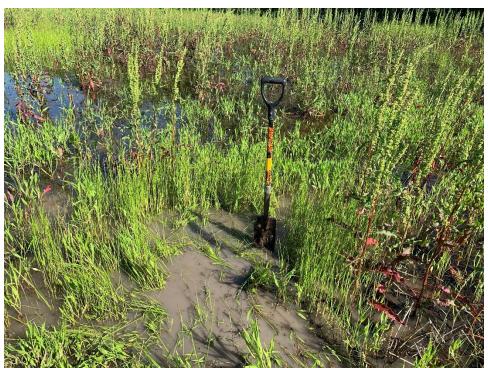
Photograph 15. View of WP 4. This sample location did not meet the three necessary criteria to be considered a wetland.

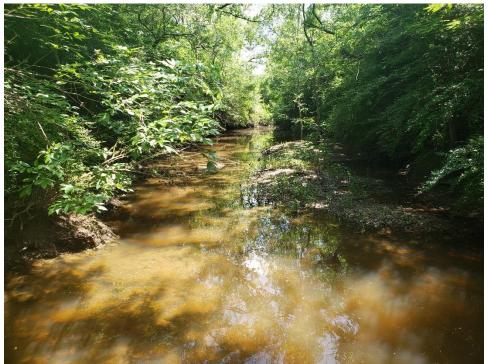
Photograph 16. View looking south at Feature 11, Dry Fork Hickory Creek. This feature entered the project area at two separate locations (Feature 11a and 11b). This feature is likely to be considered jurisdictional.

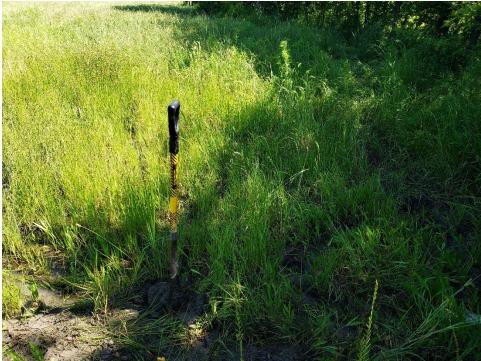
Photograph 17. View of WP 5. This sample location was located along a mapped NHD line but did not meet the three necessary criteria to be considered a wetland. No OHWM was observed at this location or any point along the location of the mapped NHD line within the project area.

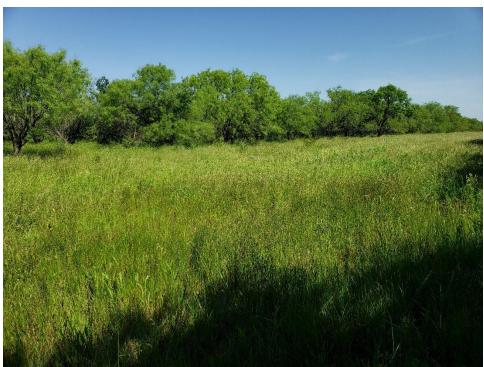
Photograph 18. View looking west at the location of a mapped NHD-line (referenced in photograph 17) within the project area. No OHWM was observed within the project area.

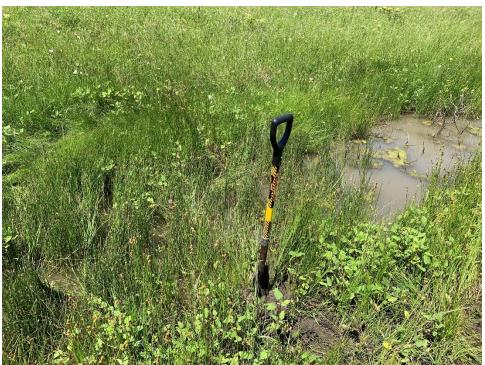
**Photograph 19.** View of WP 8 within Feature 13. This sample point did meet the three necessary criteria to be considered a wetland. This wetland was located along a mapped NHD line and would likely be considered jurisdictional.

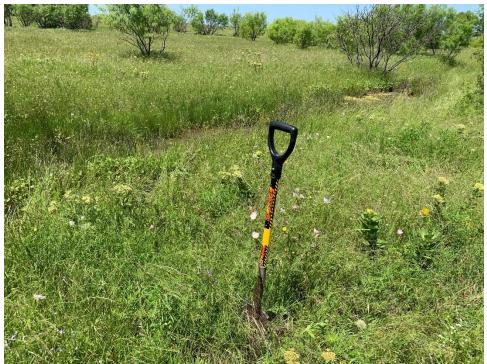
Photograph 20. View of WP 9 adjacent to Feature 13. This sample point did not meet the three necessary criteria to be considered a wetland.

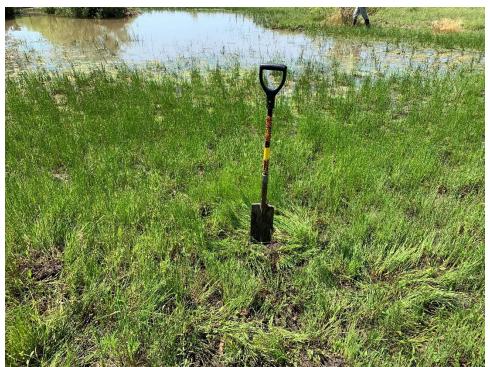
Photograph 21. View of WP 6 within Feature 14. This sample location did meet the three necessary criteria to be considered a wetland.

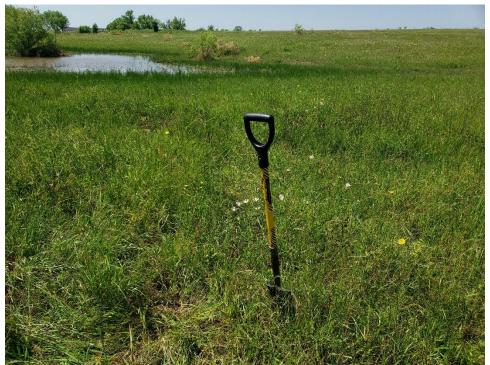
**Photograph 22.** View of WP 7 adjacent to Feature 14, an impoundment with a fringe wetland. This sample location did not meet the three necessary criteria to be considered a wetland.

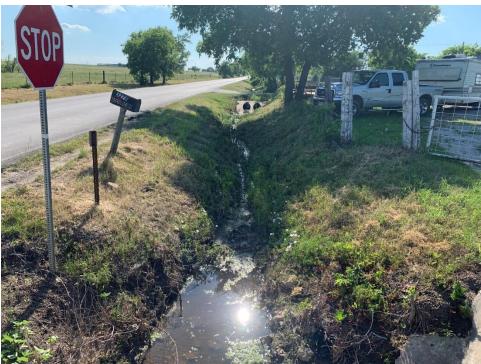
Photograph 23. View looking west at the OHWM within Feature 15, an unnamed tributary to Dry Fork Hickory Creek. This feature would likely be considered jurisdictional.

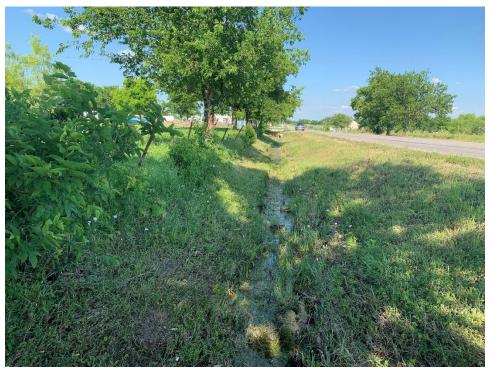
**Photograph 24.** View looking east along the wetland within Feature 15. This feature is along the mapped NHD unnamed tributary to Dry Fork Hickory Creek and would likely be considered jurisdictional.

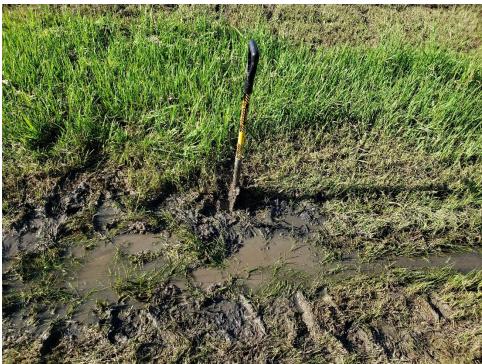
**Photograph 25.** View of WP 2 within Feature 15. This sample location has significantly disturbed vegetation but did meet the three necessary criteria to be considered a wetland.

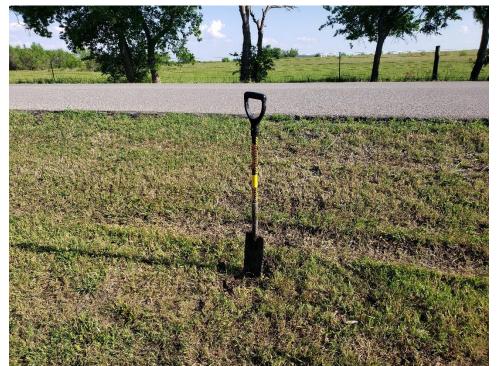
Photograph 26. View of WP 3 adjacent to Feature 15. This sample location did not meet the three necessary criteria to be considered a wetland.

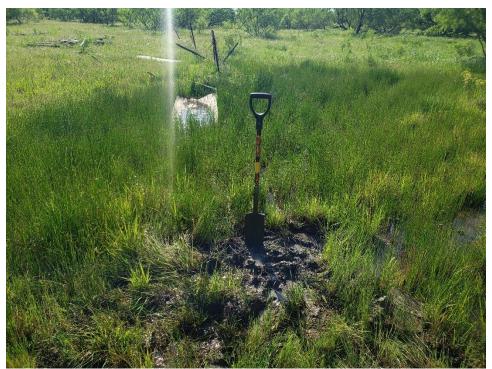
Photograph 27. View of WP 1. This sample location did not meet the three necessary criteria to be considered a wetland.

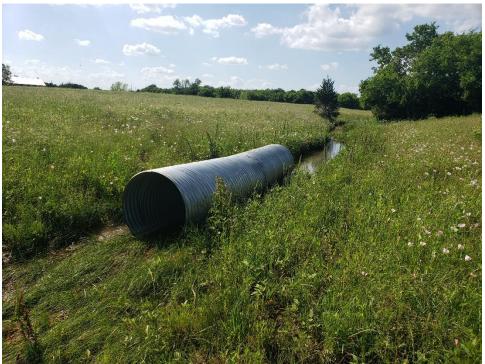
Photograph 28. View looking northeast at Feature 16, an unnamed tributary to Dry Fork Hickory Creek. This feature is likely to be considered jurisdictional.

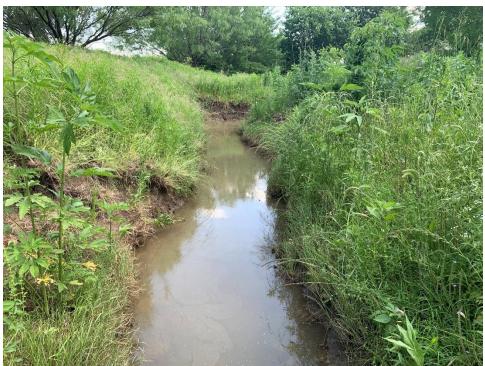
Photograph 29. View looking south along Feature 17, an unnamed tributary to Dry Fork Hickory Creek. This feature is likely to be considered jurisdictional.

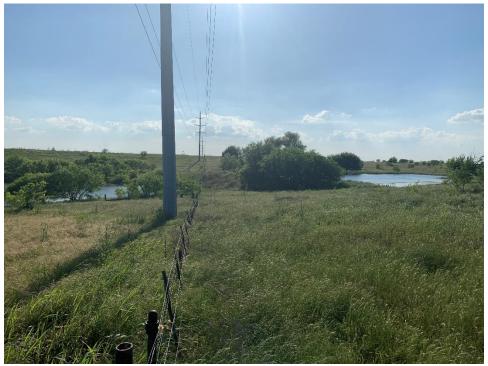
Photograph 30. View looking west at Feature 19a and 19b. No ROE was obtained to access these features. These impoundments are located along a mapped NHD line, an unnamed tributary to Dry Hickory Creek, and would likely be considered jurisdictional.
