# Historical Resources Survey Report

## Reconnaissance Survey

**Project Name:** State Loop 288

**Project Limits:** IH 35W to IH 35

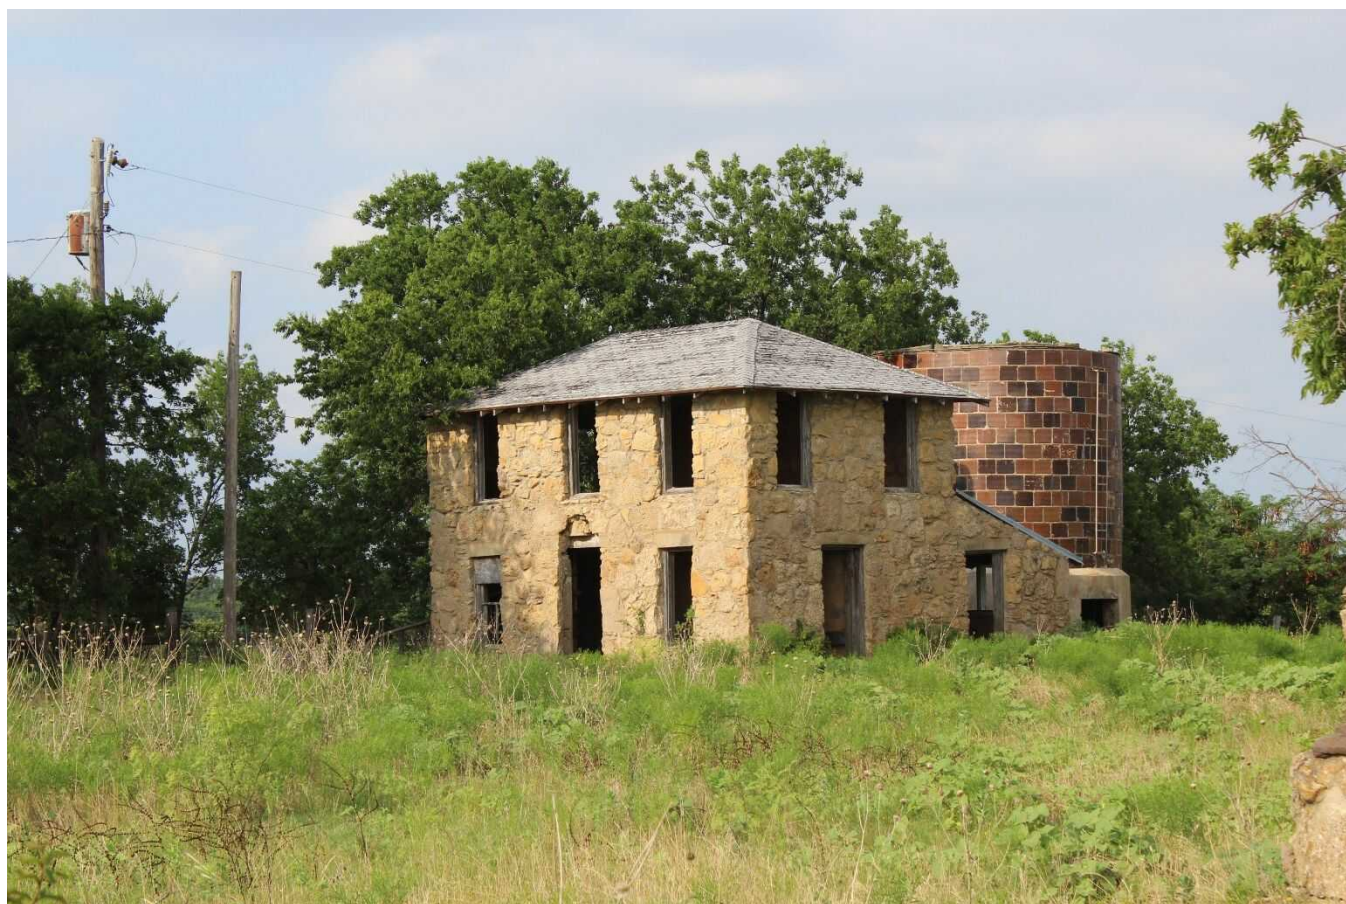
Survey Date:	June 24, 2019
Resource No:	01a
Project Location:	Denton County
Project Name and CSJ:	State Loop 288, CSJ 2250-02-014, etc.
Address, Lat/Long:	No Address, FM 2449 33.186176, -97.205997
Function/Sub-function:	AGRICULTURE/Vacant
Construction Date:	Ca. 1920
NRHP Eligibility:	Not Eligible
Integrity/Comments:	Resource 01a is a two-story masonry building with fieldstone walls, wood-frame windows with concrete lintels, and a hipped roof with modest eaves and exposed rafter tails. A matching saltbox addition is on the east side along with a brick chimney. The building has been called both a “smokehouse” and an “apartment washroom” by persons with knowledge of the property. The building is vacant, with no windows or doors. The building is a remnant of the former Cole Ranch. Visibility was limited due to vegetation and roaming livestock.

Camera facing northeast.

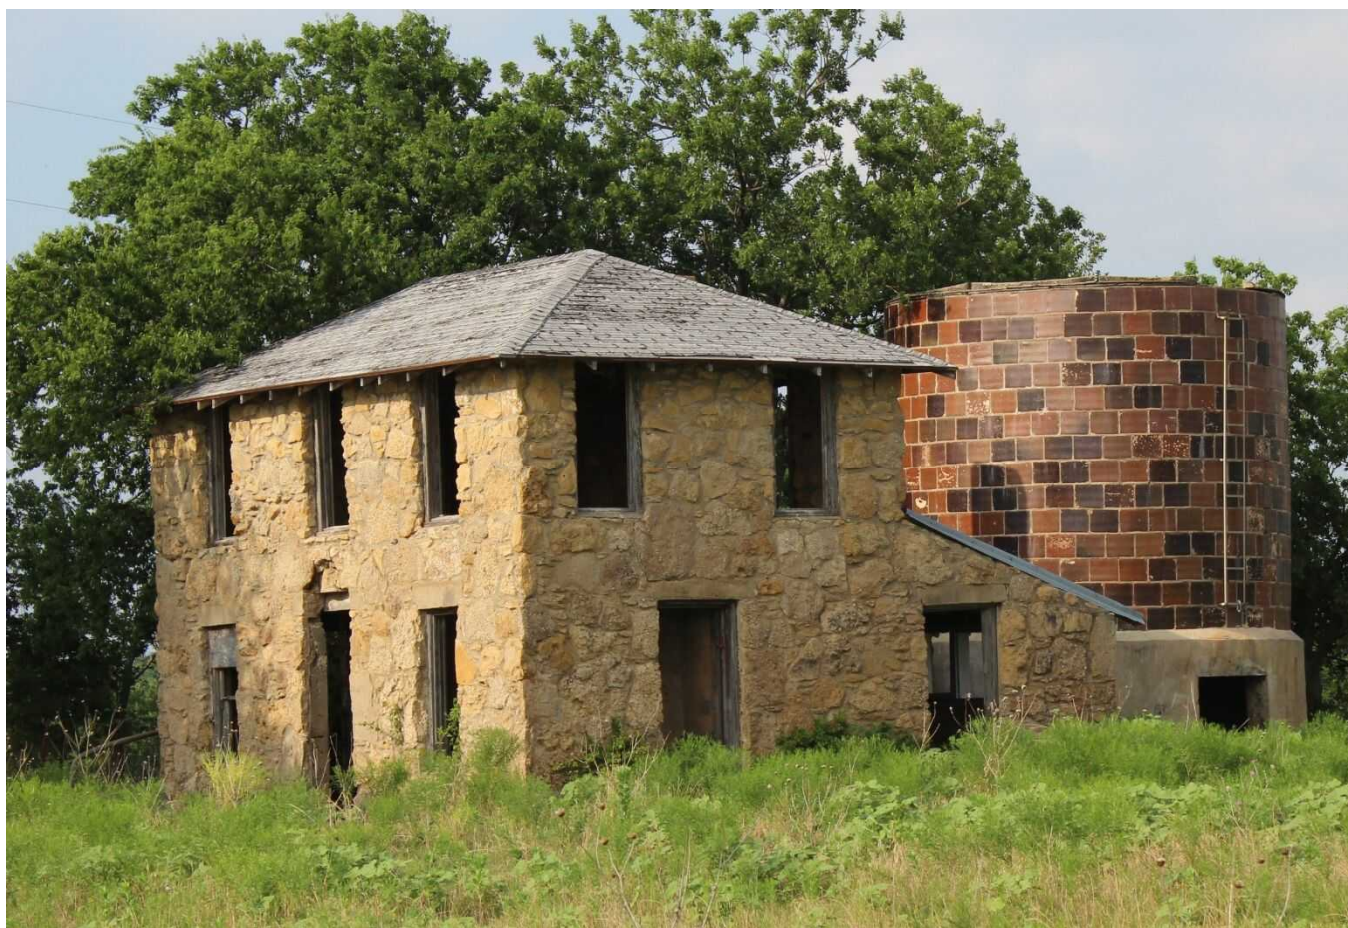
Survey Date:	June 24, 2019
Resource No:	01a
Project Location:	Denton County
Project Name and CSJ:	State Loop 288, CSJ 2250-02-014, etc.
Address, Lat/Long:	No Address, FM 2449 33.186176, -97.205997
Function/Sub-function:	AGRICULTURE/Vacant
Construction Date:	Ca. 1920
NRHP Eligibility:	Not Eligible
Integrity/Comments:	Resource 01a is a two-story masonry building with fieldstone walls, wood-frame windows with concrete lintels, and a hipped roof with modest eaves and exposed rafter tails. A matching saltbox addition is on the east side along with a brick chimney. The building has been called both a “smokehouse” and an “apartment washroom” by persons with knowledge of the property. The building is vacant, with no windows or doors. The building is a remnant of the former Cole Ranch. Visibility was limited due to vegetation and roaming livestock.

Camera facing northwest.

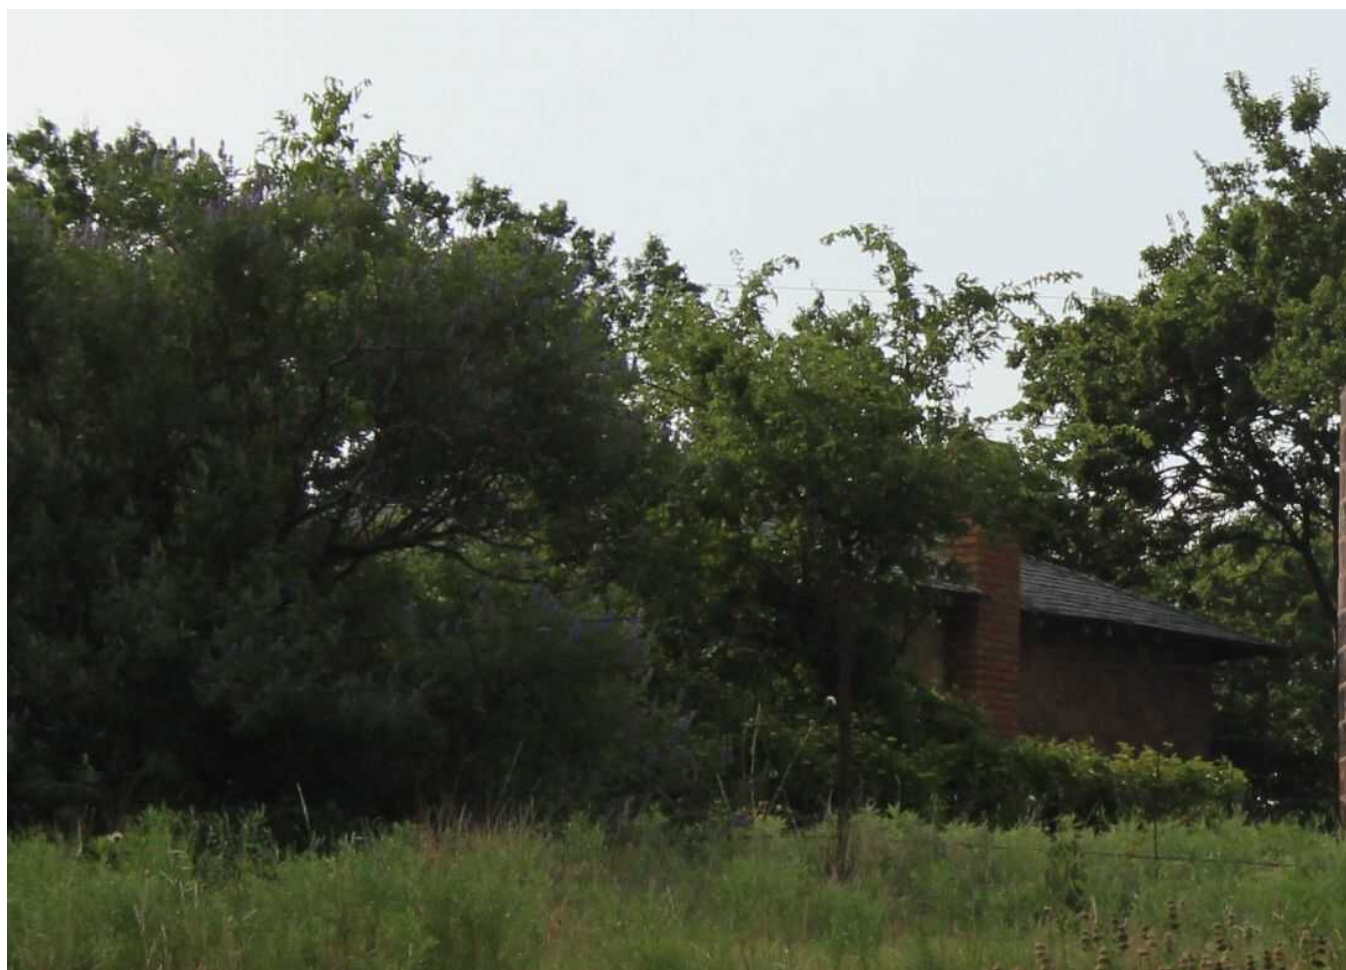
Survey Date:	June 24, 2019
Resource No:	01a
Project Location:	Denton County
Project Name and CSJ:	State Loop 288, CSJ 2250-02-014, etc.
Address, Lat/Long:	No Address, FM 2449 33.186176, -97.205997
Function/Sub-function:	AGRICULTURE/Vacant
Construction Date:	Ca. 1920
NRHP Eligibility:	Not Eligible
Integrity/Comments:	Resource 01a is a two-story masonry building with fieldstone walls, wood-frame windows with concrete lintels, and a hipped roof with modest eaves and exposed rafter tails. A matching saltbox addition is on the east side along with a brick chimney. The building has been called both a "smokehouse" and an "apartment washroom" by persons with knowledge of the property. The building is vacant, with no windows or doors. The building is a remnant of the former Cole Ranch. Visibility was limited due to vegetation and roaming livestock.

Obscured view showing chimney, camera facing northwest.

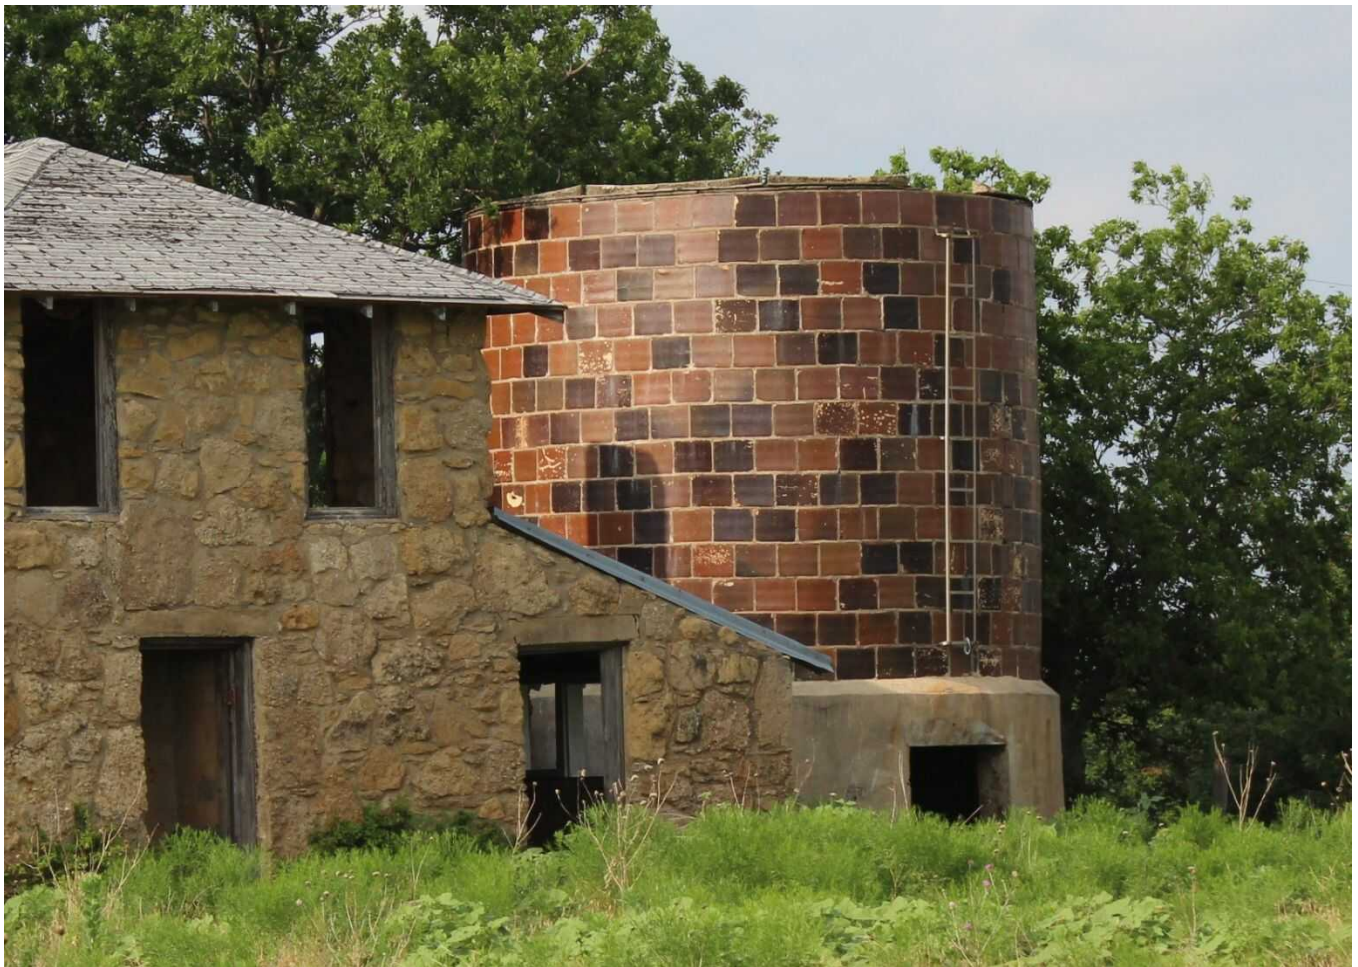
Survey Date:	June 24, 2019
Resource No:	01b
Project Location:	Denton County
Project Name and CSJ:	State Loop 288, CSJ 2250-02-014, etc.
Address, Lat/Long:	No Address, FM 2449 33.186185, -97.205916
Function/Sub-function:	AGRICULTURE/Cistern
Construction Date:	Ca. 1920
NRHP Eligibility:	Not Eligible
Integrity/Comments:	Resource 01b is a large concrete cistern on a raised concrete base, covered with red clay tiles. The roof is not visible, but aerial photos suggest it is missing and may have once been wood. The cistern is no longer in use.

Camera facing northeast.

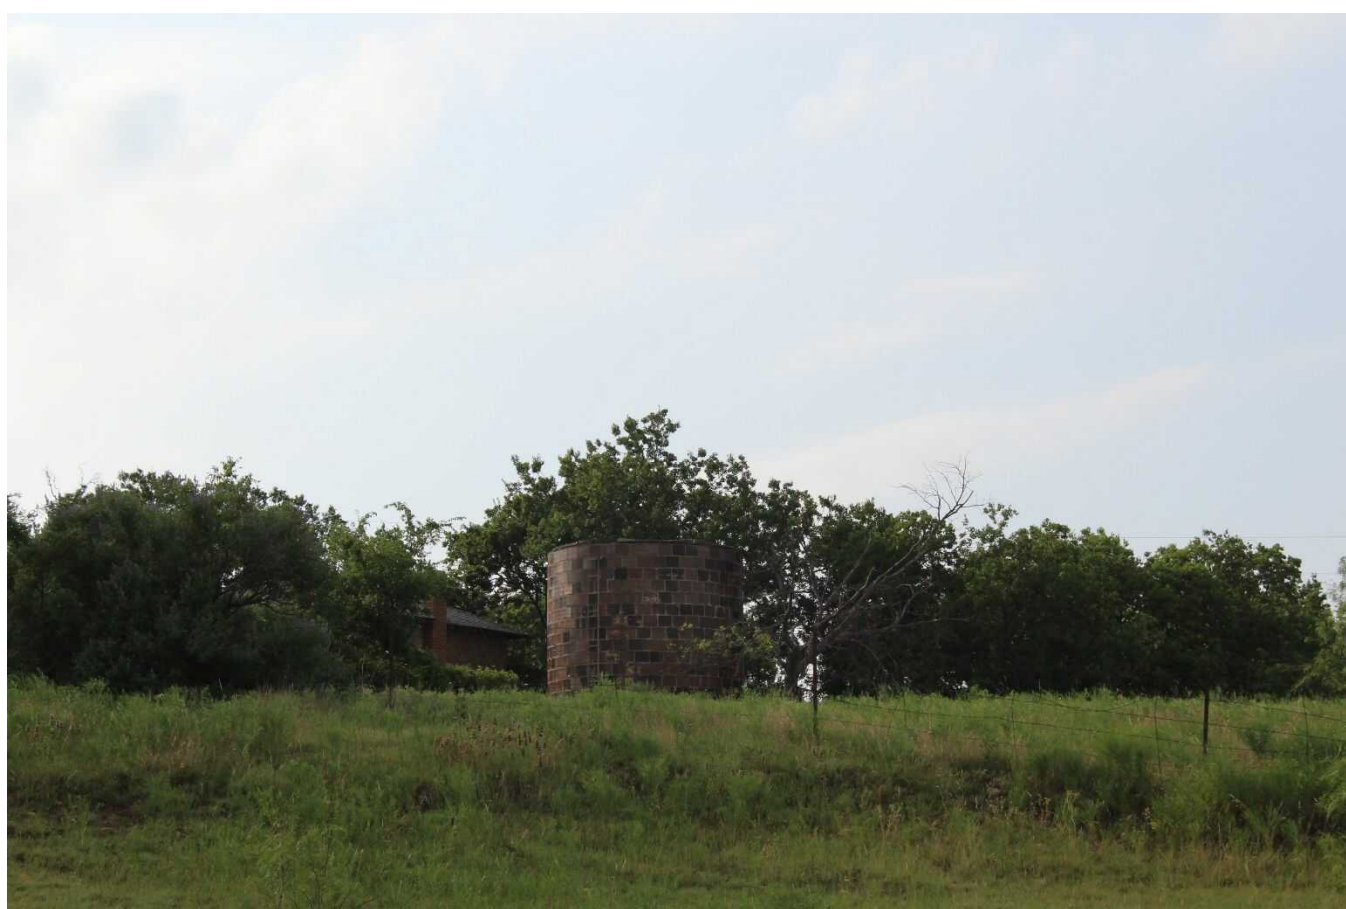
Survey Date:	June 24, 2019
Resource No:	01b
Project Location:	Denton County
Project Name and CSJ:	State Loop 288, CSJ 2250-02-014, etc.
Address, Lat/Long:	No Address, FM 2449 33.186185, -97.205916
Function/Sub-function:	AGRICULTURE/Cistern
Construction Date:	Ca. 1920
NRHP Eligibility:	Not Eligible
Integrity/Comments:	Resource 01b is a large concrete cistern on a raised concrete base, covered with red clay tiles. The roof is not visible, but aerial photos suggest it is missing and may have once been wood. The cistern is no longer in use.

Camera facing northwest.

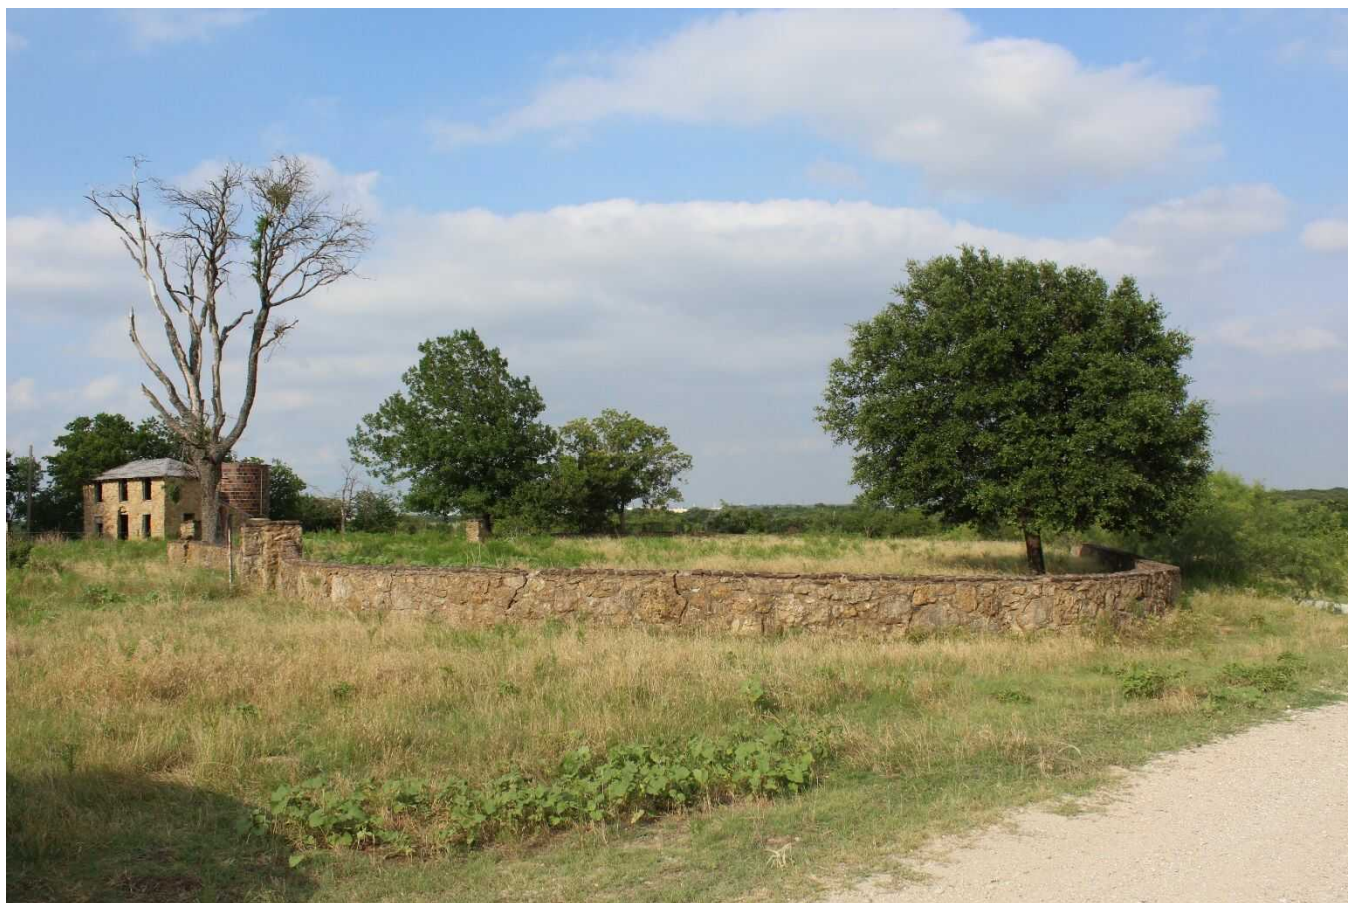
Survey Date:	June 24, 2019
Resource No:	01c
Project Location:	Denton County
Project Name and CSJ:	State Loop 288, CSJ 2250-02-014, etc.
Address, Lat/Long:	No Address, FM 2449 33.185775, -97.206128
Function/Sub-function:	AGRICULTURE/Walls
Construction Date:	Ca. 1920
NRHP Eligibility:	Not Eligible
Integrity/Comments:	Resource 01c is a series of stone walls that once enclosed a yard in front of the main house (demolished).

Camera facing northeast.

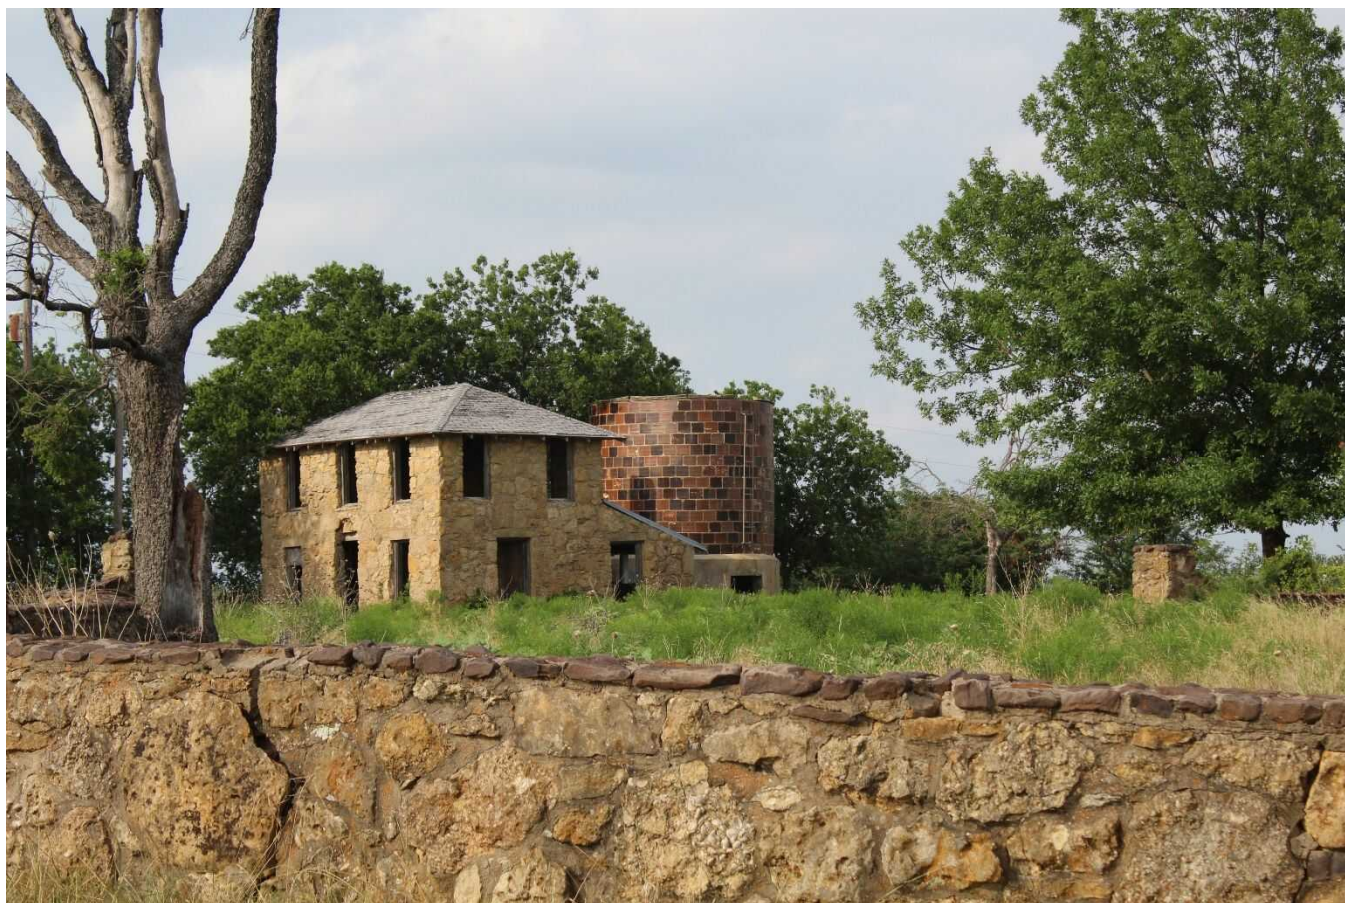
Survey Date:	June 24, 2019
Resource No:	01c
Project Location:	Denton County
Project Name and CSJ:	State Loop 288, CSJ 2250-02-014, etc.
Address, Lat/Long:	No Address, FM 2449 33.185775, -97.206128
Function/Sub-function:	AGRICULTURE/Walls
Construction Date:	Ca. 1920
NRHP Eligibility:	Not Eligible
Integrity/Comments:	Resource 01c is a series of stone walls than once enclosed a yard in front of the main house (demolished).

Wall detail, camera facing northeast.

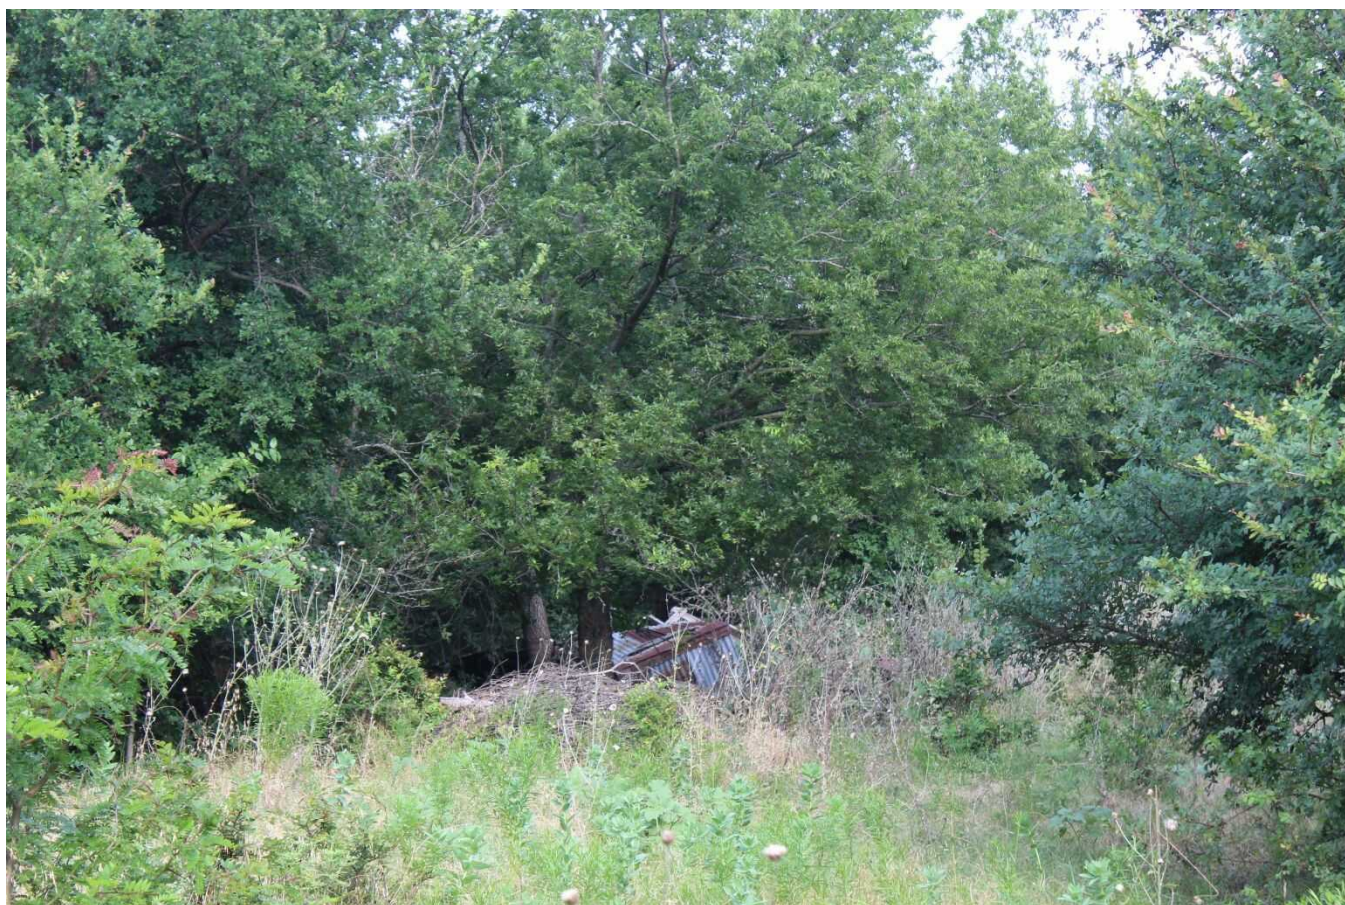
Survey Date:	June 24, 2019
Resource No:	01d
Project Location:	Denton County
Project Name and CSJ:	State Loop 288, CSJ 2250-02-014, etc.
Address, Lat/Long:	No Address, FM 2449 33.186409, -97.204884
Function/Sub-function:	AGRICULTURE/Ruin
Construction Date:	Ca. 1940
NRHP Eligibility:	Not Eligible
Integrity/Comments:	Resource 01d is a collapsed wood barn. Nothing structural remains.

Camera facing north.

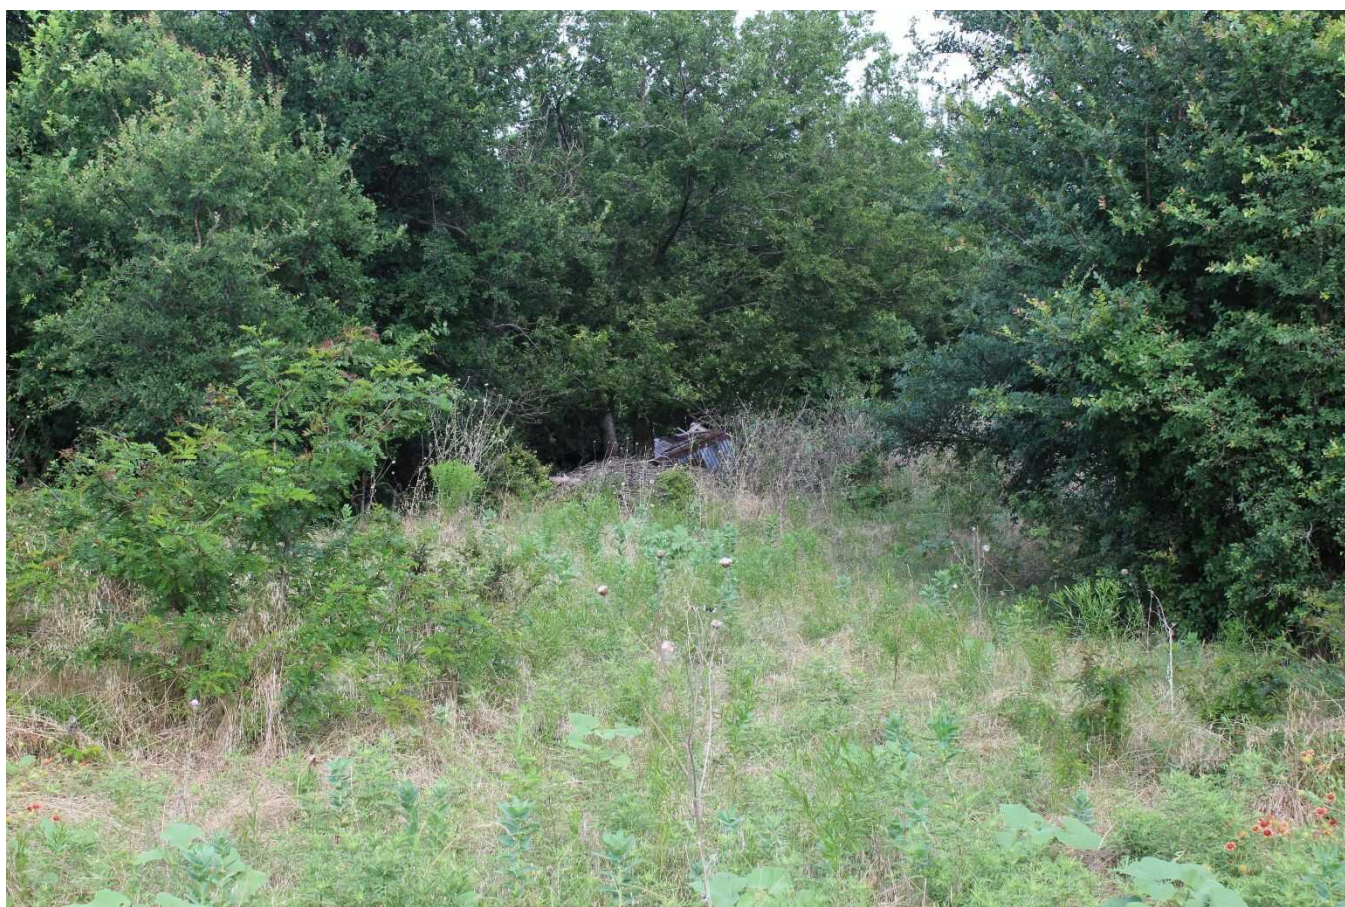
Survey Date:	June 24, 2019
Resource No:	01d
Project Location:	Denton County
Project Name and CSJ:	State Loop 288, CSJ 2250-02-014, etc.
Address, Lat/Long:	No Address, FM 2449 33.186409, -97.204884
Function/Sub-function:	AGRICULTURE/Ruin
Construction Date:	Ca. 1940
NRHP Eligibility:	Not Eligible
Integrity/Comments:	Resource 01d is a collapsed wood barn. Nothing structural remains.

Camera facing north.

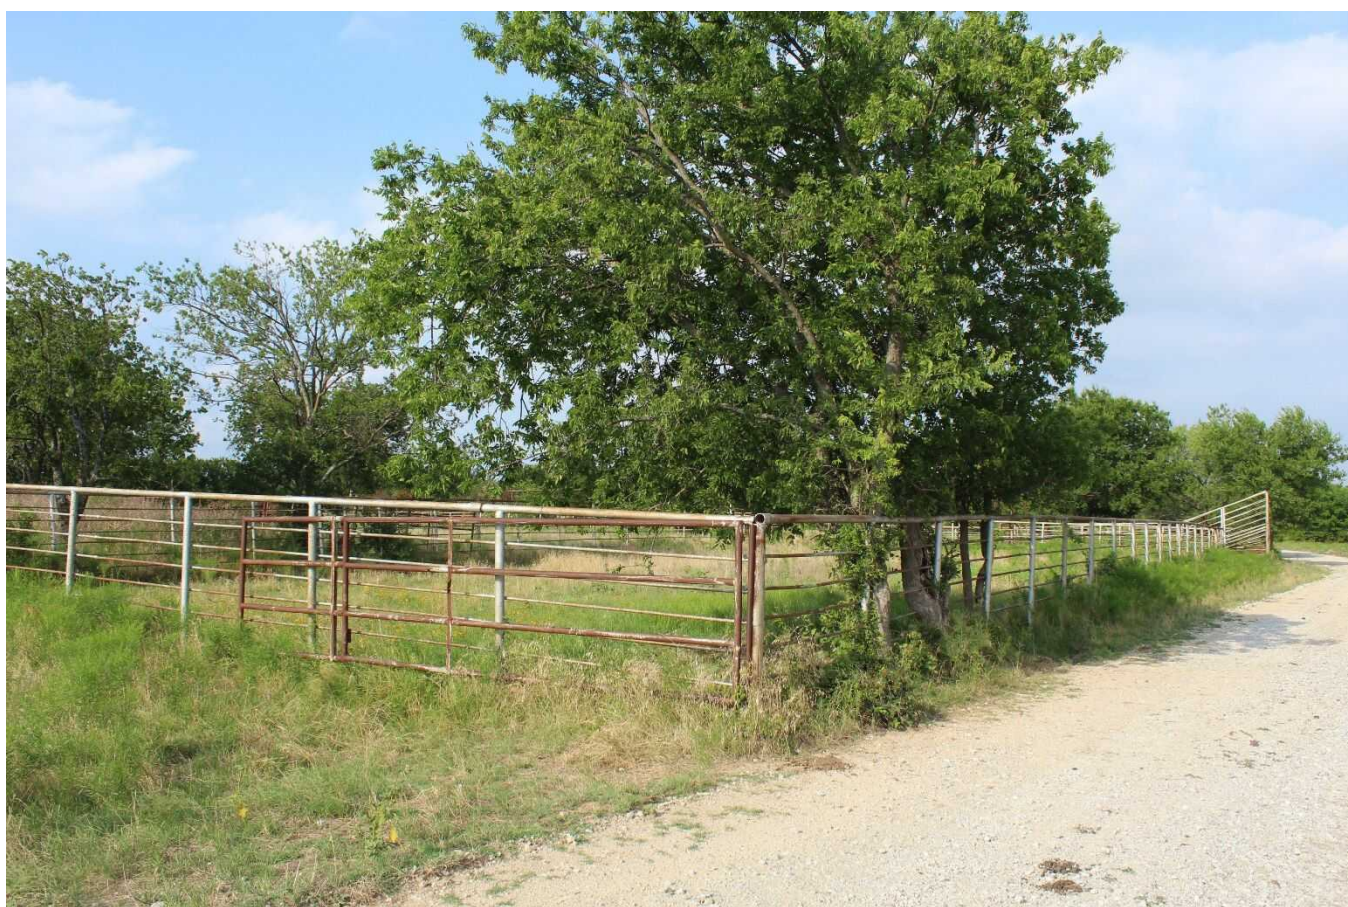
Survey Date:	June 24, 2019
Resource No:	01e
Project Location:	Denton County
Project Name and CSJ:	State Loop 288, CSJ 2250-02-014, etc.
Address, Lat/Long:	No Address, FM 2449 33.185718, -97.204535
Function/Sub-function:	AGRICULTURE/Corral
Construction Date:	Ca. 1955
NRHP Eligibility:	Not Eligible
Integrity/Comments:	Resource 01e is an animal corral composed of a series of steel tube fencing, with a steel tube cattle gate. Historic aerials show a barn was once located adjacent to the corrals, but it has been demolished.

Camera facing northeast.

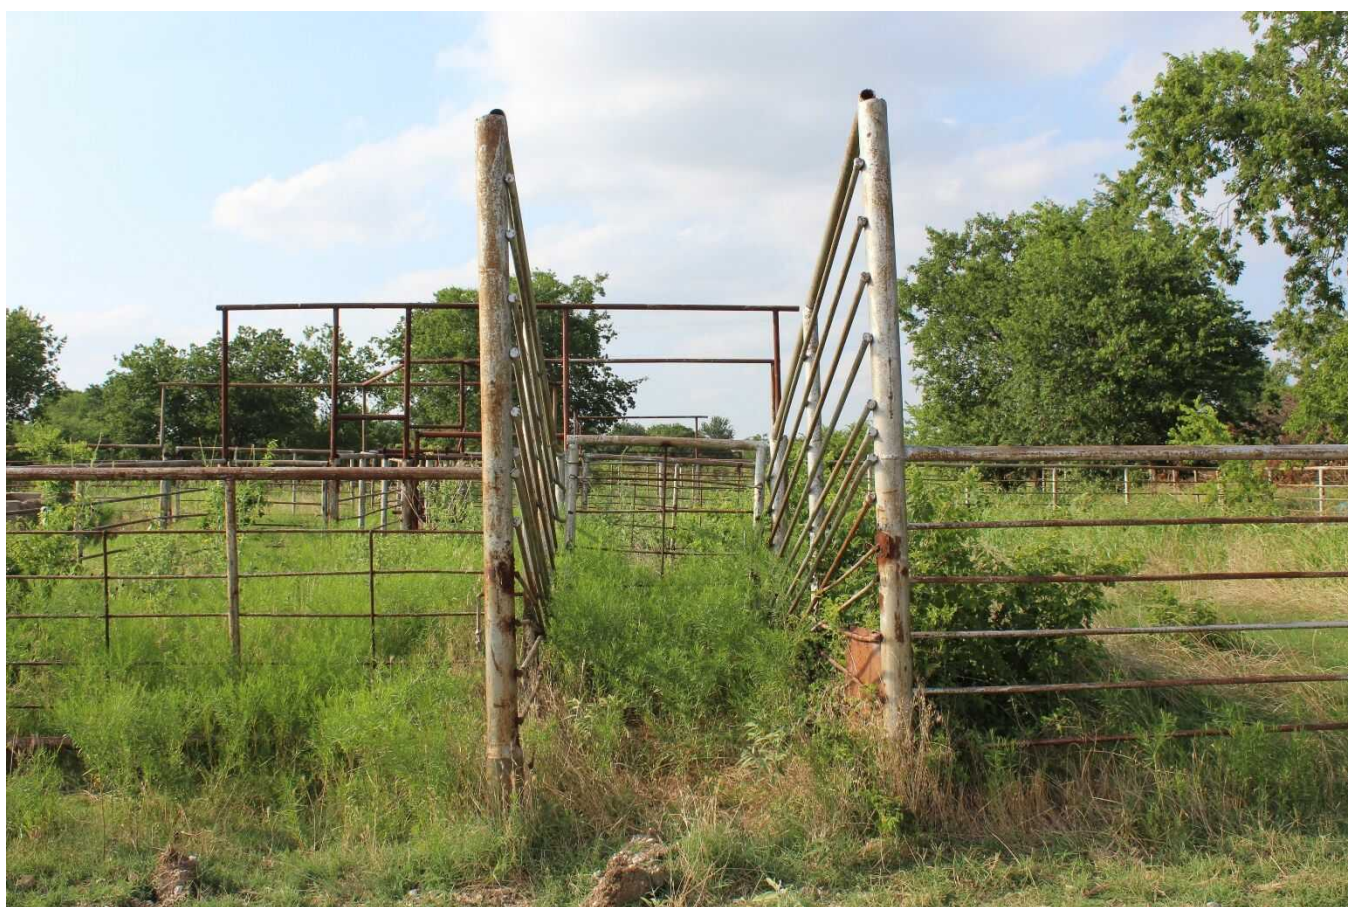
Survey Date:	June 24, 2019
Resource No:	01e
Project Location:	Denton County
Project Name and CSJ:	State Loop 288, CSJ 2250-02-014, etc.
Address, Lat/Long:	No Address, FM 2449 33.185718, -97.204535
Function/Sub-function:	AGRICULTURE/Corral
Construction Date:	Ca. 1955
NRHP Eligibility:	Not Eligible
Integrity/Comments:	Resource 01e is an animal corral composed of a series of steel tube fencing, with a steel tube cattle gate. Historic aerials show a barn was once located adjacent to the corrals but it has been demolished.

Cattle gate, camera facing north.

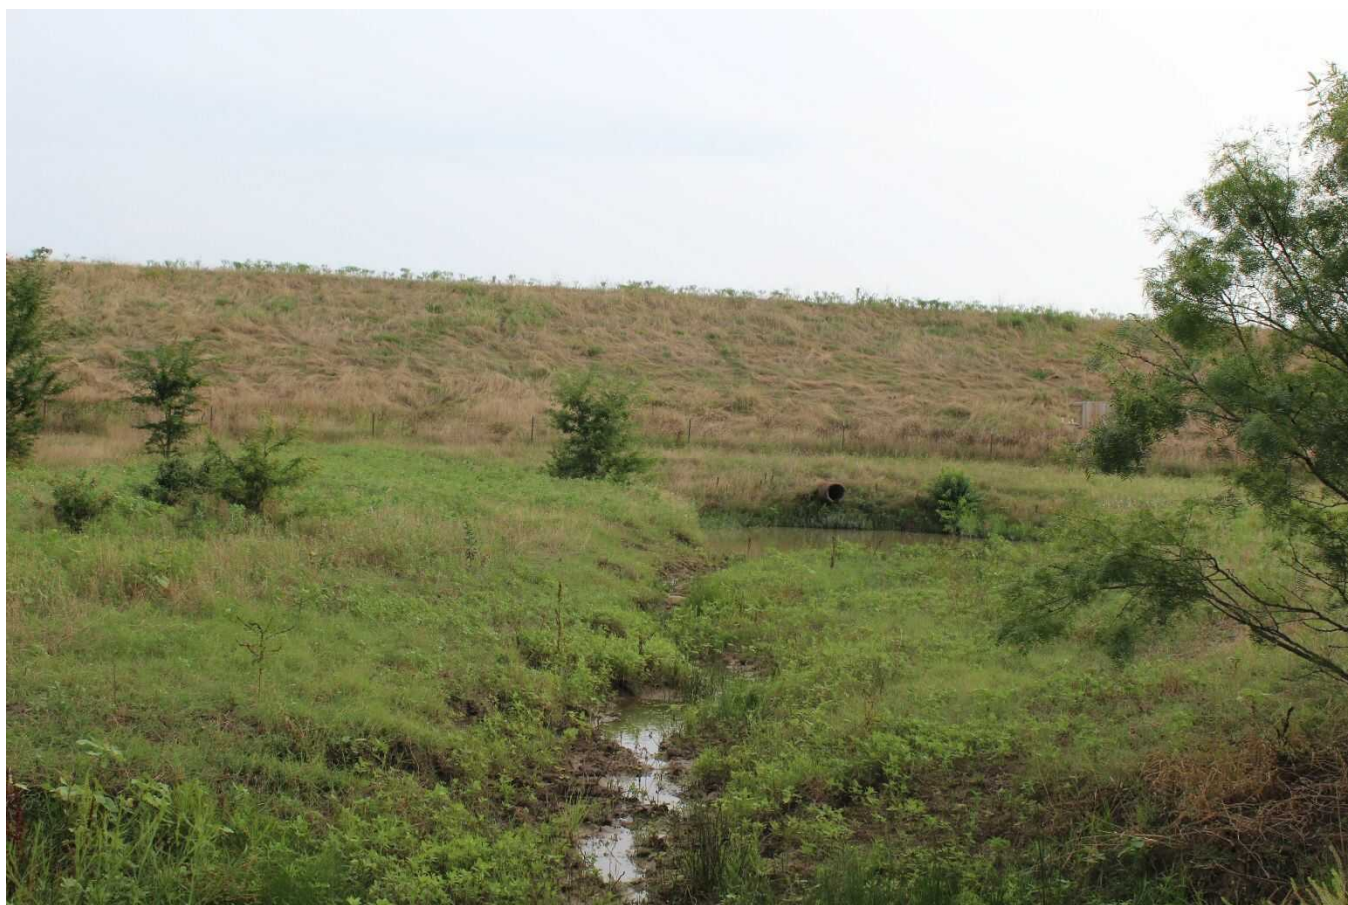
Survey Date:	June 24, 2019
Resource No:	01f
Project Location:	Denton County
Project Name and CSJ:	State Loop 288, CSJ 2250-02-014, etc.
Address, Lat/Long:	No Address, FM 2449 33.185047, -97.205264
Function/Sub-function:	AGRICULTURE/Dam
Construction Date:	Ca. 1955
NRHP Eligibility:	Not Eligible
Integrity/Comments:	Resource 01f is the Soil Conservation Service Site 13 Reservoir dam. The earthen embankment dam is roughly 900 feet long with a single concrete pipe serving as a spillway. It impounds a section of Hickory Creek.

Camera facing south.

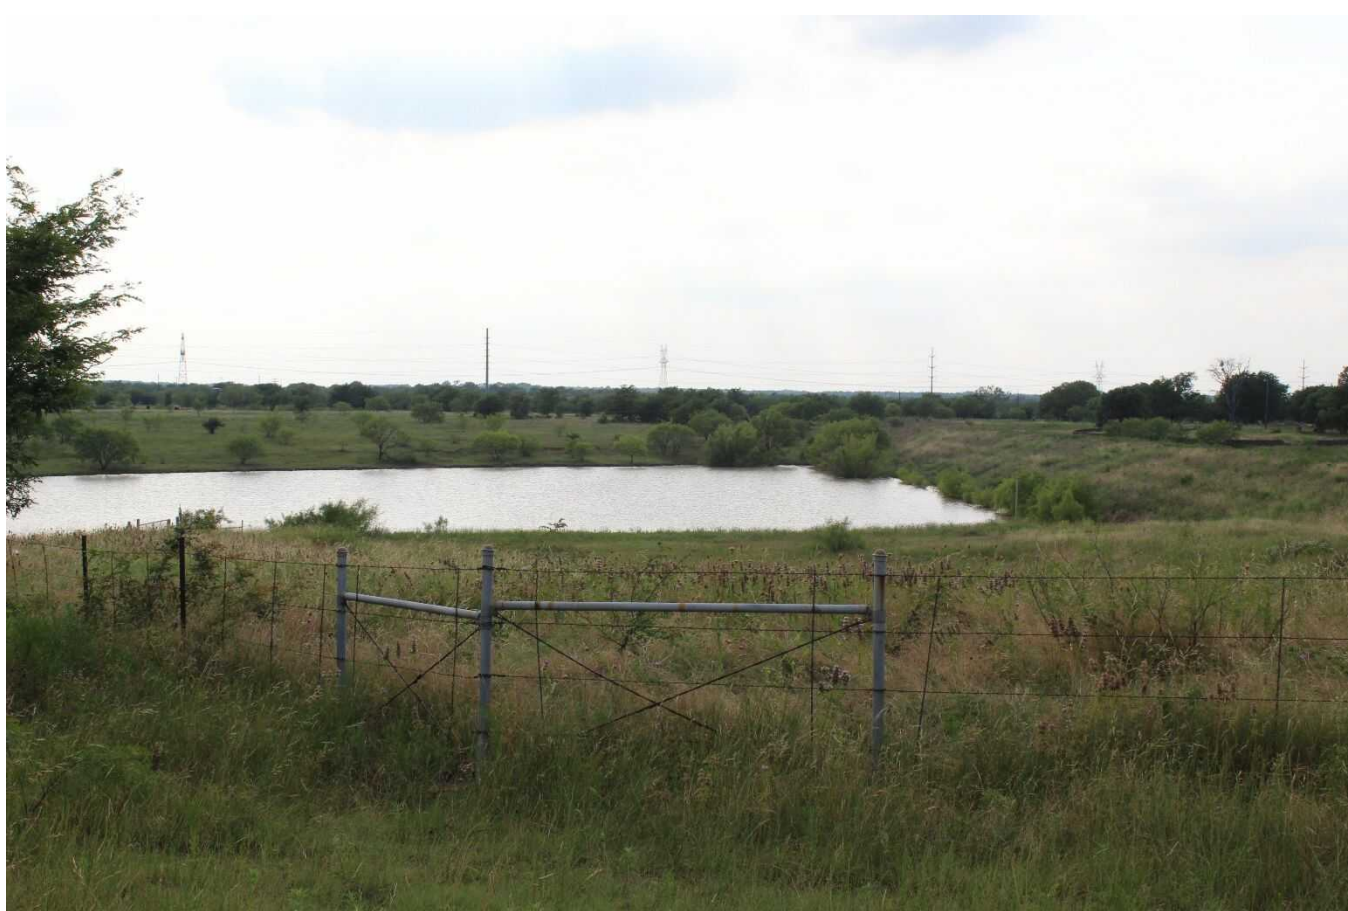
Survey Date:	June 24, 2019
Resource No:	01f
Project Location:	Denton County
Project Name and CSJ:	State Loop 288, CSJ 2250-02-014, etc.
Address, Lat/Long:	No Address, FM 2449 33.185047, -97.205264
Function/Sub-function:	AGRICULTURE/Dam
Construction Date:	Ca. 1955
NRHP Eligibility:	Not Eligible
Integrity/Comments:	Resource 01f is the Soil Conservation Service Site 13 Reservoir dam. The earthen embankment dam is roughly 900 feet long with a single concrete pipe serving as a spillway. It impounds a section of Hickory Creek.

Camera facing west.

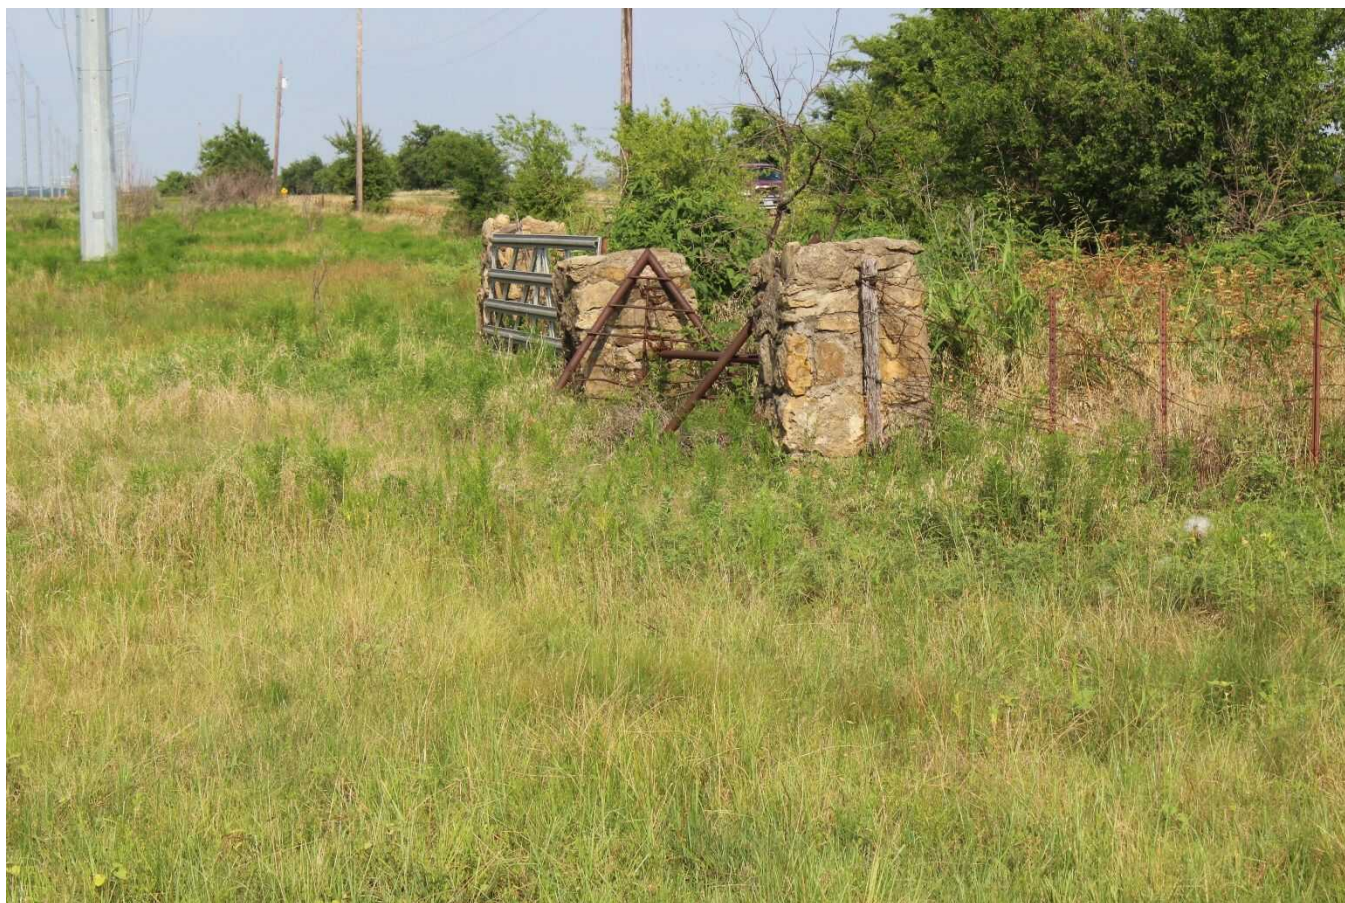
Survey Date:	June 24, 2019
Resource No:	01g
Project Location:	Denton County
Project Name and CSJ:	State Loop 288, CSJ 2250-02-014, etc.
Address, Lat/Long:	No Address, FM 2449 33.177147, -97.202229
Function/Sub-function:	AGRICULTURE/Gate
Construction Date:	Ca. 1920
NRHP Eligibility:	Not Eligible
Integrity/Comments:	Resource 01g is the original stone gate for the Cole Ranch. It is no longer in use and has been replaced by a steel gate immediately to the west.

Camera facing northwest.

Resource No.	Address/ Location	Function/ Sub-function	Architectural Style	Date(s)	Integrity/Comments	NRHP Eligibility
01g	No Address, FM 2449 33.177147, -97.202229	AGRICULTURE/Gate	No Style	Ca. 1920	Resource 01g is the original stone gate for the Cole Ranch. It is no longer in use and has been replaced by a steel gate immediately to the west.	Not Eligible
02a	No Address, Tom Cole Road 33.204486, -97.210206	AGRICULTURE/Barn	No Style	Ca. 1965	Resource 02a is a barn of frame construction featuring a metal saltbox roof, vertical wood siding painted red, four open bays running parallel to the roof ridgeline, and a gable-side entry on the south façade. The barn is vacant/not in use. The west-half of the roof is missing, exposing the rafters. A fence extends from the east façade, forming a pen.	Not Eligible
02b	No Address, Tom Cole Road 33.204252, -97.207320	AGRICULTURE/storag e tank	No Style	Ca. 1965	Resource 02b is an elevated multi-column storage tank. It is supported by four steel columns. A steel ladder is attached to the tank.	Not Eligible

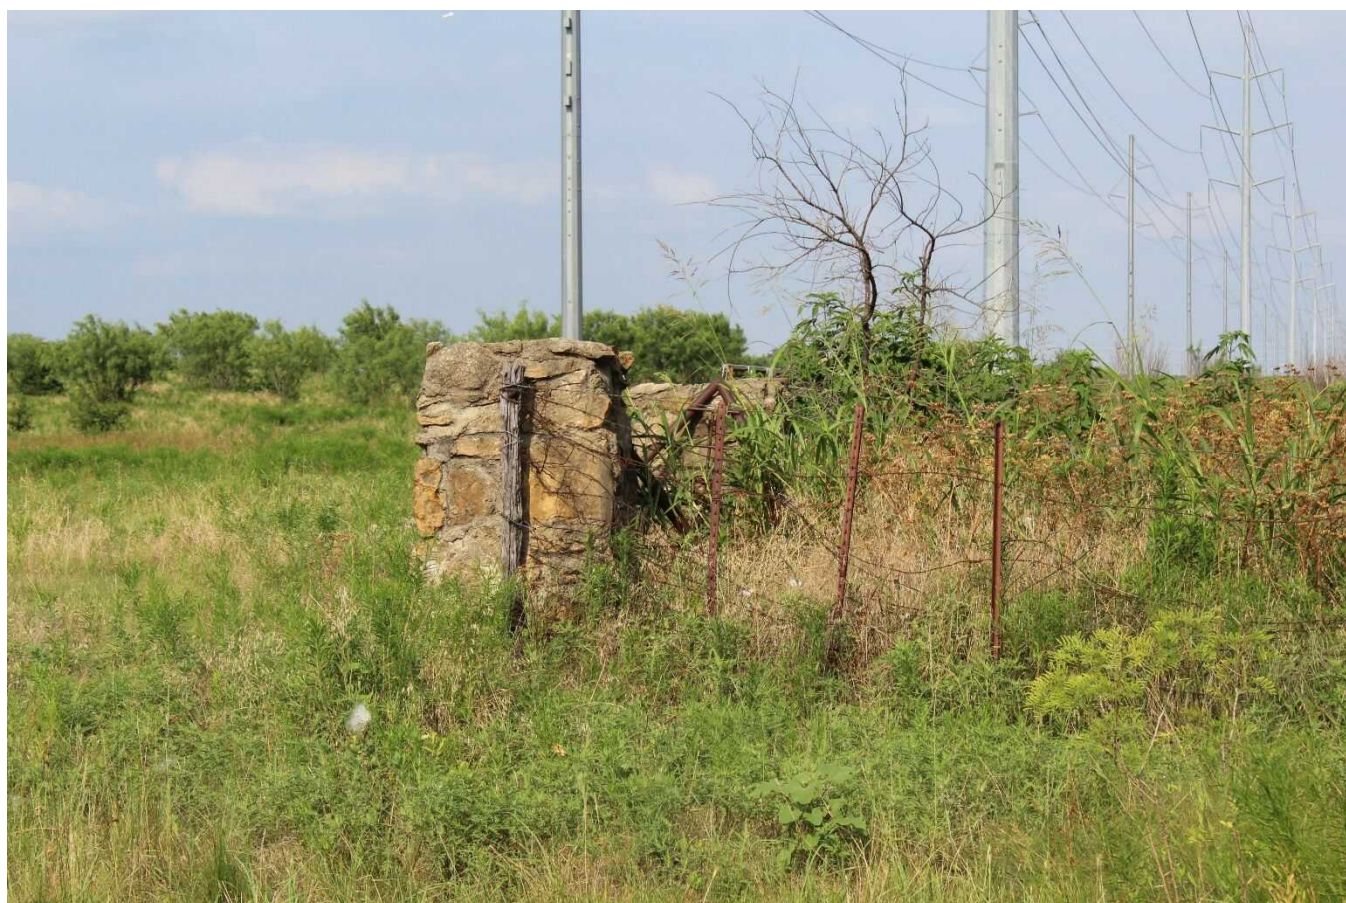
Survey Date:	June 24, 2019
Resource No:	01g
Project Location:	Denton County
Project Name and CSJ:	State Loop 288, CSJ 2250-02-014, etc.
Address, Lat/Long:	No Address, FM 2449 33.177147, -97.202229
Function/Sub-function:	AGRICULTURE/Gate
Construction Date:	Ca. 1920
NRHP Eligibility:	Not Eligible
Integrity/Comments:	Resource 01g is the original stone gate for the Cole Ranch. It is no longer in use and has been replaced by a steel gate immediately to the west.

Camera facing northeast.

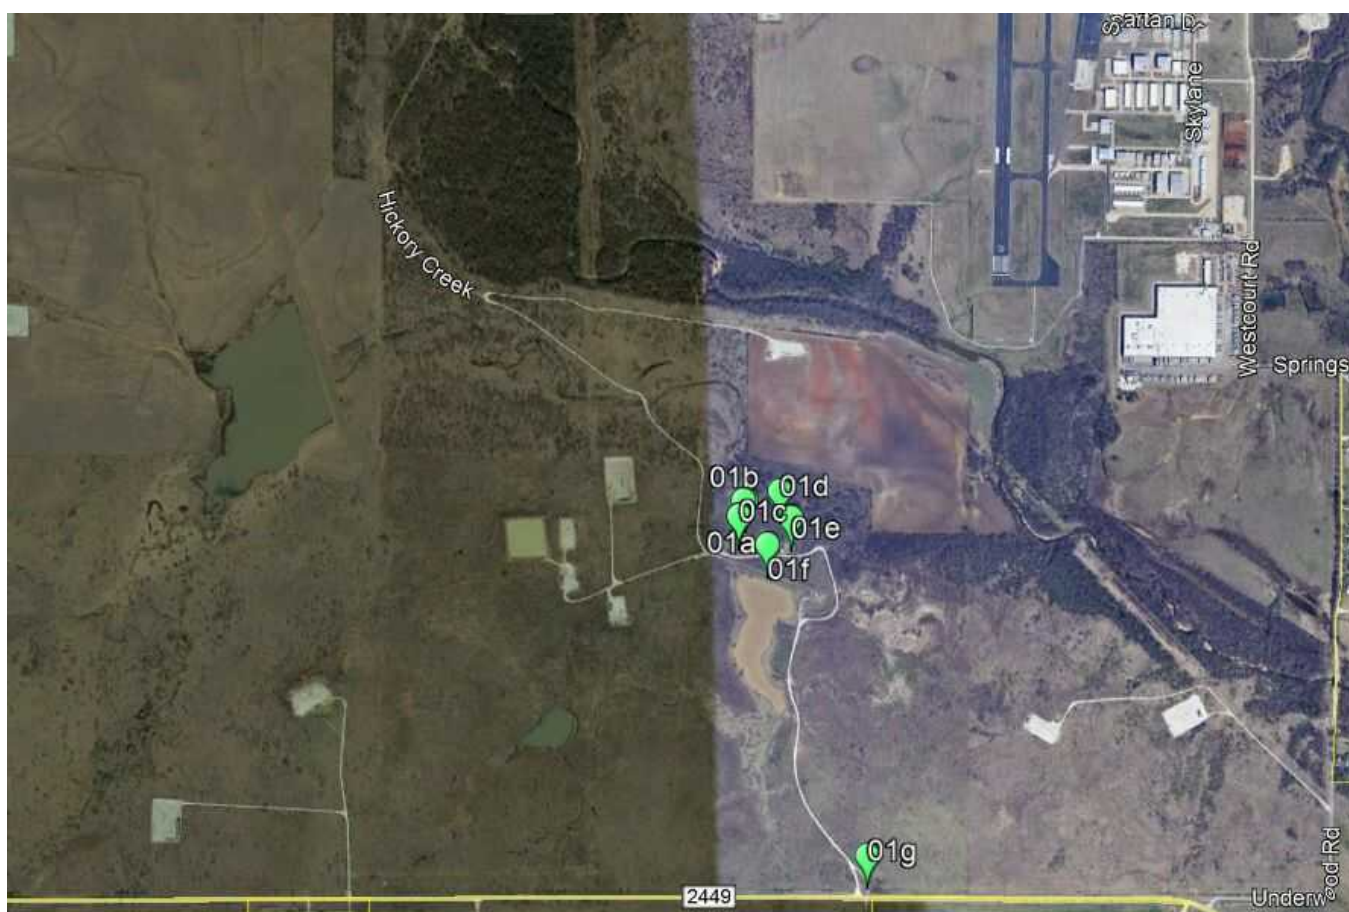
Survey Date:	June 24, 2019
Resource No:	01
Project Location:	Denton County
Project Name and CSJ:	State Loop 288, CSJ 2250-02-014, etc.
Address, Lat/Long:	No Address, FM 2449 33.186176, -97.205997
Function/Sub-function:	AGRICULTURE/Ranch
Construction Date:	Ca. 1920-1955
NRHP Eligibility:	Not Eligible
Integrity/Comments:	Resource 01 is the former Cole Ranch, which once consisted of a multitude of buildings up through the 1950s and was used for grain cultivation. The property has since been subdivided, most of the buildings have been demolished, and the land is now used only for cattle grazing. Several modern pump jacks and oil/gas related resources are located on the property due to oil leases (these date to the 1980s or later). Demolished buildings include the main house and all of the barns (including a wood Quonset hut style building).

Aerial view facing north.

For an agricultural property to be recommended eligible under Criterion C, at a minimum, the property must have integrity of design, workmanship, and materials. In addition, an agricultural property should have integrity of feeling (Moore, Jr, et al: 2013, 6-32). M.T. Cole Ranch lacks integrity of design due to the condition of its buildings and the demolition of its main house and several barns, which has affected the overall spatial relationship of the three agricultural zones. Therefore, Resource 01 is recommended not eligible under Criterion C.
