# Historical Resources Survey Report

## Reconnaissance Survey

**Project Name:** State Loop 288

**Project Limits:** IH 35W to IH 35

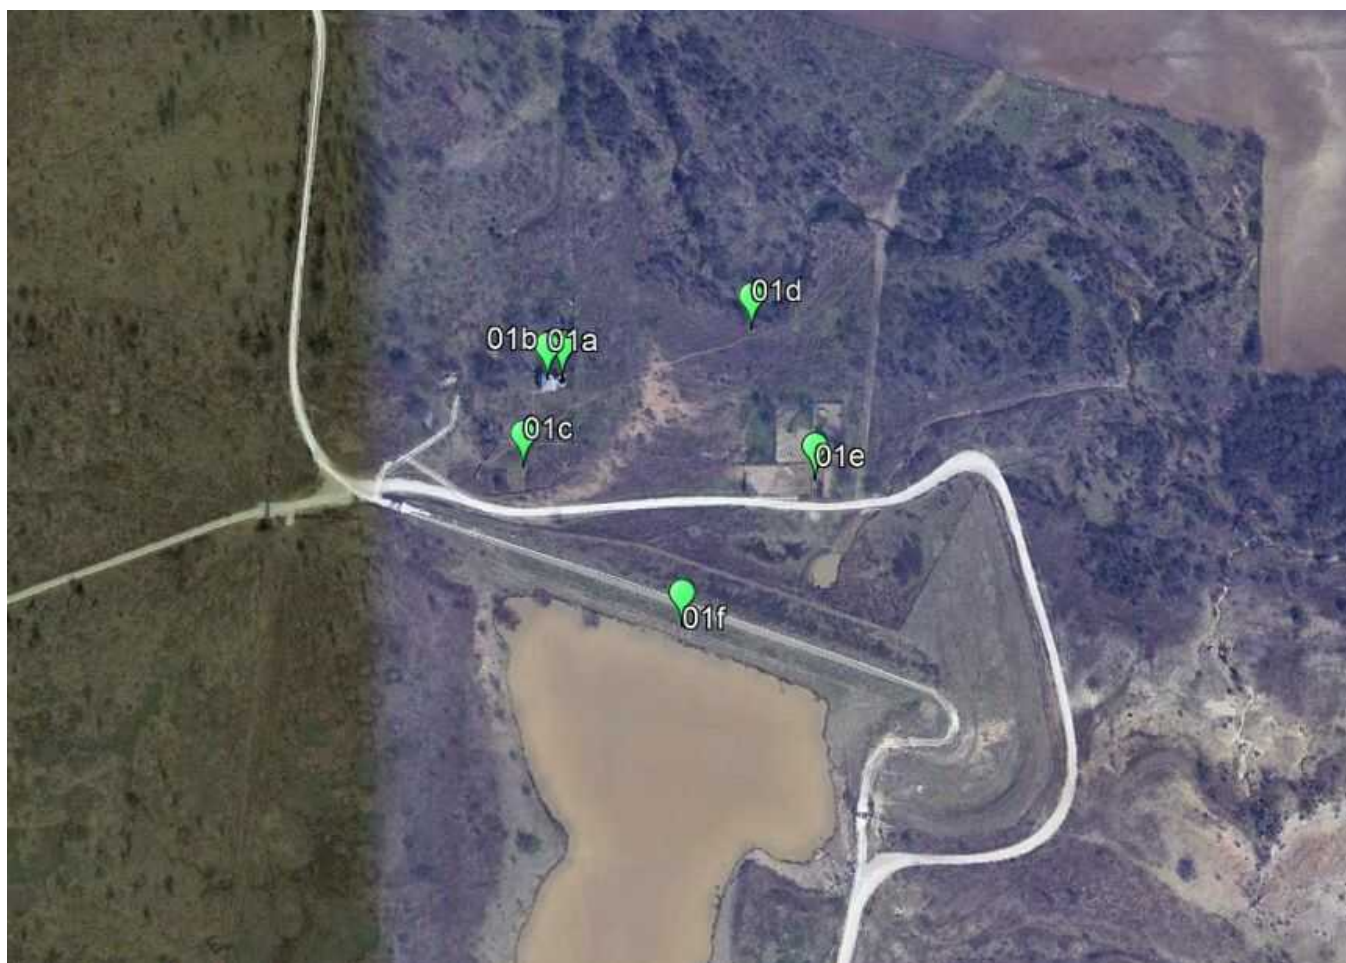
Survey Date:	June 24, 2019
Resource No:	01
Project Location:	Denton County
Project Name and CSJ:	State Loop 288, CSJ 2250-02-014, etc.
Address, Lat/Long:	No Address, FM 2449 33.186176, -97.205997
Function/Sub-function:	AGRICULTURE/Ranch
Construction Date:	Ca. 1920-1955
NRHP Eligibility:	Not Eligible
Integrity/Comments:	Resource 01 is the former Cole Ranch, which once consisted of a multitude of buildings up through the 1950s and was used for grain cultivation. The property has since been subdivided, most of the buildings have been demolished, and the land is now used only for cattle grazing. Several modern pump jacks and oil/gas related resources are located on the property due to oil leases (these date to the 1980s or later). Demolished buildings include the main house and all of the barns (including a wood Quonset hut style building).

Aerial view of the ranch core, facing north.

For an agricultural property to be recommended eligible under Criterion C, at a minimum, the property must have integrity of design, workmanship, and materials. In addition, an agricultural property should have integrity of feeling (Moore, Jr, et al: 2013, 6-32). M.T. Cole Ranch lacks integrity of design due to the condition of its buildings and the demolition of its main house and several barns, which has affected the overall spatial relationship of the three agricultural zones. Therefore, Resource 01 is recommended not eligible under Criterion C.

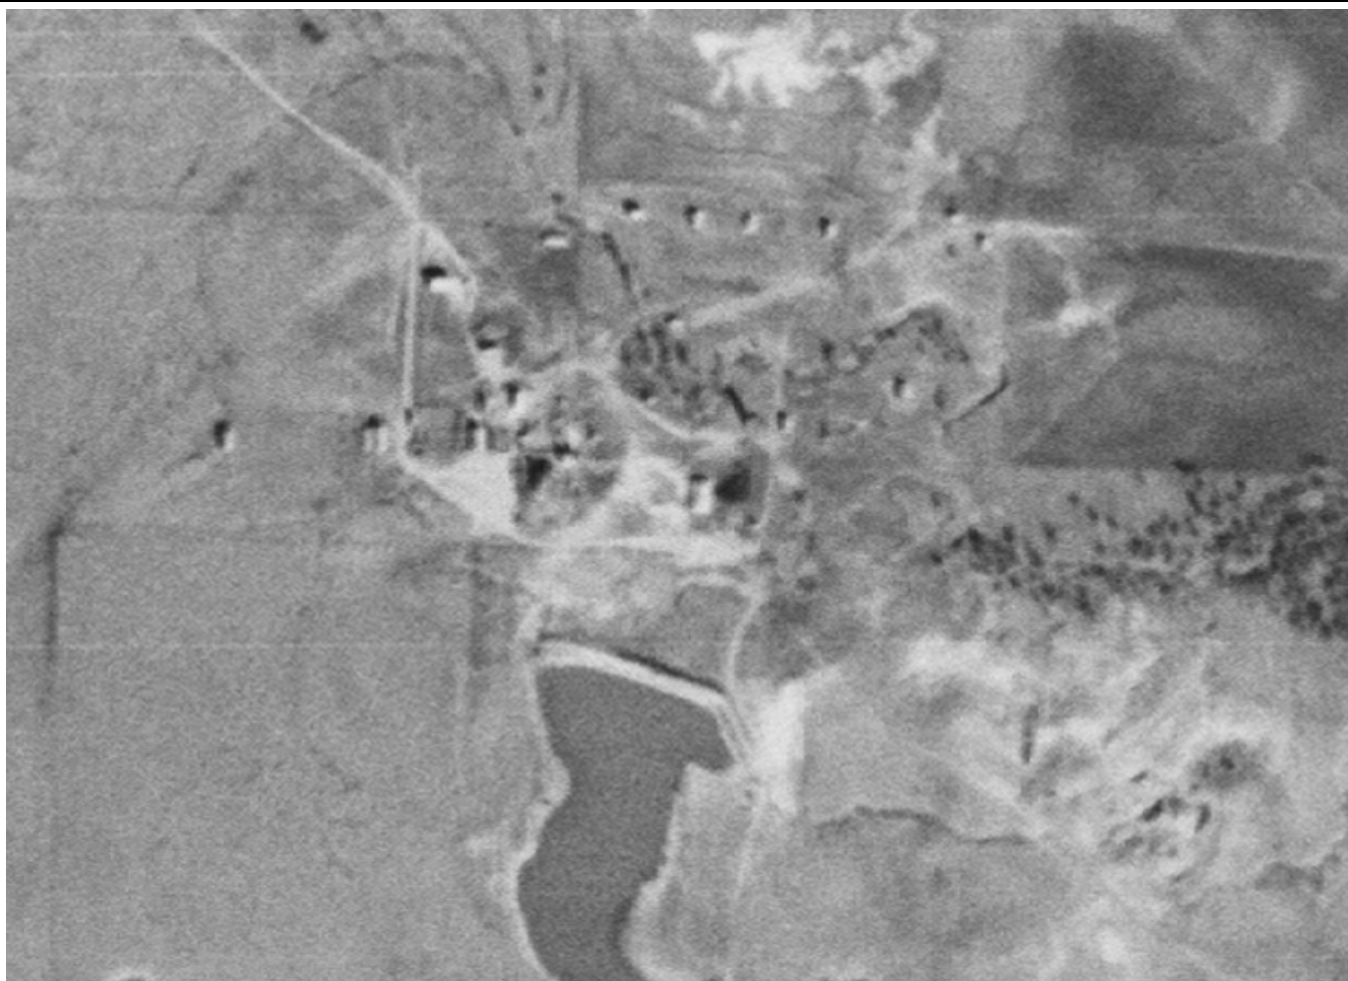
Survey Date:	June 24, 2019
Resource No:	01
Project Location:	Denton County
Project Name and CSJ:	State Loop 288, CSJ 2250-02-014, etc.
Address, Lat/Long:	No Address, FM 2449 33.186176, -97.205997
Function/Sub-function:	AGRICULTURE/Ranch
Construction Date:	Ca. 1920-1955
NRHP Eligibility:	Not Eligible
Integrity/Comments:	Resource 01 is the former Cole Ranch, which once consisted of a multitude of buildings up through the 1950s and was used for grain cultivation. The property has since been subdivided, most of the buildings have been demolished, and the land is now used only for cattle grazing. Several modern pump jacks and oil/gas related resources are located on the property due to oil leases (these date to the 1980s or later). Demolished buildings include the main house and all of the barns (including a wood Quonset hut style building).

1953 aerial photo of the ranch core. USGS.

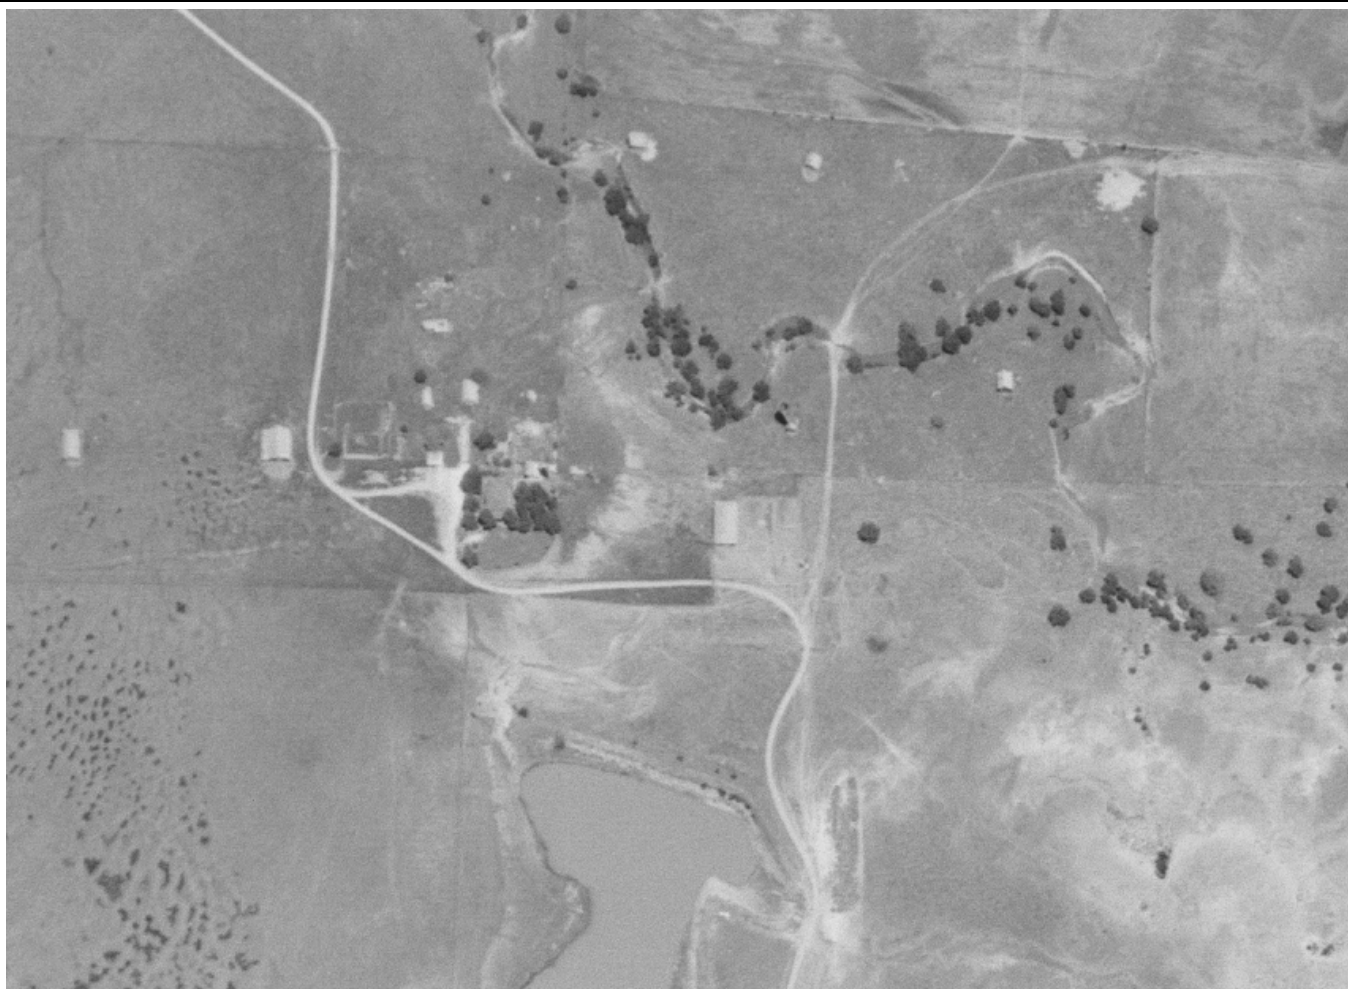
Survey Date:	June 24, 2019
Resource No:	01
Project Location:	Denton County
Project Name and CSJ:	State Loop 288, CSJ 2250-02-014, etc.
Address, Lat/Long:	No Address, FM 2449 33.186176, -97.205997
Function/Sub-function:	AGRICULTURE/Ranch
Construction Date:	Ca. 1920-1955
NRHP Eligibility:	Not Eligible
Integrity/Comments:	Resource 01 is the former Cole Ranch, which once consisted of a multitude of buildings up through the 1950s and was used for grain cultivation. The property has since been subdivided, most of the buildings have been demolished, and the land is now used only for cattle grazing. Several modern pump jacks and oil/gas related resources are located on the property due to oil leases (these date to the 1980s or later). Demolished buildings include the main house and all of the barns (including a wood Quonset hut style building).

1968 aerial photo of the ranch core. USGS.

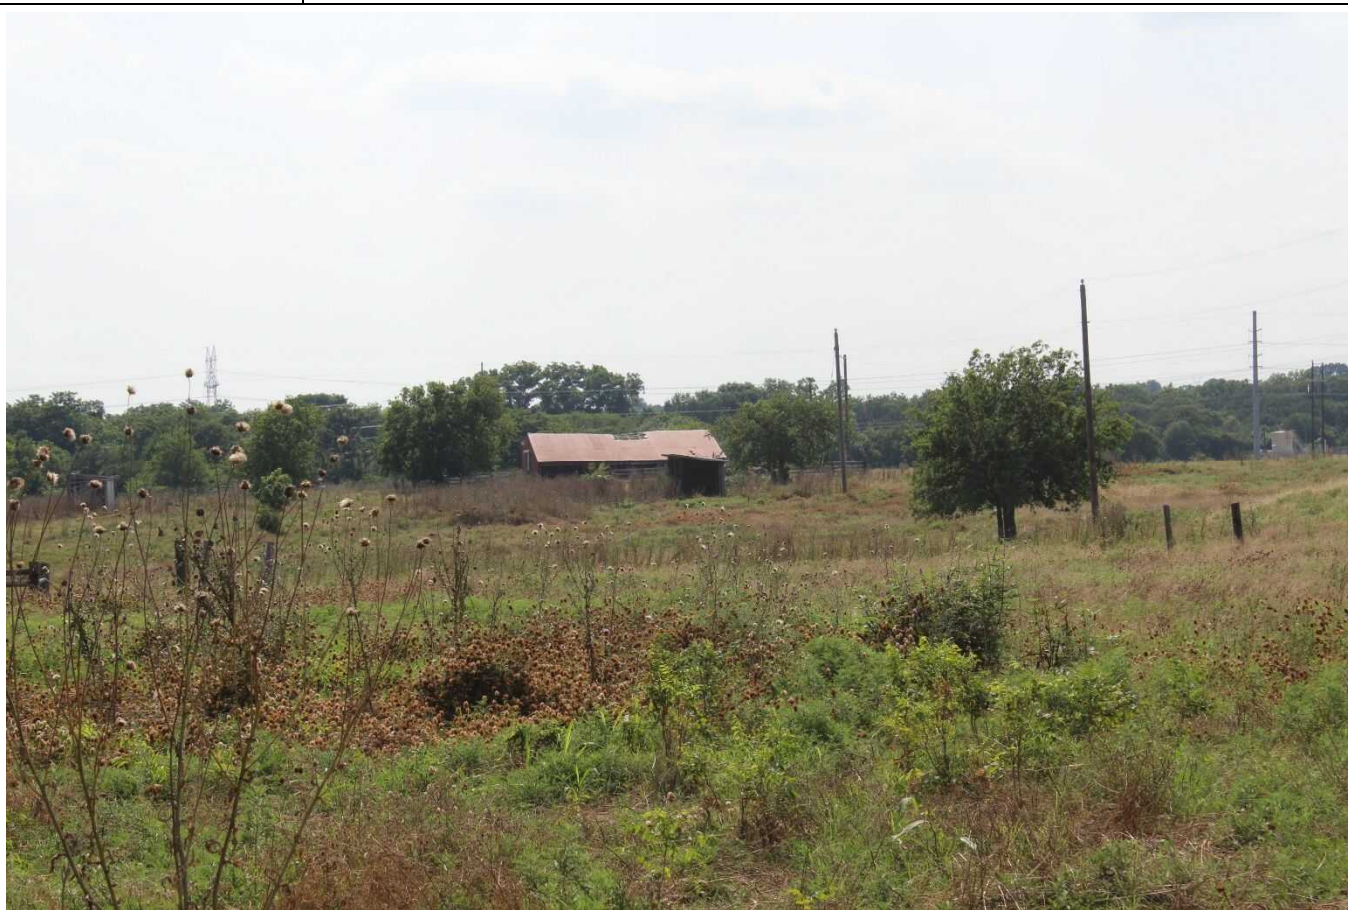
Survey Date:	June 24, 2019
Resource No:	02a
Project Location:	Denton County
Project Name and CSJ:	State Loop 288, CSJ 2250-02-014, etc.
Address, Lat/Long:	No Address, Tom Cole Road 33.204486, -97.210206
Function/Sub-function:	AGRICULTURE/Barn
Construction Date:	Ca. 1965
NRHP Eligibility:	Not eligible
Integrity/Comments:	Resource 02a is a barn of frame construction featuring a metal saltbox roof, vertical wood siding painted red, four open bays running parallel to the roof ridgeline, and a gable-side entry on the south façade. The barn is vacant/not in use. The west-half of the roof is missing, exposing the rafters. A fence extends from the east façade, forming a pen.

Camera facing west.

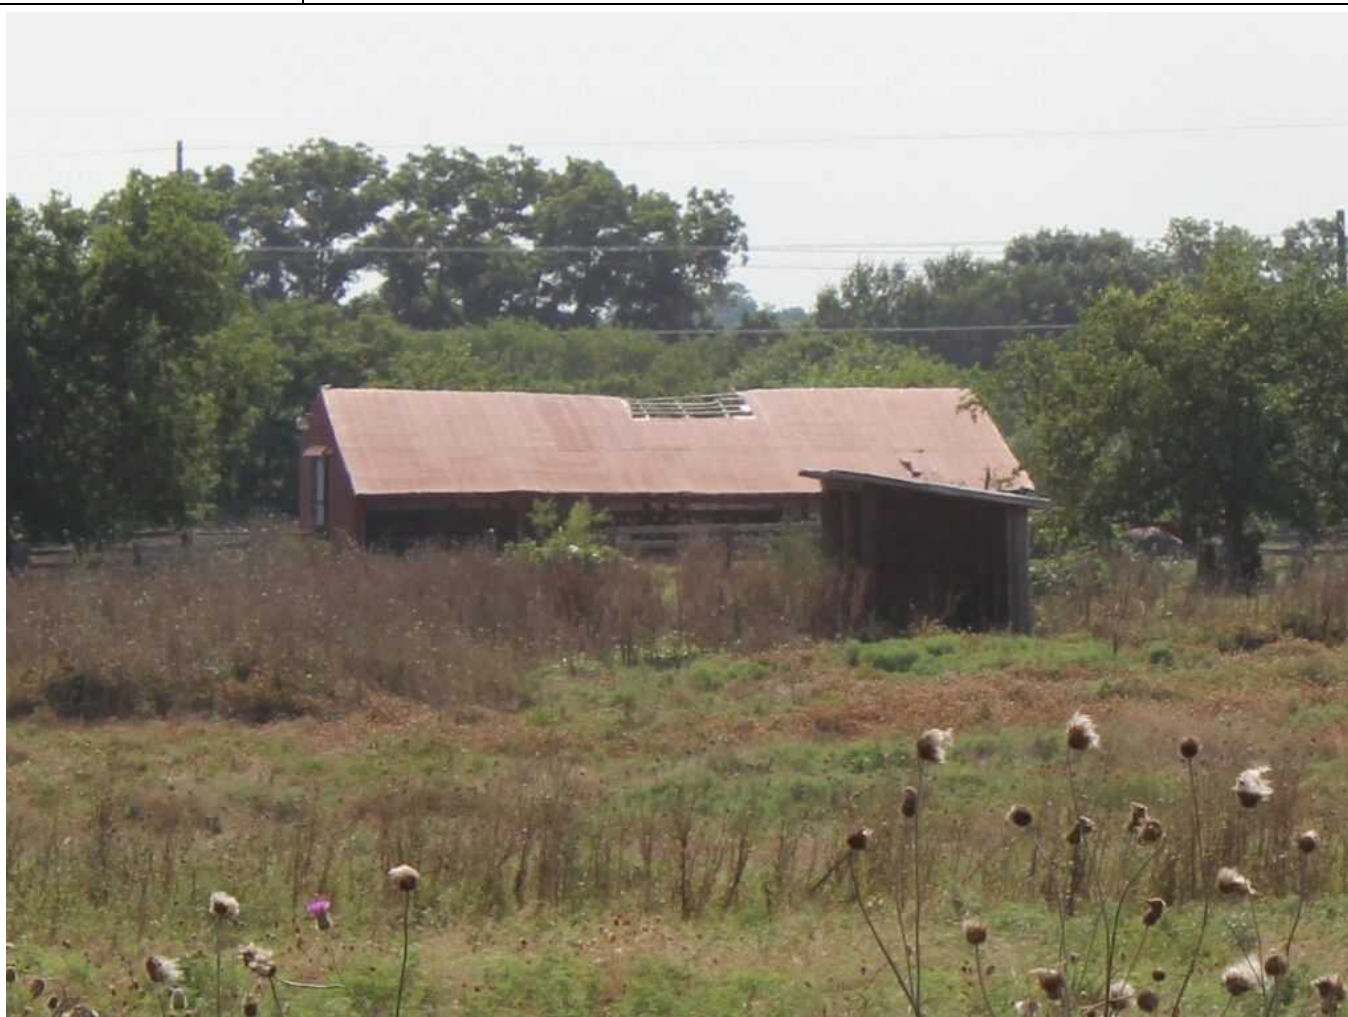
Survey Date:	June 24, 2019
Resource No:	02a
Project Location:	Denton County
Project Name and CSJ:	State Loop 288, CSJ 2250-02-014, etc.
Address, Lat/Long:	No Address, Tom Cole Road 33.204486, -97.210206
Function/Sub-function:	AGRICULTURE/Barn
Construction Date:	Ca. 1965
NRHP Eligibility:	Not eligible
Integrity/Comments:	Resource 02a is a barn of frame construction featuring a metal saltbox roof, vertical wood siding painted red, four open bays running parallel to the roof ridgeline, and a gable-side entry on the south façade. The barn is vacant/not in use. The west-half of the roof is missing, exposing the rafters. A fence extends from the east façade, forming a pen.

Camera facing west.

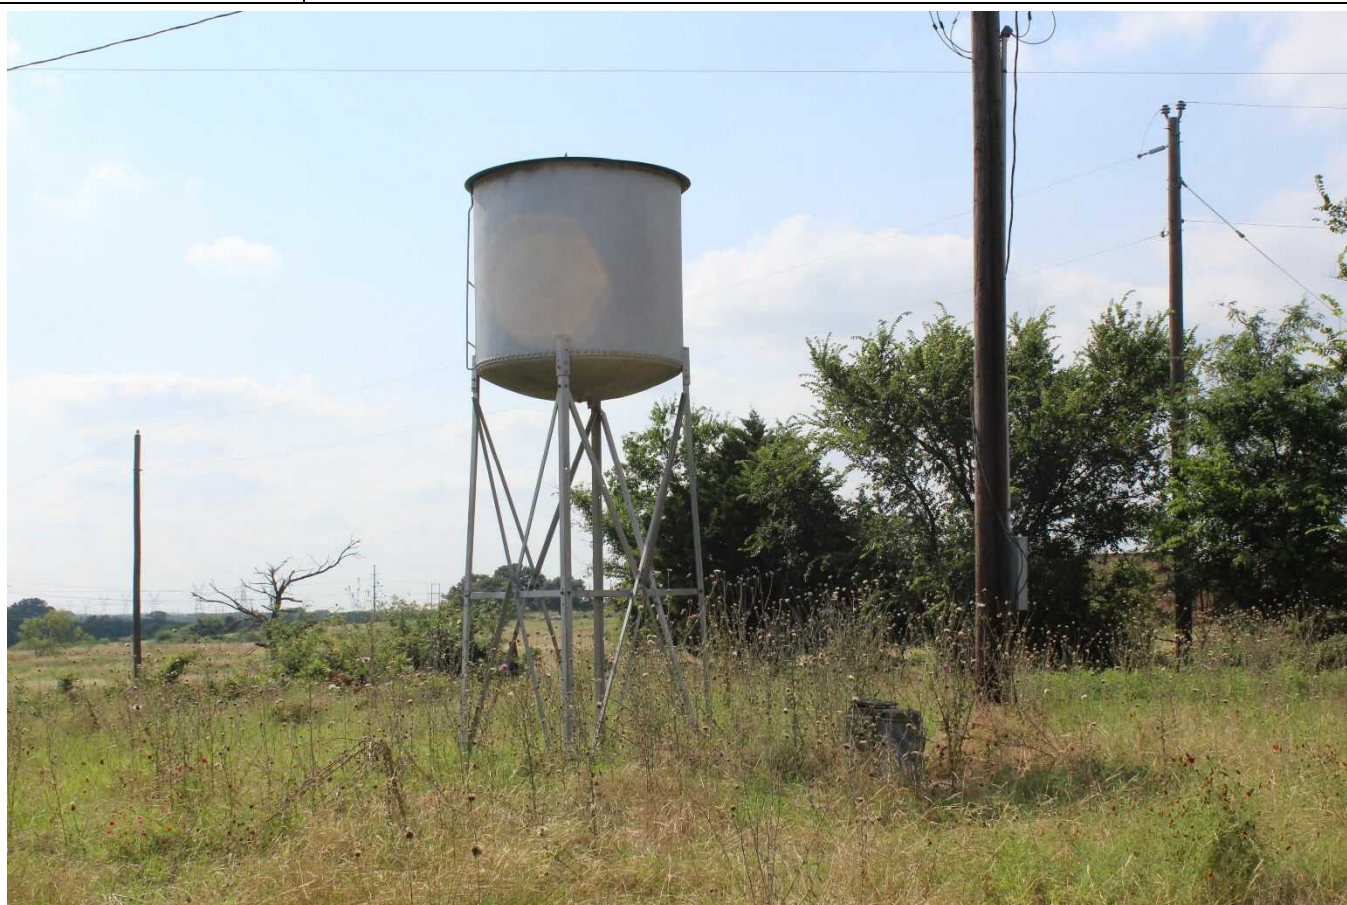
Survey Date:	June 24, 2019
Resource No:	02b
Project Location:	Denton County
Project Name and CSJ:	State Loop 288, CSJ 2250-02-014, etc.
Address, Lat/Long:	No Address, Tom Cole Road 33.204252, -97.207320
Function/Sub-function:	AGRICULTURE/storage tank
Construction Date:	Ca. 1965
NRHP Eligibility:	Not eligible
Integrity/Comments:	Resource 02b is an elevated multi-column storage tank. It is supported by four steel columns. A steel ladder is attached to the tank.

Camera facing northwest.

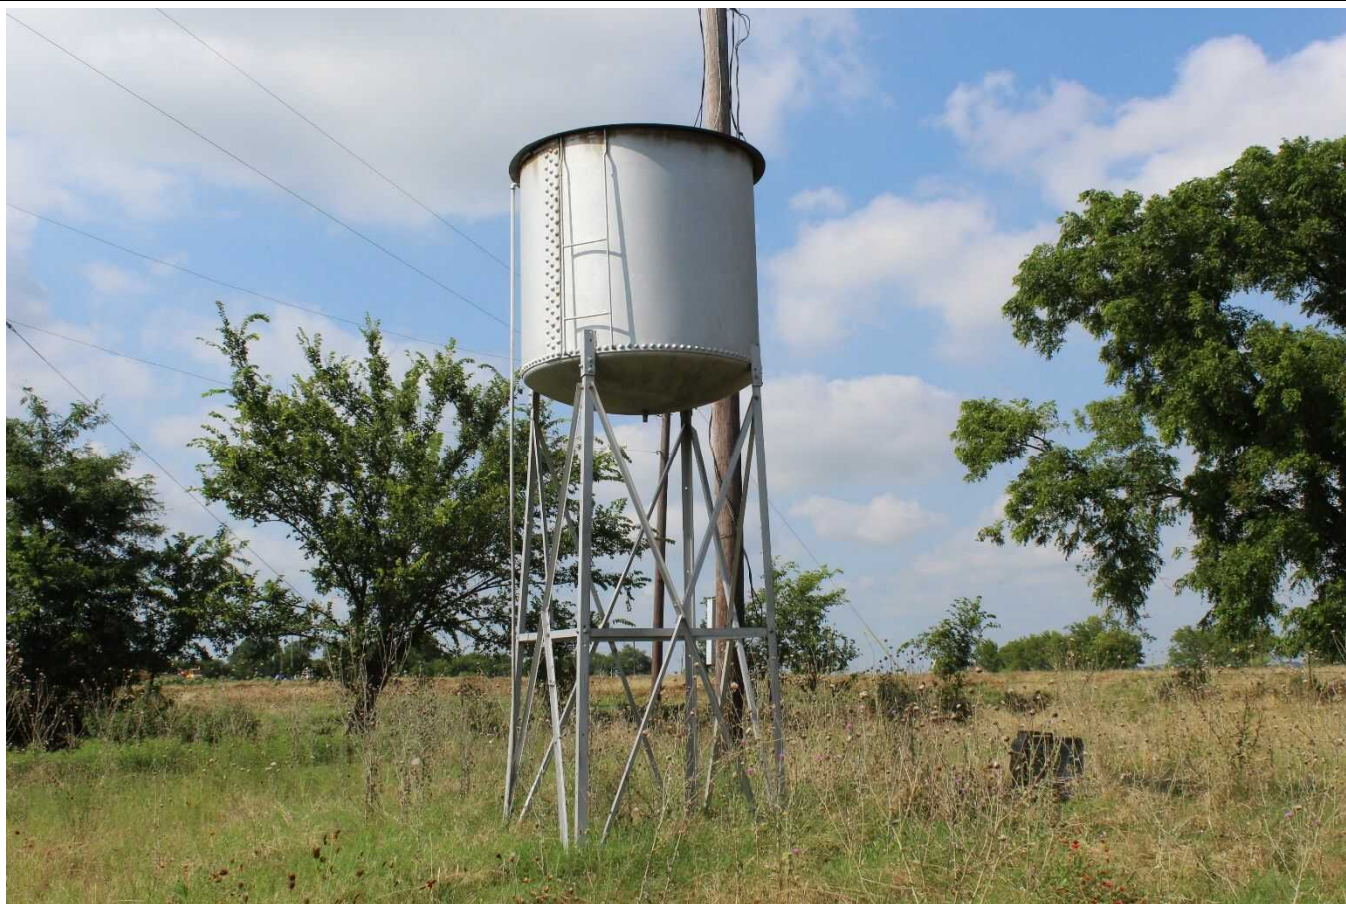
Survey Date:	June 24, 2019
Resource No:	02b
Project Location:	Denton County
Project Name and CSJ:	State Loop 288, CSJ 2250-02-014, etc.
Address, Lat/Long:	No Address, Tom Cole Road 33.204252, -97.207320
Function/Sub-function:	AGRICULTURE/storage tank
Construction Date:	Ca. 1965
NRHP Eligibility:	Not eligible
Integrity/Comments:	Resource 02b is an elevated multi-column storage tank. It is supported by four steel columns. A steel ladder is attached to the tank.

Camera facing southeast.

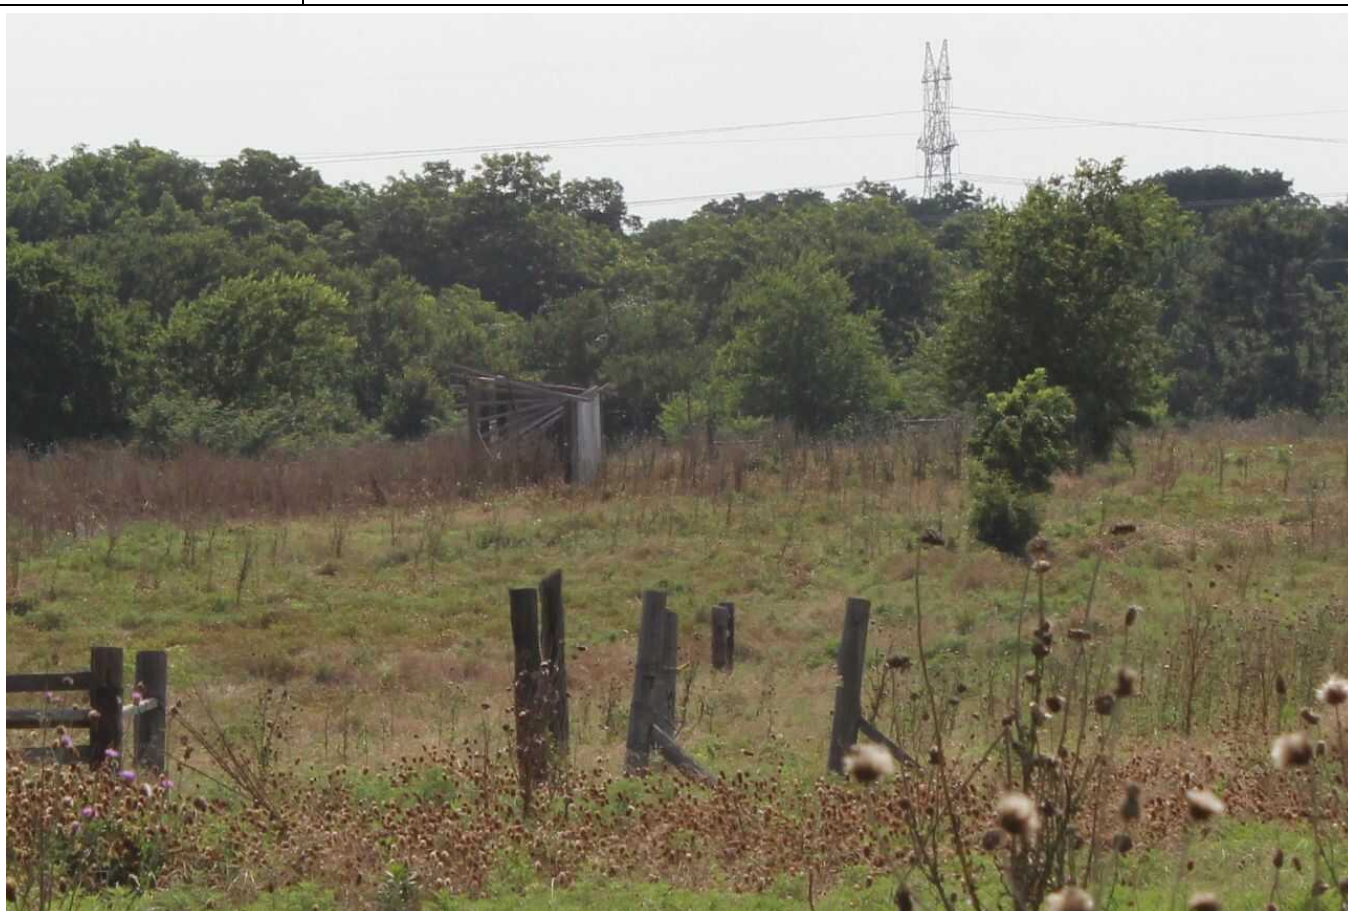
Survey Date:	June 24, 2019
Resource No:	02
Project Location:	Denton County
Project Name and CSJ:	State Loop 288, CSJ 2250-02-014, etc.
Address, Lat/Long:	No Address, Tom Cole Road 33.204545, -97.209910
Function/Sub-function:	AGRICULTURE/shed
Construction Date:	Ca. 2009
NRHP Eligibility:	Not eligible
Integrity/Comments:	Resource 02 includes two modern sheds. One shed is east of the barn, while the other is southeast of the barn. Per historic aerials, both sheds were not constructed until ca. 2009 and ca. 2010. Neither are in use.

Camera facing west.

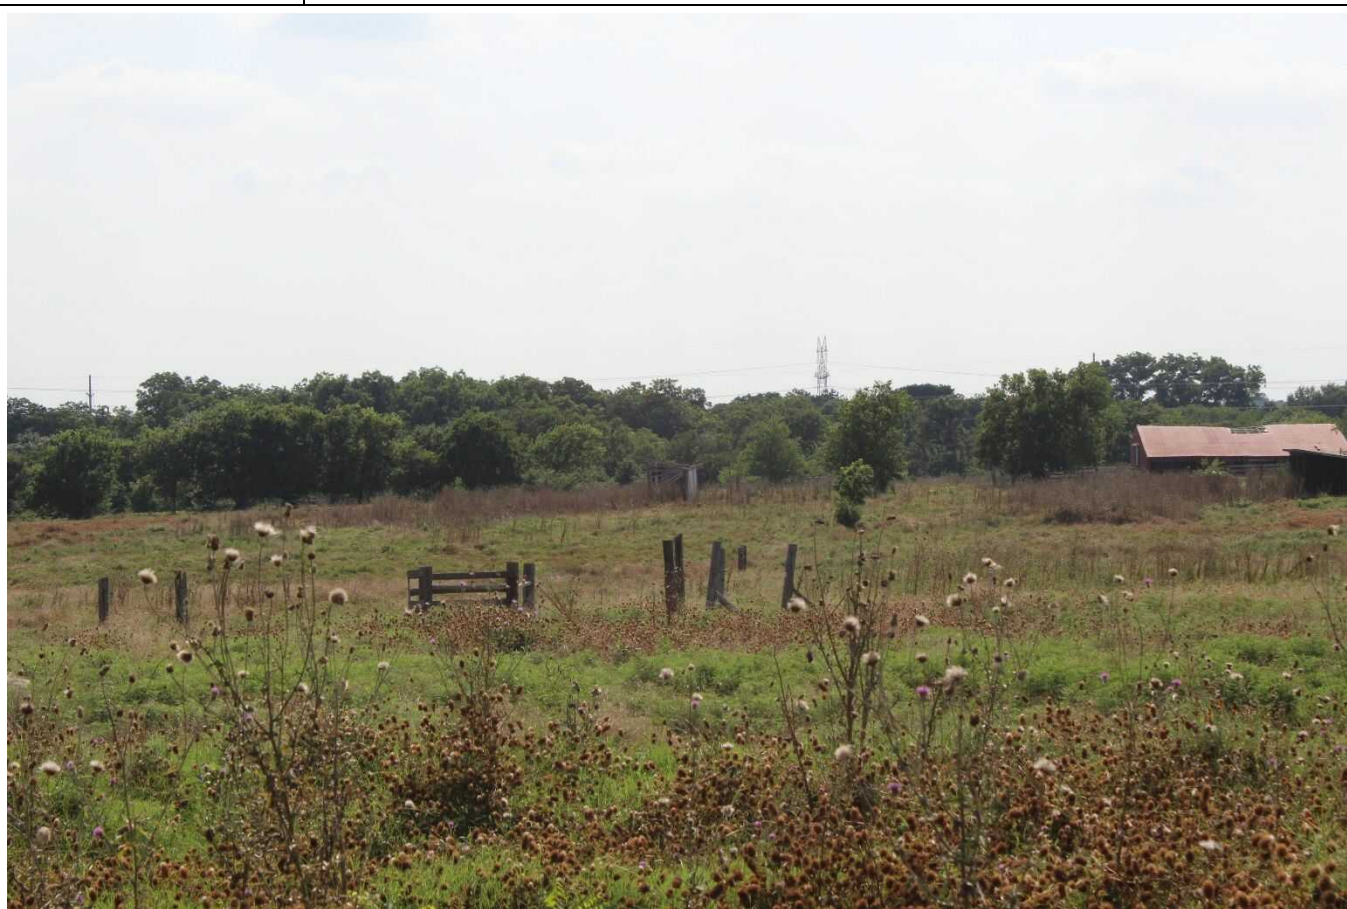
Survey Date:	June 24, 2019
Resource No:	02
Project Location:	Denton County
Project Name and CSJ:	State Loop 288, CSJ 2250-02-014, etc.
Address, Lat/Long:	No Address, Tom Cole Road 33.204119, -97.209862
Function/Sub-function:	AGRICULTURE/shed
Construction Date:	Ca. 2010
NRHP Eligibility:	Not eligible
Integrity/Comments:	Resource 02 includes two modern sheds. One shed is east of the barn, while the other is southeast of the barn. Per historic aerials, both sheds were not constructed until ca. 2009 and ca. 2010. Neither are in use.

Camera facing west.

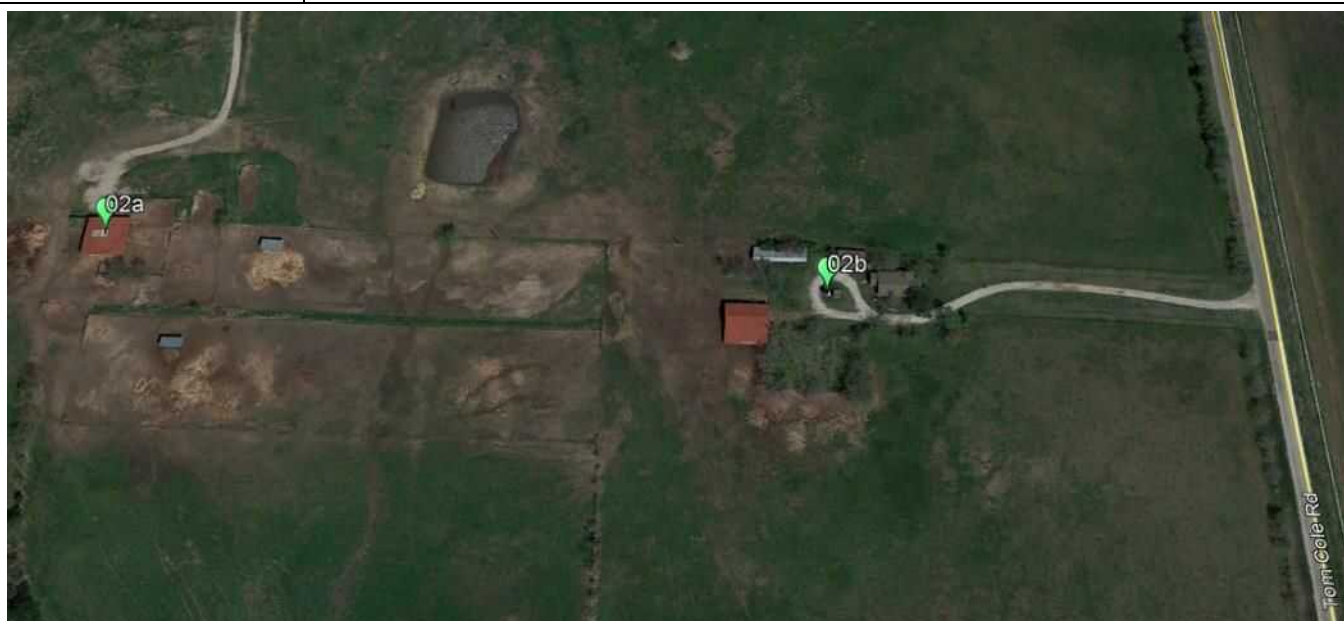
Survey Date:	June 24, 2019
Resource No:	02
Project Location:	Denton County
Project Name and CSJ:	State Loop 288, CSJ 2250-02-014, etc.
Address, Lat/Long:	No Address, Tom Cole Road 33.204252, -97.207320
Function/Sub-function:	AGRICULTURE
Construction Date:	Ca. 1965-2010
NRHP Eligibility:	Not eligible
Integrity/Comments:	Resource 02 consisted of a house and several agricultural outbuildings (barns and sheds) all of which no longer exist other than two modern sheds.

2013 aerial view, facing north.

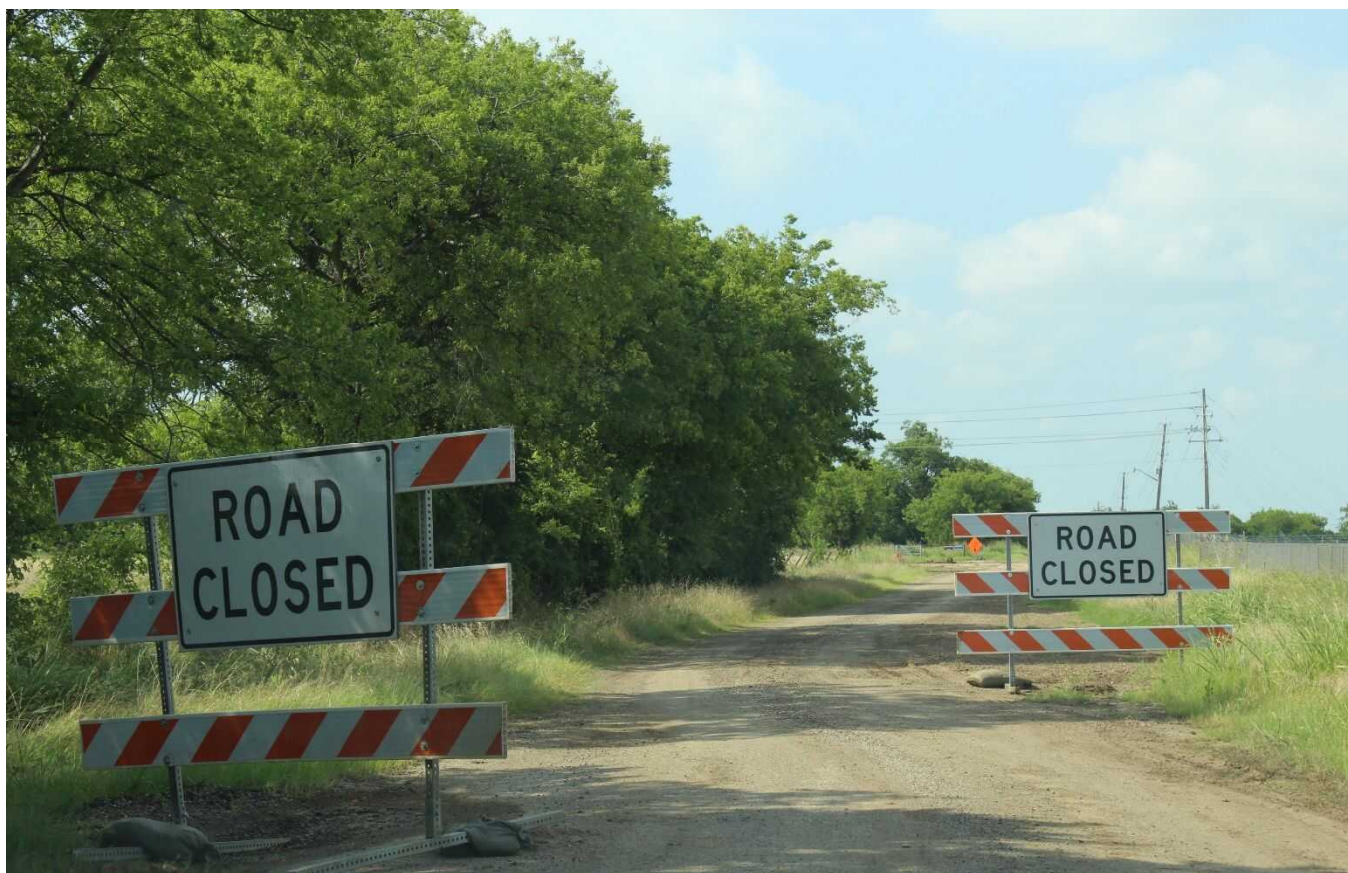
Survey Date:	June 24, 2019
Resource No:	03a
Project Location:	Denton County
Project Name and CSJ:	State Loop 288, CSJ 2250-02-014, etc.
Address, Lat/Long:	7420 Tom Cole Road 33.207715, -97.207631
Function/Sub-function:	AGRICULTURE/barn
Construction Date:	Ca. 1969
NRHP Eligibility:	Not eligible
Integrity/Comments:	Resource 03a includes a barn ca. 1969 per a USGS 1969 aerial view. Due to road closures, the surveyors were limited. Information regarding Resource 03 was gathered from aerial imagery. Storage tanks and a possible shed are present but are not of historic age (ca. 2008 and ca. 2013, respectively). The barn features a rectangular footprint and a metal, gable roof.

Camera facing west.

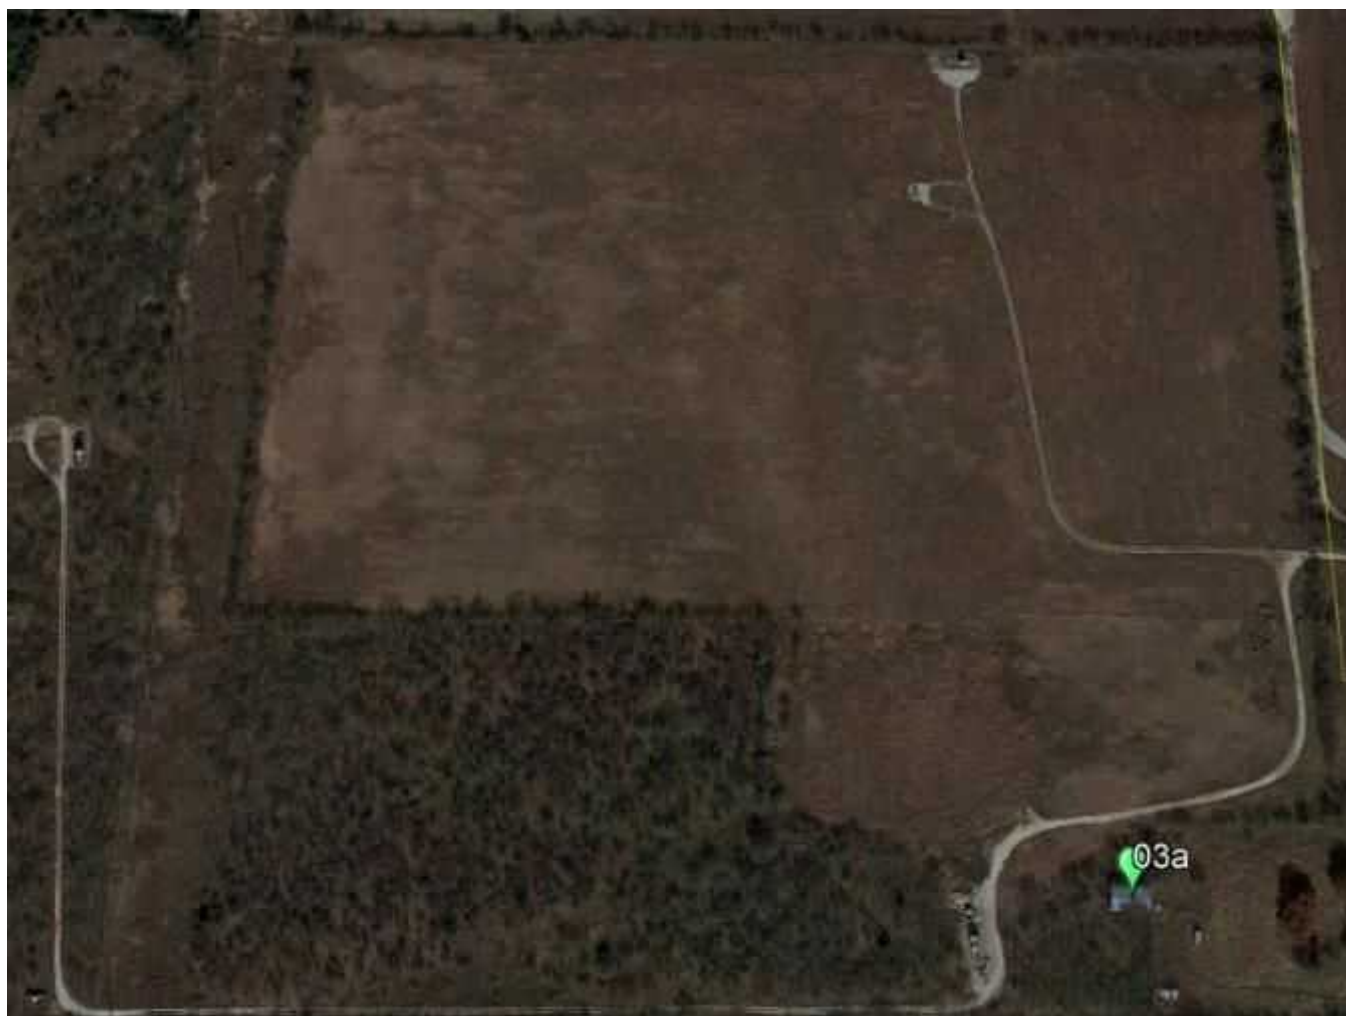
Survey Date:	June 24, 2019
Resource No:	03a
Project Location:	Denton County
Project Name and CSJ:	State Loop 288, CSJ 2250-02-014, etc.
Address, Lat/Long:	7420, Tom Cole Road 33.207715, -97.207631
Function/Sub-function:	AGRICULTURE/barn
Construction Date:	Ca. 1969
NRHP Eligibility:	Not eligible
Integrity/Comments:	Resource 03a includes a barn ca. 1969 per a USGS 1969 aerial view. Due to road closures, the surveyors were limited. Information regarding Resource 03 was gathered from aerial imagery. Storage tanks and a possible shed are present but are not of historic age (ca. 2008 and ca. 2013, respectively). The barn features a rectangular footprint and a metal, gable roof.

Aerial view, facing north.

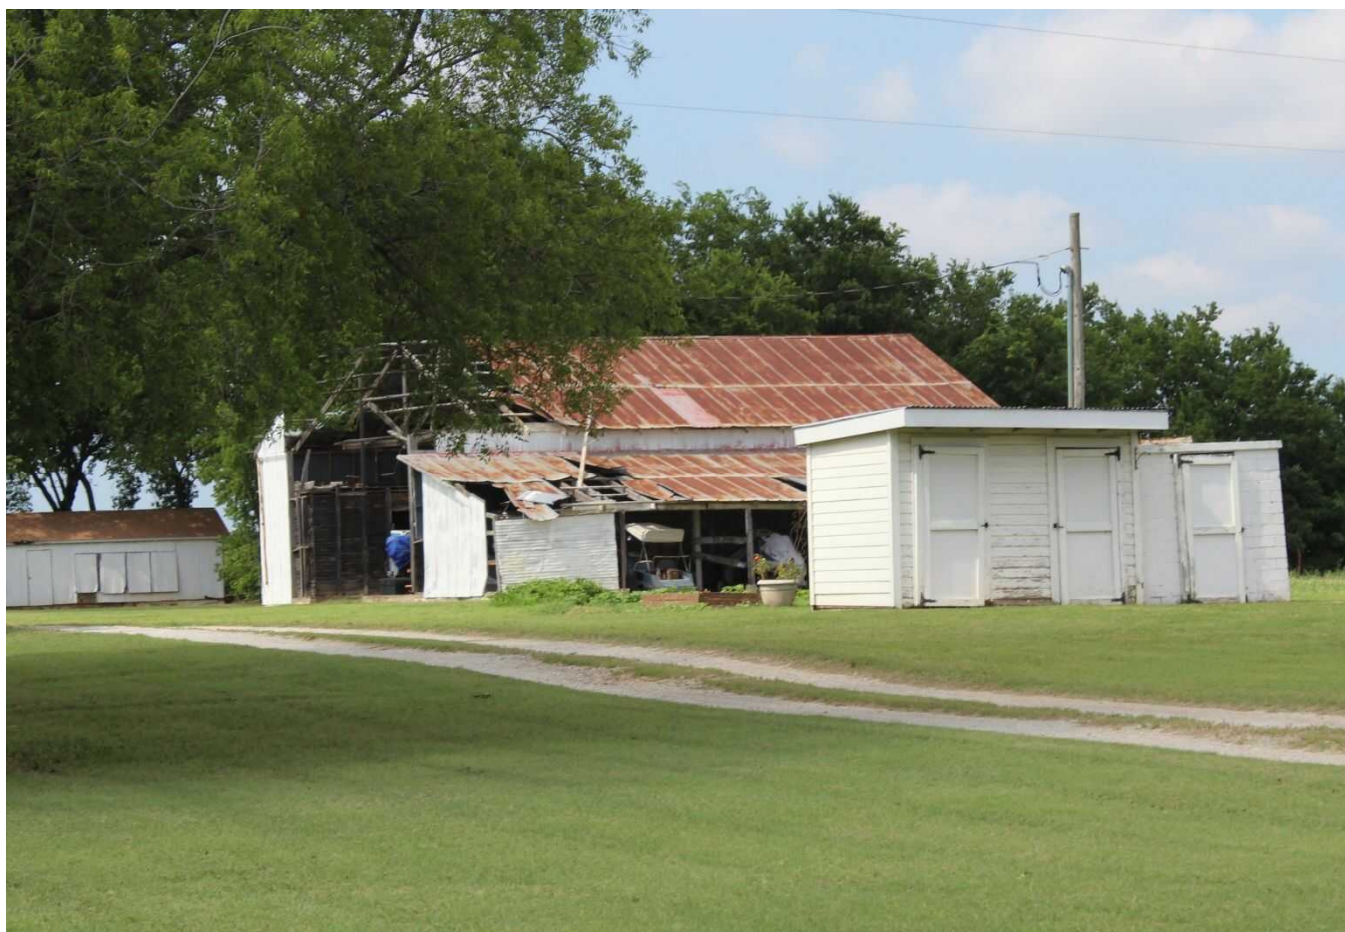
Survey Date:	June 24, 2019
Resource No:	04a
Project Location:	Denton County
Project Name and CSJ:	State Loop 288, CSJ 2250-02-014, etc.
Address, Lat/Long:	6376 Jim Christal Road 33.220790, -97.202287
Function/Sub-function:	DOMESTIC/barn
Construction Date:	Ca. 1940
NRHP Eligibility:	Not eligible
Integrity/Comments:	Resource 04a is the primary barn ca. 1940 per the owner's information. It features a metal, gable roof with a metal shed roof over an addition to the south. The barn has metal siding and vertical wood siding. The foundation material is dirt/earth and concrete with gable and side gable entry points, a vent in the east gable, and sliding doors. The addition is comprised of four open bays, a fifth partially enclosed with metal siding. Several sheets of metal roofing, primarily towards the west gable, are missing, exposing the frame construction. Evidence suggests the metal siding was applied over the barn's original horizontal wood siding. The barn is currently used as storage and a garage. Per the owner's information, there are plans to soon demolish the barn. A modern house and modern tool shed are associated with the barn, among additional historic-age agricultural buildings.

Camera facing northeast.

Resource No.	Address/ Location	Function/ Sub-function	Architectural Style	Date(s)	Integrity/Comments	NRHP Eligibility
04a	6376 Jim Christal Road 33.220790, -97.202287	DOMESTIC/barn	No Style	Ca. 1940	Resource 04a is the primary barn ca. 1940 per the owner's information. It features a metal, gable roof with a metal shed roof over an addition to the south. The foundation material is dirt/earth and concrete. The barn has metal siding and vertical wood siding, gable and side gable entry points, a vent in the east gable, and sliding doors. The addition is comprised of four open bays, a fifth partially enclosed with metal siding. Several sheets of metal roofing, primarily towards the west gable, are missing, exposing the frame construction. Evidence suggests the metal siding was applied over the barn's original horizontal wood siding. The barn is currently used as storage and a garage. Per the owner's information, there are plans to soon demolish the barn. A modern house and modern tool shed are associated with the barn, among additional historic-age agricultural buildings.	Not Eligible

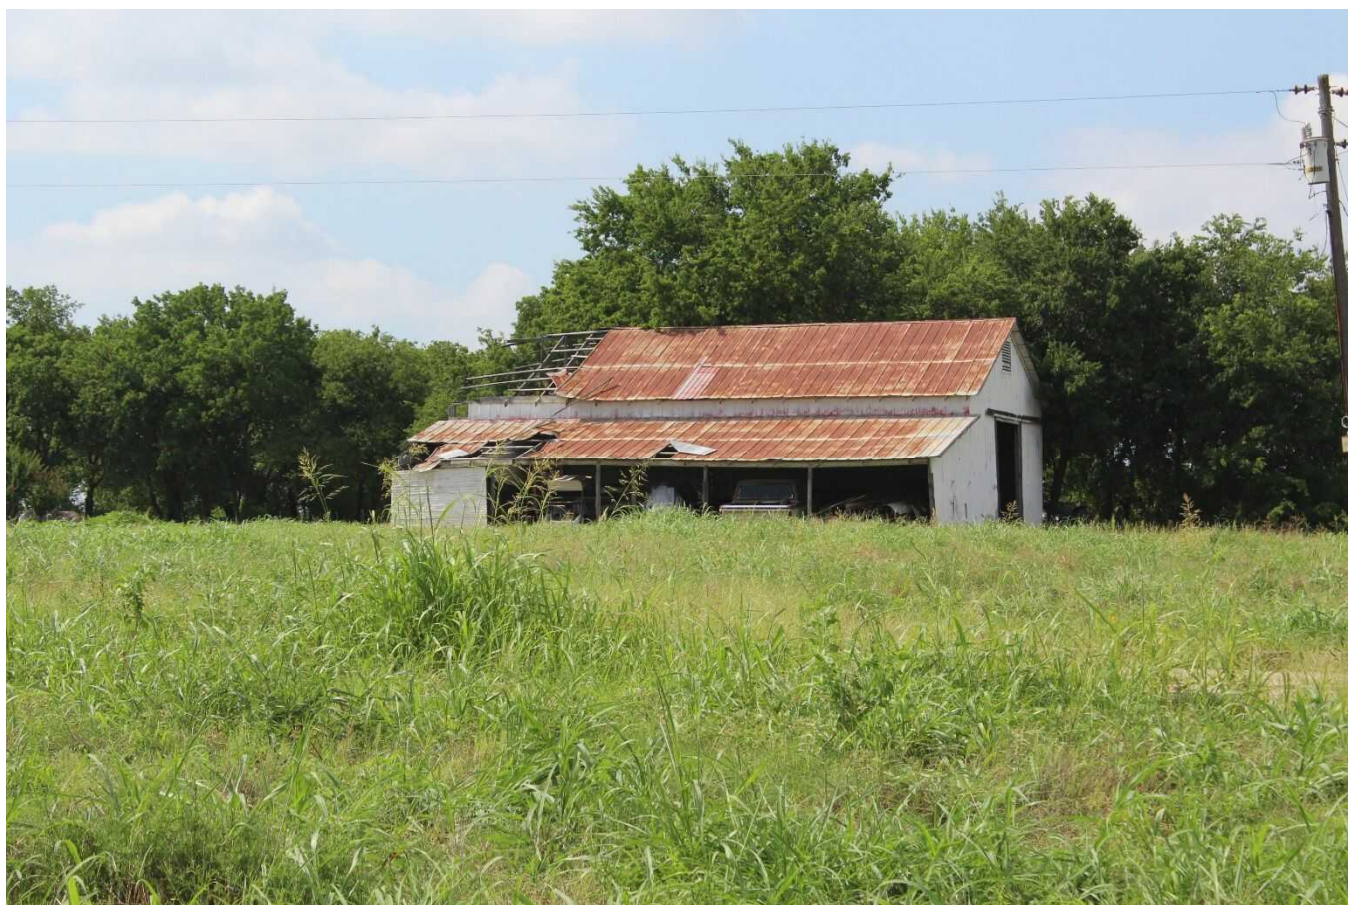
Survey Date:	June 24, 2019
Resource No:	04a
Project Location:	Denton County
Project Name and CSJ:	State Loop 288, CSJ 2250-02-014, etc.
Address, Lat/Long:	6376 Jim Christal Road 33.220790, -97.202287
Function/Sub-function:	DOMESTIC/barn
Construction Date:	Ca. 1940
NRHP Eligibility:	Not eligible
Integrity/Comments:	Resource 04a is the primary barn ca. 1940 per the owner's information. It features a metal, gable roof with a metal shed roof over an addition to the south. The barn has metal siding and vertical wood siding. The foundation material is dirt/earth and concrete with gable and side gable entry points, a vent in the east gable, and sliding doors. The addition is comprised of four open bays, a fifth partially enclosed with metal siding. Several sheets of metal roofing, primarily towards the west gable, are missing, exposing the frame construction. Evidence suggests the metal siding was applied over the barn's original horizontal wood siding. The barn is currently used as storage and a garage. Per the owner's information, there are plans to soon demolish the barn. A modern house and modern tool shed are associated with the barn, among additional historic-age agricultural buildings.

Camera facing northwest.

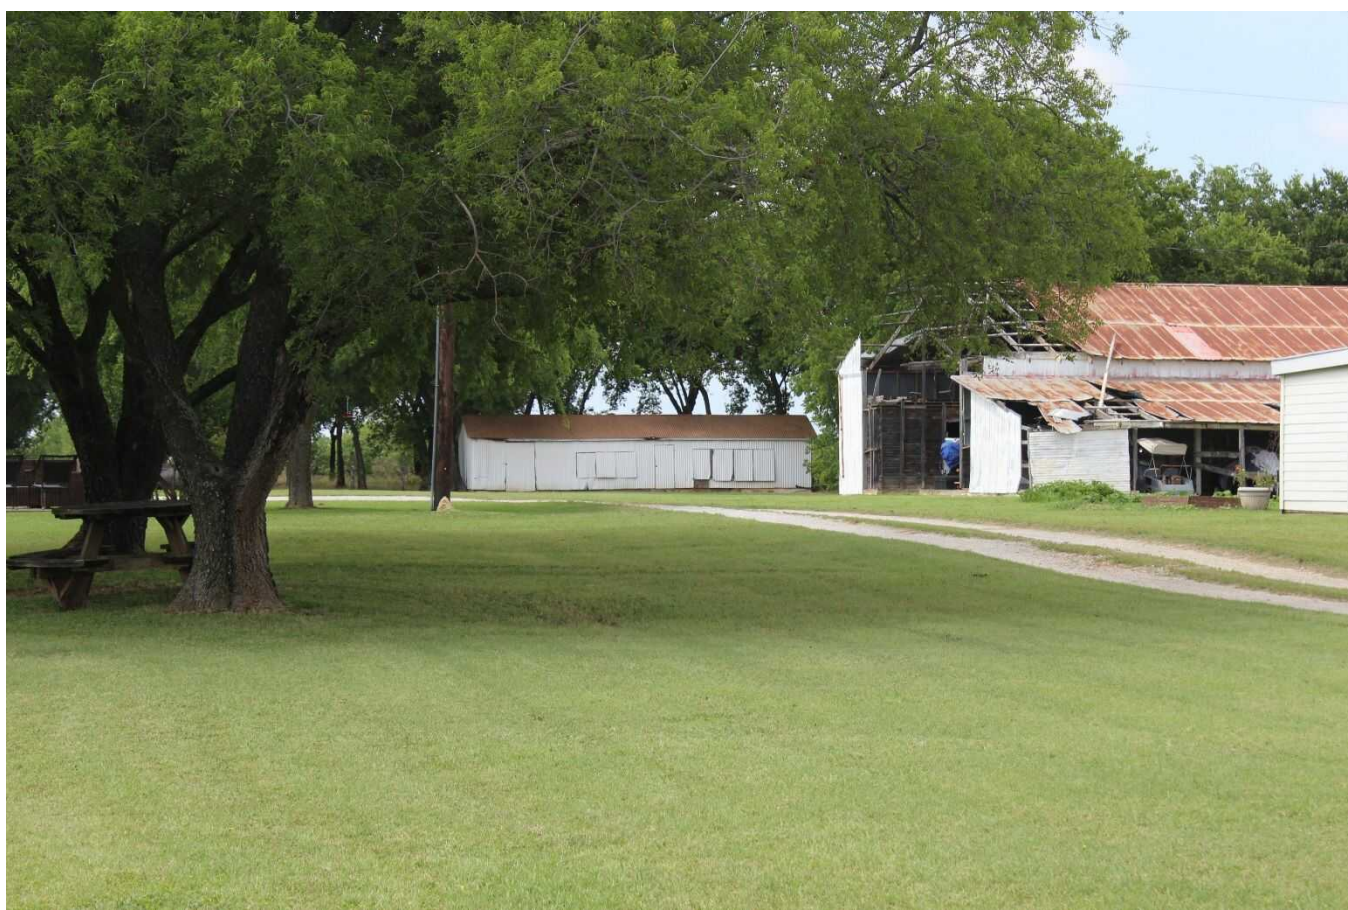
Survey Date:	June 24, 2019
Resource No:	04b
Project Location:	Denton County
Project Name and CSJ:	State Loop 288, CSJ 2250-02-014, etc.
Address, Lat/Long:	6376 Jim Christal Road 33.221065, -97.202378
Function/Sub-function:	DOMESTIC/barn
Construction Date:	Ca. 1940
NRHP Eligibility:	Not eligible
Integrity/Comments:	Resource 04b is a barn featuring metal siding over vertical wood siding, a metal, side gable roof, a concrete foundation, gable side entries, and seven windows along the south façade. Evidence suggests the metal siding was installed over the original wood siding, and the windows were boarded up using the same material.

Camera facing northeast.

04b	6376 Jim Christal Road 33.221065, -97.202378	DOMESTIC/barn	No Style	Ca. 1940	Resource 04b is a barn featuring metal siding over vertical wood siding, a metal side gable roof, a concrete foundation, gable side entries, and seven windows along the south façade. Evidence suggests the metal siding was installed over the original wood siding, and the windows were boarded up using the same material.	Not Eligible
04c	6376 Jim Christal Road 33.220432, -97.202466	DOMESTIC/ wellhouse	No Style	Ca. 1940	Resource 04c is a wellhouse ca. 1940 per the owner's information. It features a metal shed roof and vertical wood siding. The wellhouse has three bays along the south façade with a brick addition to the east, which consists of a metal flat roof and a single bay.	Not Eligible
04d	6376 Jim Christal Road 33.220179, -97.201957	DOMESTIC/barn foundation	No Style	Ca. 1940	Resource 04d is the concrete foundation of a ca. 1940s dairy barn per the owner's information. It has a rectangular footprint oriented east/west with a terracing effect, sloping downward to the east.	Not Eligible
