# Historical Resources Survey Report

## Reconnaissance Survey

**Project Name:** State Loop 288

**Project Limits:** IH 35W to IH 35

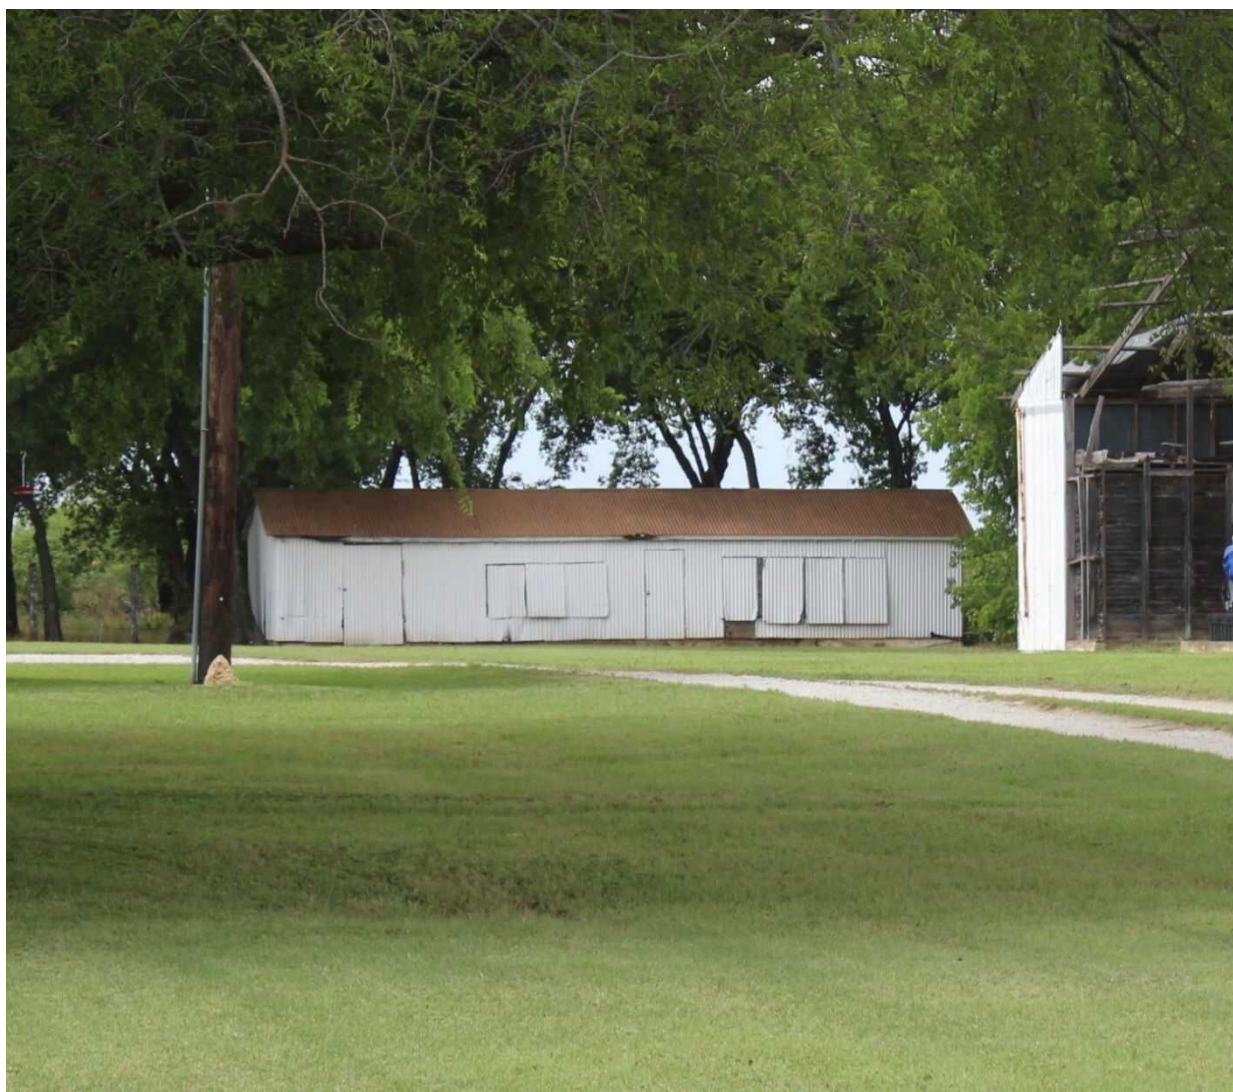
Survey Date:	June 24, 2019
Resource No:	04b
Project Location:	Denton County
Project Name and CSJ:	State Loop 288, CSJ 2250-02-014, etc.
Address, Lat/Long:	6376 Jim Christal Road 33.221065, -97.202378
Function/Sub-function:	DOMESTIC/barn
Construction Date:	Ca. 1940
NRHP Eligibility:	Not eligible
Integrity/Comments:	Resource 04b is a barn featuring metal siding over vertical wood siding, a metal, side gable roof, a concrete foundation, gable side entries, and seven windows along the south façade. Evidence suggests the metal siding was installed over the original wood siding, and the windows were boarded up using the same material.

Camera facing northeast.

04b	6376 Jim Christal Road 33.221065, -97.202378	DOMESTIC/barn	No Style	Ca. 1940	Resource 04b is a barn featuring metal siding over vertical wood siding, a metal side gable roof, a concrete foundation, gable side entries, and seven windows along the south façade. Evidence suggests the metal siding was installed over the original wood siding, and the windows were boarded up using the same material.	Not Eligible
04c	6376 Jim Christal Road 33.220432, -97.202466	DOMESTIC/ wellhouse	No Style	Ca. 1940	Resource 04c is a wellhouse ca. 1940 per the owner's information. It features a metal shed roof and vertical wood siding. The wellhouse has three bays along the south façade with a brick addition to the east, which consists of a metal flat roof and a single bay.	Not Eligible
04d	6376 Jim Christal Road 33.220179, -97.201957	DOMESTIC/barn foundation	No Style	Ca. 1940	Resource 04d is the concrete foundation of a ca. 1940s dairy barn per the owner's information. It has a rectangular footprint oriented east/west with a terracing effect, sloping downward to the east.	Not Eligible

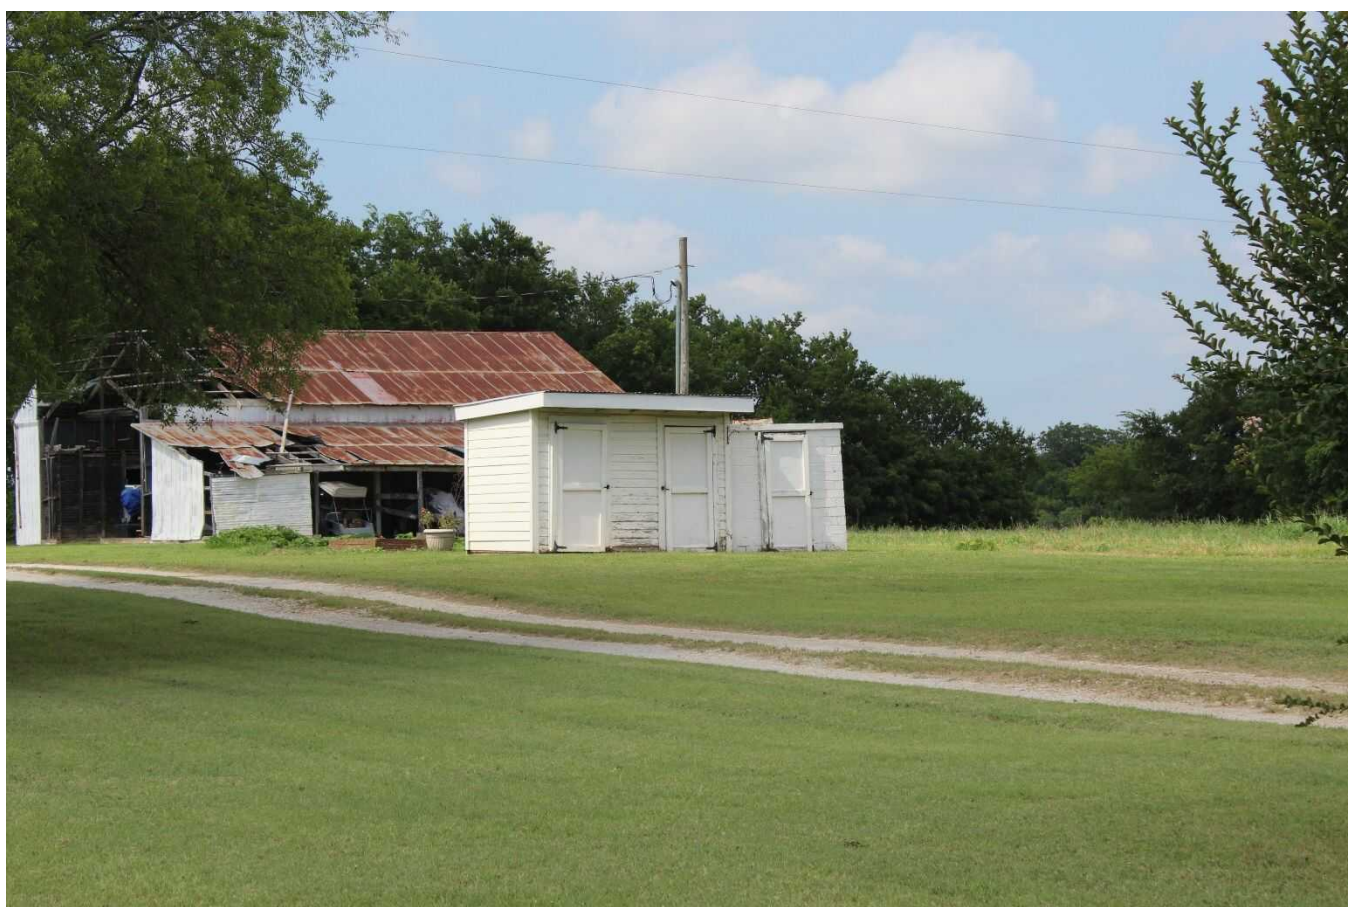
Survey Date:	June 24, 2019
Resource No:	04c
Project Location:	Denton County
Project Name and CSJ:	State Loop 288, CSJ 2250-02-014, etc.
Address, Lat/Long:	6376 Jim Christal Road 33.220432, -97.202466
Function/Sub-function:	DOMESTIC/wellhouse
Construction Date:	Ca. 1940
NRHP Eligibility:	Not eligible
Integrity/Comments:	Resource 04c is a wellhouse ca. 1940 per the owner's information. It features a metal shed roof and vertical wood siding. The wellhouse has three bays along the south façade with a brick addition to the east, which consists of a metal flat roof and a single bay.

Camera facing northeast.

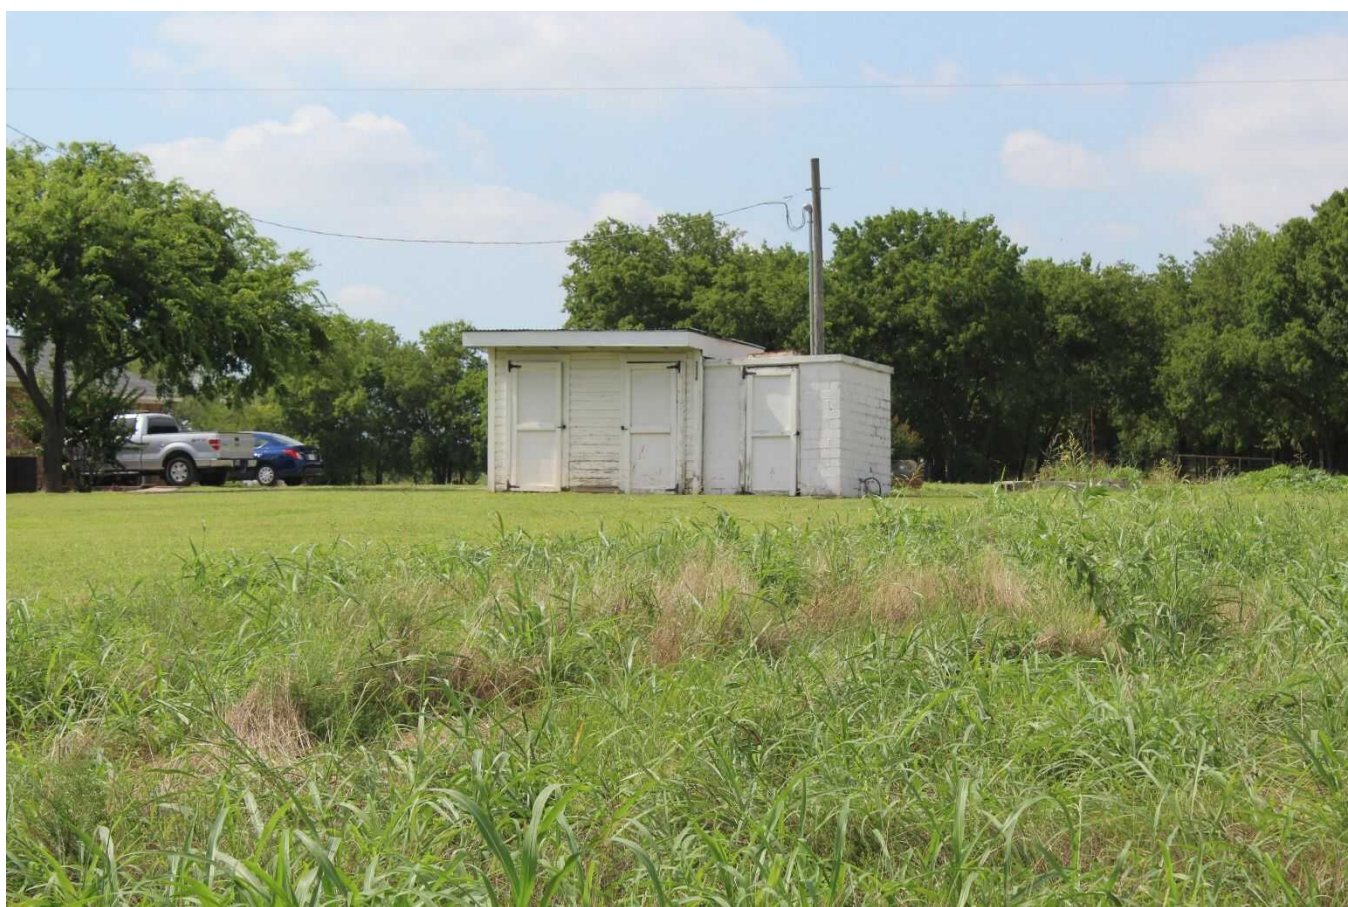
Survey Date:	June 24, 2019
Resource No:	04c
Project Location:	Denton County
Project Name and CSJ:	State Loop 288, CSJ 2250-02-014, etc.
Address, Lat/Long:	6376 Jim Christal Road 33.220432, -97.202466
Function/Sub-function:	DOMESTIC/wellhouse
Construction Date:	Ca. 1940
NRHP Eligibility:	Not eligible
Integrity/Comments:	Resource 04c is a wellhouse ca. 1940 per the owner's information. It features a metal shed roof and vertical wood siding. The wellhouse has three bays along the south façade with a brick addition to the east, which consists of a metal flat roof and a single bay.

Camera facing northwest.

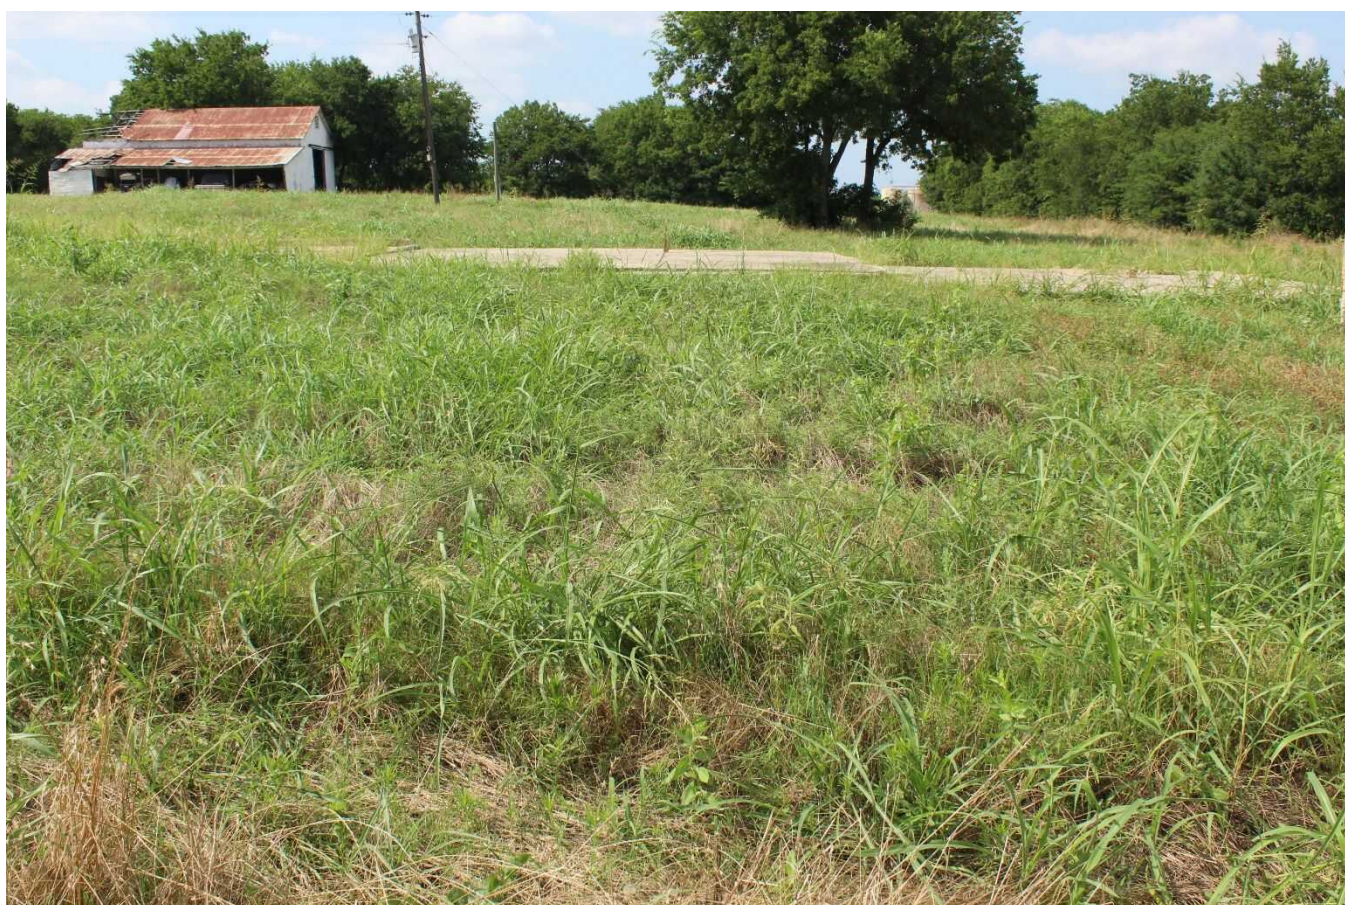
Survey Date:	June 24, 2019
Resource No:	04d
Project Location:	Denton County
Project Name and CSJ:	State Loop 288, CSJ 2250-02-014, etc.
Address, Lat/Long:	6376 Jim Christal Road 33.220179, -97.201957
Function/Sub-function:	DOMESTIC/barn foundation
Construction Date:	Ca. 1940
NRHP Eligibility:	Not eligible
Integrity/Comments:	Resource 04d is the concrete foundation of a ca. 1940s dairy barn per the owner's information. It has a rectangular footprint oriented east/west with a terracing effect, sloping downward to the east.

Camera facing north.

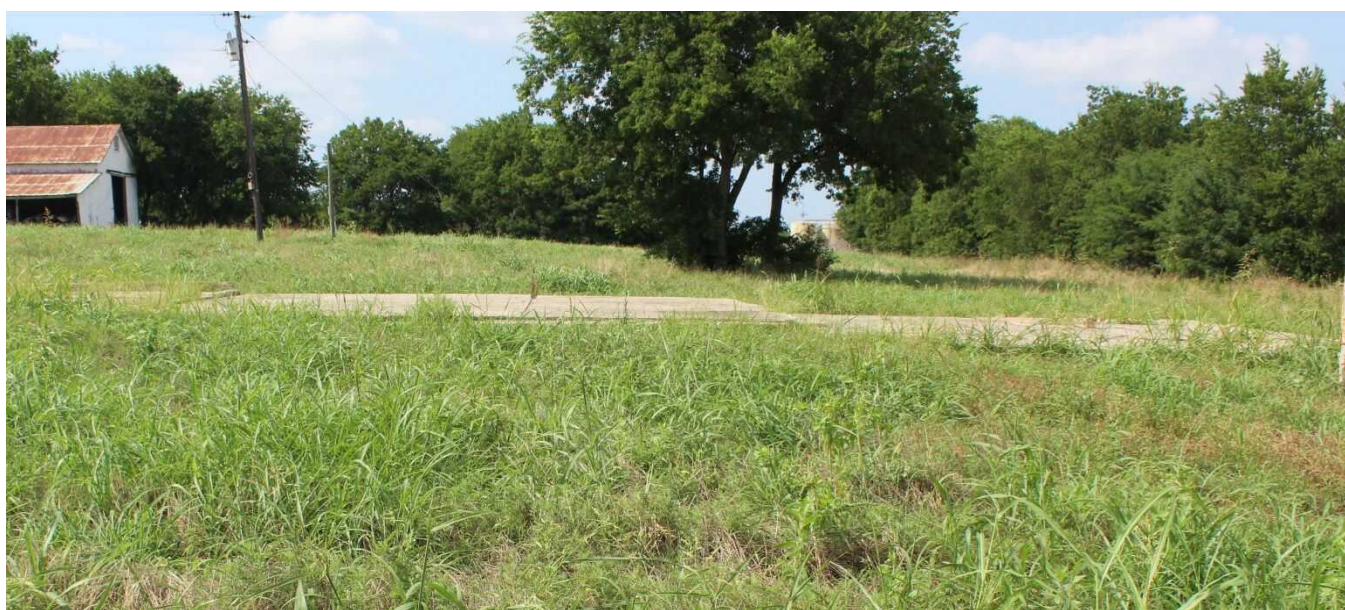
Survey Date:	June 24, 2019
Resource No:	04d
Project Location:	Denton County
Project Name and CSJ:	State Loop 288, CSJ 2250-02-014, etc.
Address, Lat/Long:	6376 Jim Christal Road 33.220179, -97.201957
Function/Sub-function:	AGRICULTURE/foundation
Construction Date:	Ca. 1940
NRHP Eligibility:	Not eligible
Integrity/Comments:	Resource 04d is the concrete foundation of a ca. 1940s dairy barn per the owner's information. It has a rectangular footprint oriented east/west with a terracing effect, sloping downward to the east.

Camera facing north.

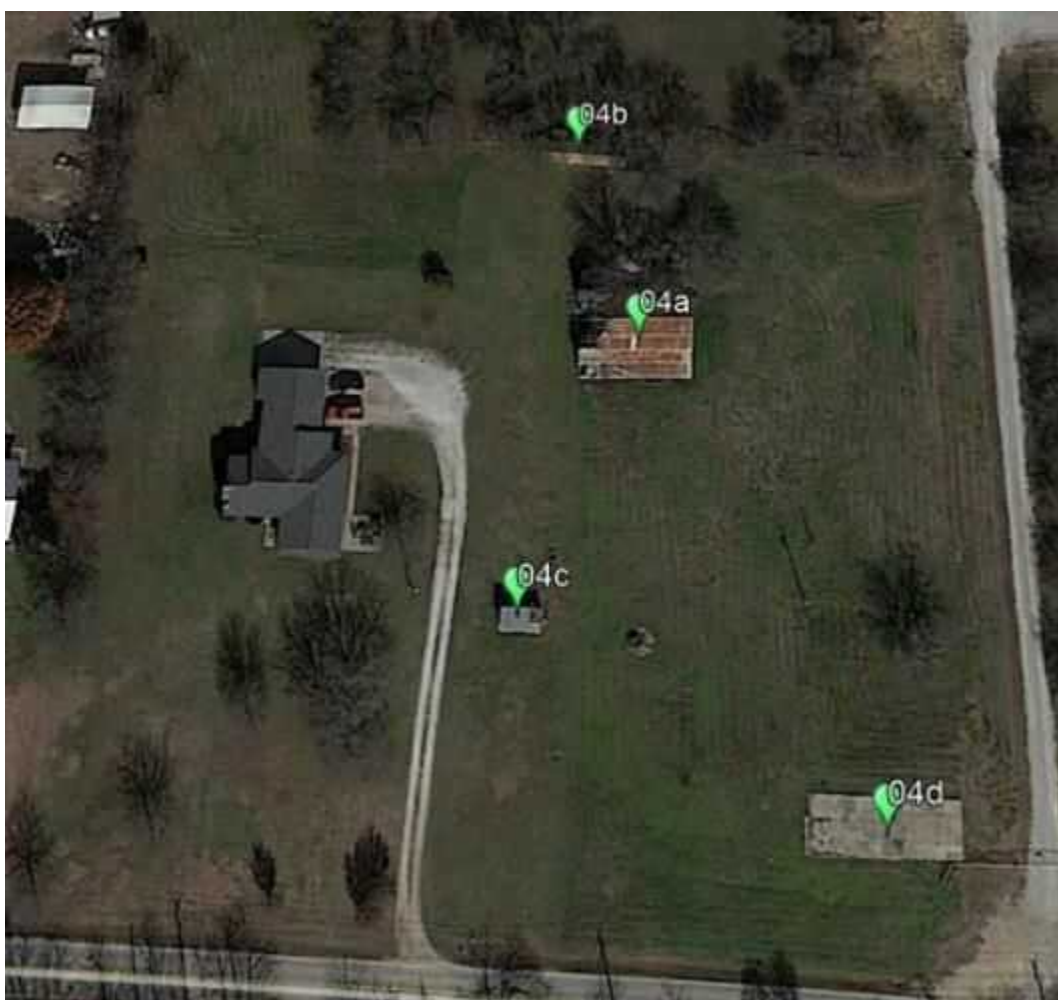
Survey Date:	June 24, 2019
Resource No:	04
Project Location:	Denton County
Project Name and CSJ:	State Loop 288, CSJ 2250-02-014, etc.
Address, Lat/Long:	6376 Jim Christal Road 33.220790, -97.202287
Function/Sub-function:	DOMESTIC
Construction Date:	Ca. 1940-1990
NRHP Eligibility:	Not eligible
Integrity/Comments:	Resource 04 is a farmstead consisting of a modern single-family dwelling and shed, and several historic-age barns and outbuildings. A dairy barn and a pole barn have been demolished but are present in a 2001 aerial image. The farmstead no longer serves an agricultural purpose.

Aerial view, facing north.

While a domestic parcel, Resource 04 is a former dairy farmstead, which was comprised of three barns, two of which were dairy barns, a possible pole barn, and a wellhouse. Only one dairy barn, the foundation of the second, a barn, and the wellhouse remain. A modern house is also present, which was relocated to the parcel approximately twenty years ago per the owner's information. Per the owner's information, the remaining dairy barn is scheduled to be demolished soon. The remaining agricultural buildings, including the barn and dairy barn have metal siding over their original wood siding. The dairy barn is in poor condition. Although Resource 04 has participated in agricultural practices, it does not meet a level of significance required under Criterion A for important historic events and trends. The property has no known association with a significant figure under Criterion B, and due to the condition of the remaining agricultural buildings, Resource 04 does not meet the requirements to be considered eligible under Criterion C.

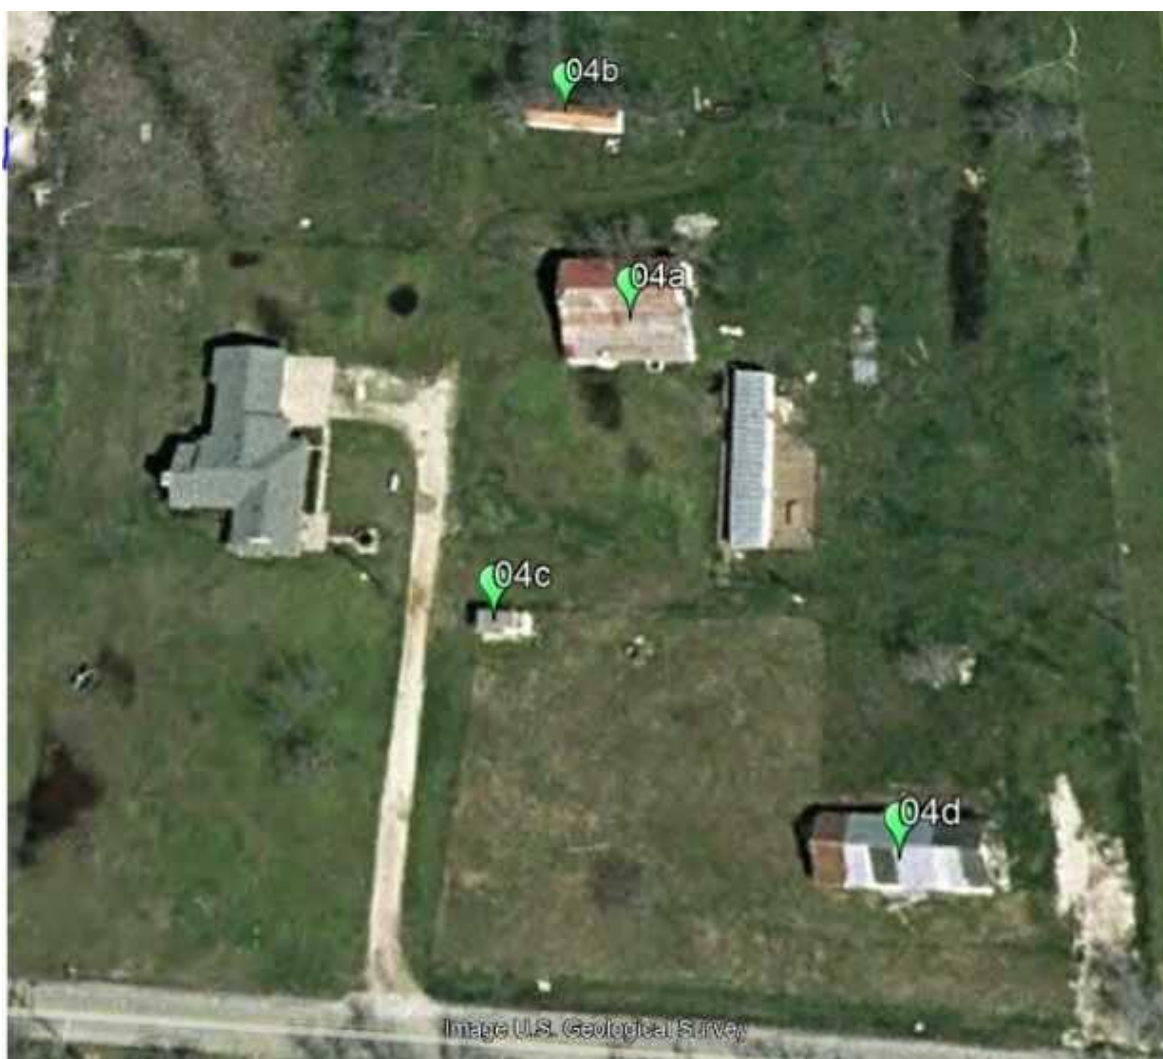
Survey Date:	June 24, 2019
Resource No:	04
Project Location:	Denton County
Project Name and CSJ:	State Loop 288, CSJ 2250-02-014, etc.
Address, Lat/Long:	6376 Jim Christal Road 33.220790, -97.202287
Function/Sub-function:	DOMESTIC
Construction Date:	Ca. 1940-1990
NRHP Eligibility:	Not eligible
Integrity/Comments:	Resource 04 is a farmstead consisting of a modern single-family dwelling and shed, and several historic-age barns and outbuildings. A dairy barn and a pole barn have been demolished but are present in a 2001 aerial image. The farmstead no longer serves an agricultural purpose.

2001 aerial view, facing north.

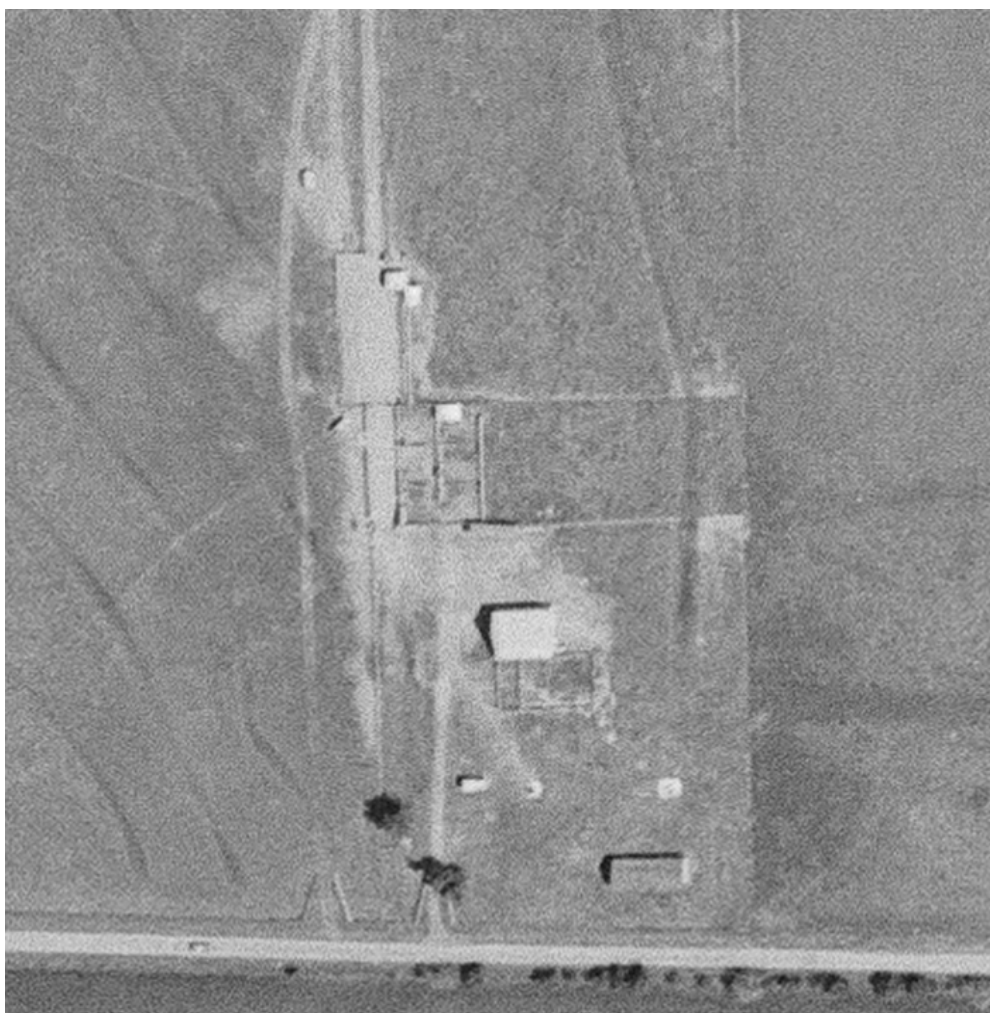
Survey Date:	June 24, 2019
Resource No:	04
Project Location:	Denton County
Project Name and CSJ:	State Loop 288, CSJ 2250-02-014, etc.
Address, Lat/Long:	6376 Jim Christal Road 33.220790, -97.202287
Function/Sub-function:	DOMESTIC
Construction Date:	Ca. 1940-1990
NRHP Eligibility:	Not eligible
Integrity/Comments:	Resource 04 is a farmstead consisting of a modern single-family dwelling and shed, and several historic-age barns and outbuildings. A dairy barn and a pole barn have been demolished but are present in a 2001 aerial image. The farmstead no longer serves an agricultural purpose.

1969 aerial view, facing north. USGS.

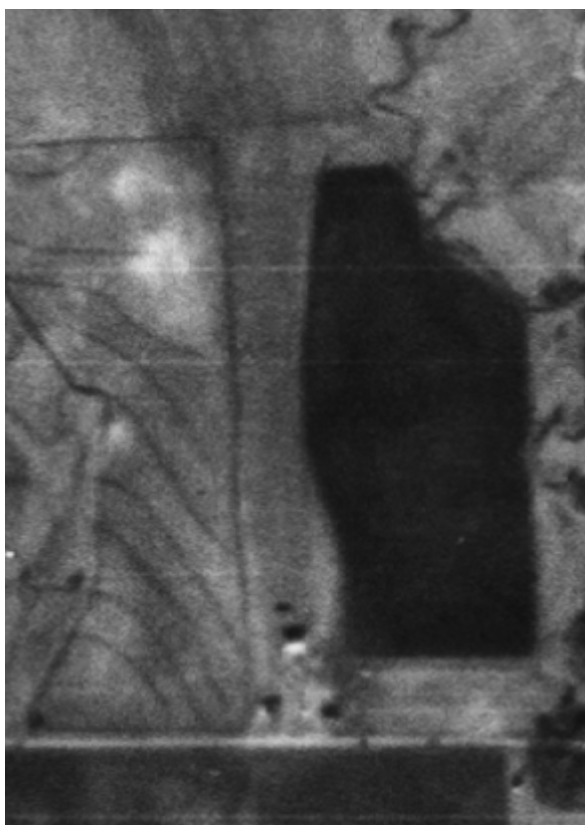
Survey Date:	June 24, 2019
Resource No:	04
Project Location:	Denton County
Project Name and CSJ:	State Loop 288, CSJ 2250-02-014, etc.
Address, Lat/Long:	6376 Jim Christal Road 33.220790, -97.202287
Function/Sub-function:	DOMESTIC
Construction Date:	Ca. 1940
NRHP Eligibility:	Not eligible
Integrity/Comments:	Resource 04 is a farmstead consisting of a modern single-family dwelling and shed, and several historic-age barns and outbuildings. A dairy barn and a pole barn have been demolished but are present in a 2001 aerial image. The farmstead no longer serves an agricultural purpose.

1952 aerial view, facing north. USGS

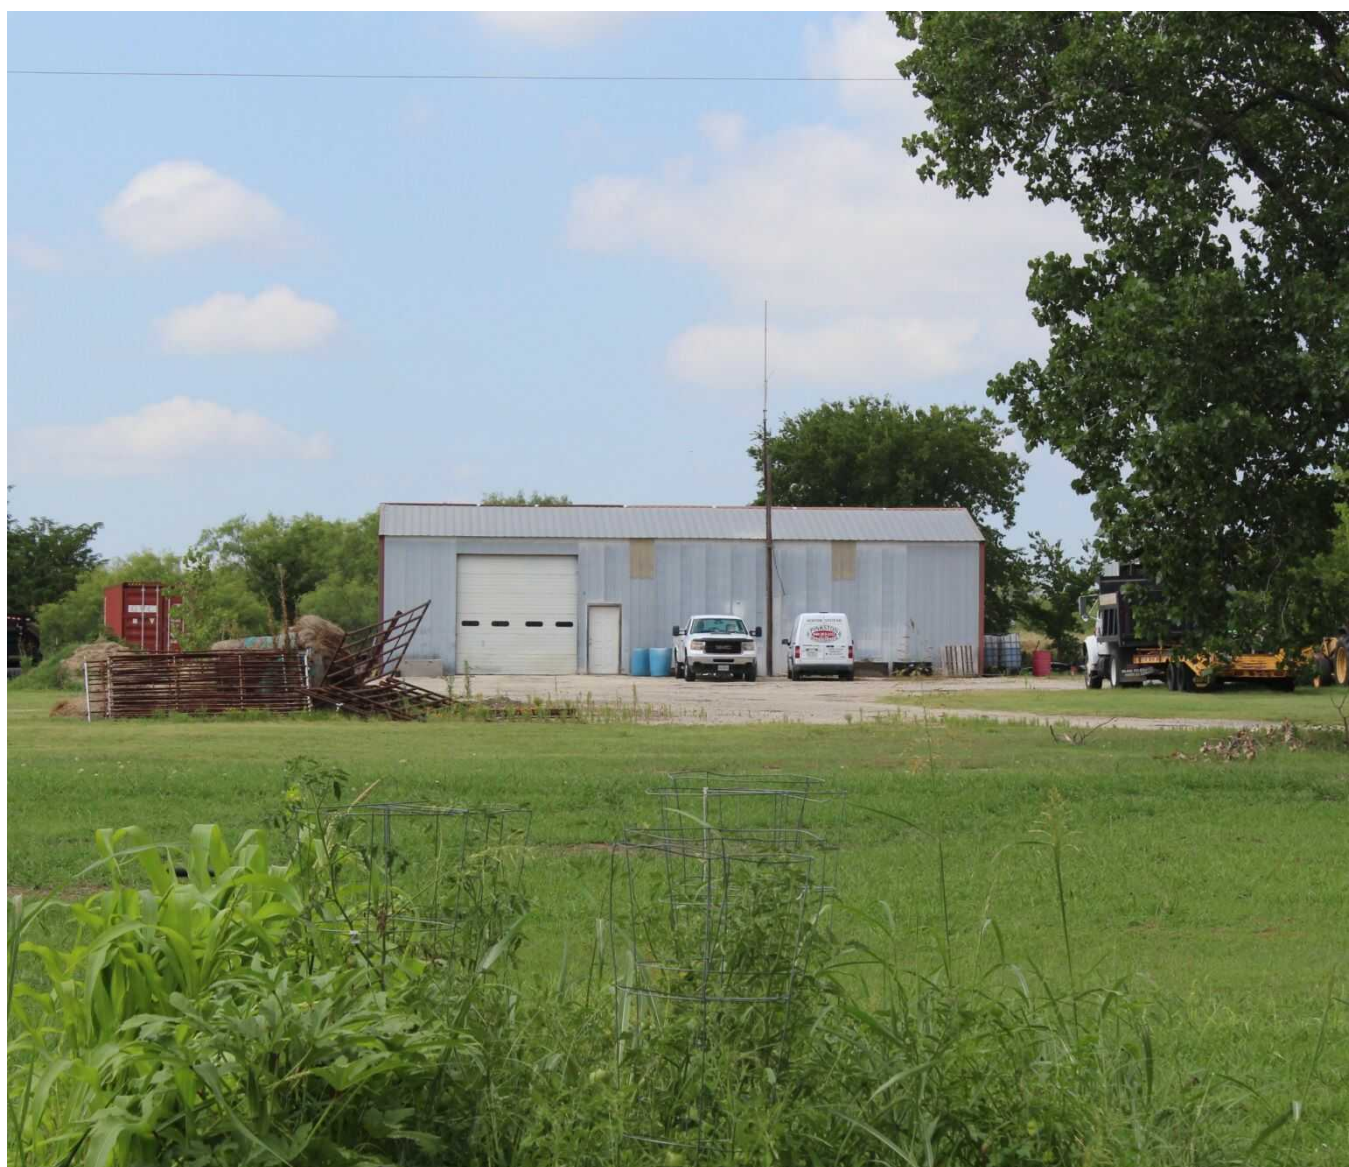
Survey Date:	June 24, 2019
Resource No:	05b
Project Location:	Denton County
Project Name and CSJ:	State Loop 288, CSJ 2250-02-014, etc.
Address, Lat/Long:	6430 Jim Christal Road 33.221334, -97.203664
Function/Sub-function:	DOMESTIC/machine shed
Construction Date:	Ca. 1972
NRHP Eligibility:	Not eligible
Integrity/Comments:	Resource 05b is a machine shed featuring a rectangular footprint, a metal side-gable roof, metal siding, a rolling garage door, and a six-panel door. The machine shed currently serves as storage for large machinery.

Camera facing north.

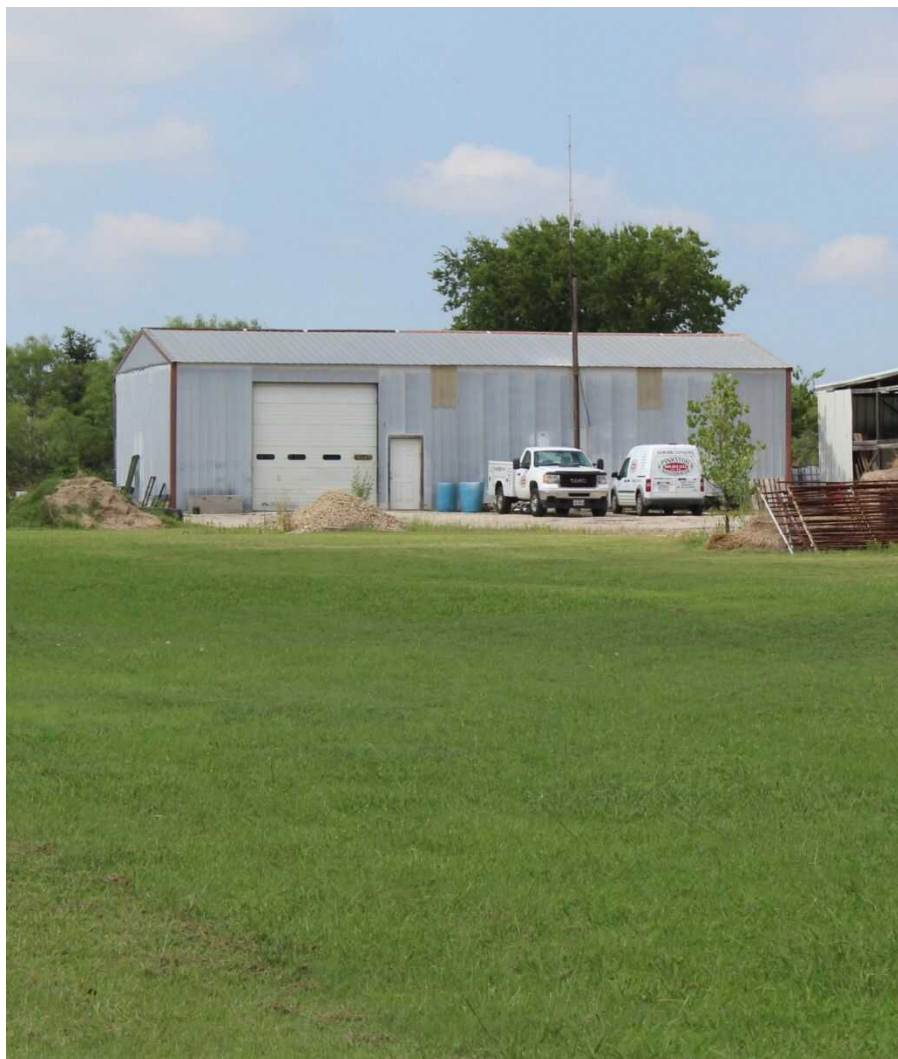
Survey Date:	June 24, 2019
Resource No:	05b
Project Location:	Denton County
Project Name and	State Loop 288, CSJ 2250-02-014, etc.
Address, Lat/Long:	6430 Jim Christal Road 33.221334, -97.203664
Function/Sub-	DOMESTIC/machine shed
Construction Date:	Ca. 1972
NRHP Eligibility:	Not eligible
Integrity/Comments:	Resource 05b is a machine shed featuring a rectangular footprint, a metal side-gable roof, metal siding, a rolling garage door, and a six-panel door. The machine shed currently serves as storage for large machinery.

Camera facing northeast.

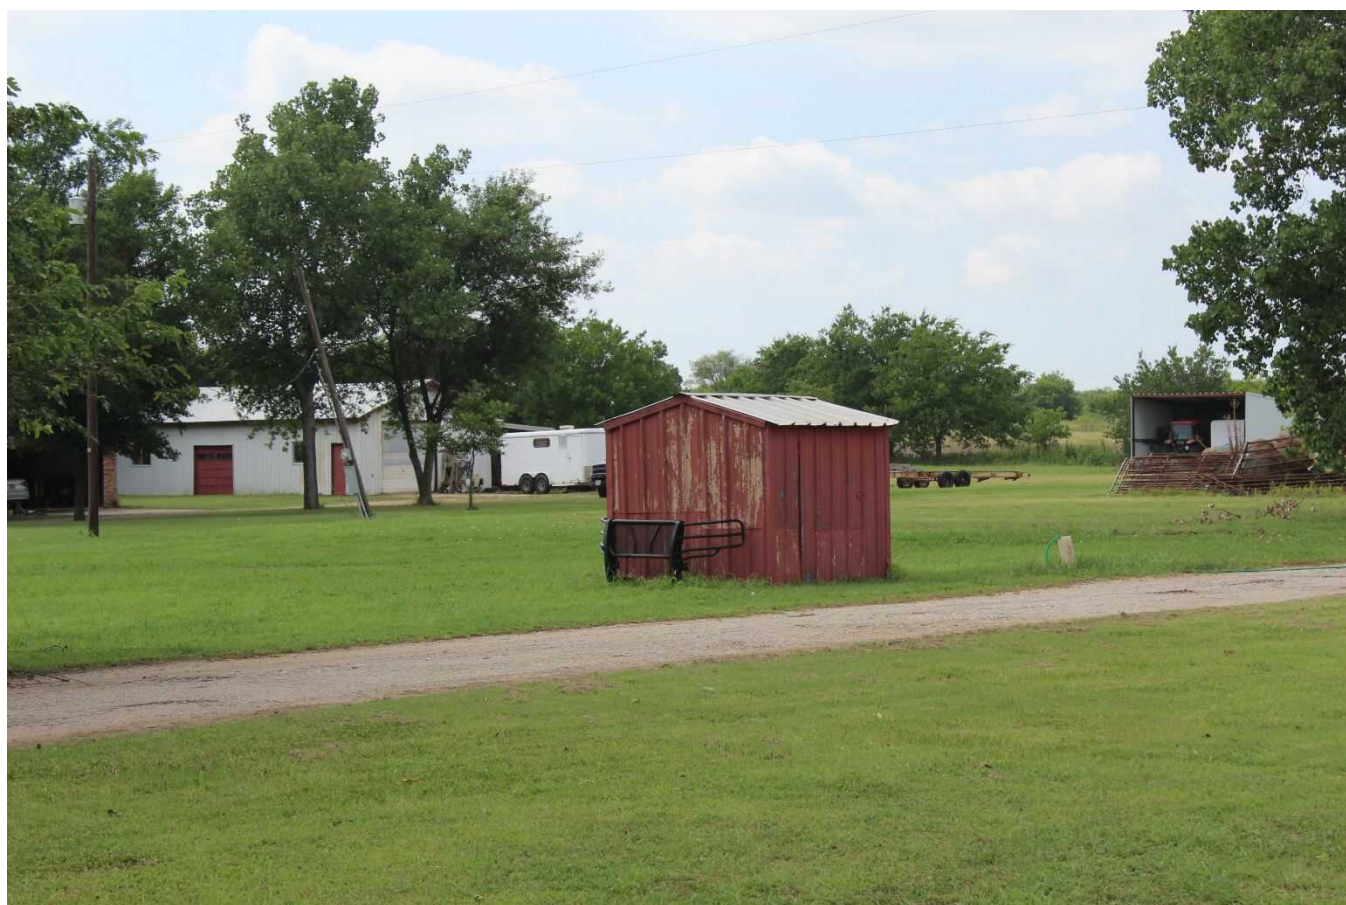
Survey Date:	June 24, 2019
Resource No:	05c
Project Location:	Denton County
Project Name and CSJ:	State Loop 288, CSJ 2250-02-014, etc.
Address, Lat/Long:	6430 Jim Christal Road 33.220353, -97.203615
Function/Sub-function:	DOMESTIC/wellhouse
Construction Date:	Ca. 1972
NRHP Eligibility:	Not eligible
Integrity/Comments:	Resource 05c is a wellhouse featuring a square footprint, a metal gable roof, metal siding, painted red, and what appears to be a closed window on the east façade.

Camera facing northwest.

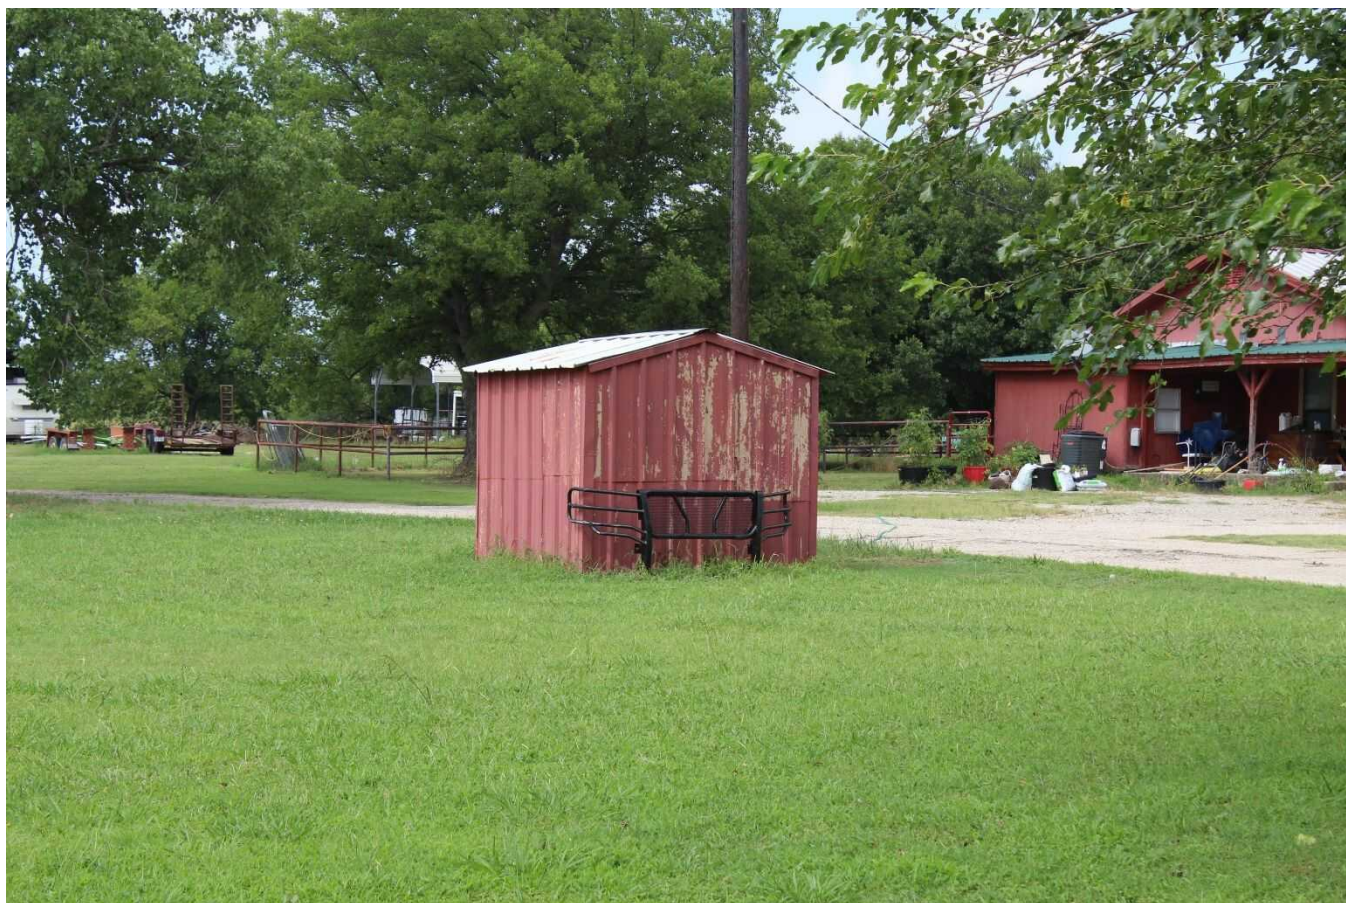
Survey Date:	June 24, 2019
Resource No:	05c
Project Location:	Denton County
Project Name and CSJ:	State Loop 288, CSJ 2250-02-014, etc.
Address, Lat/Long:	6430 Jim Christal Road 33.220353, -97.203615
Function/Sub-function:	DOMESTIC/wellhouse
Construction Date:	Ca. 1972
NRHP Eligibility:	Not eligible
Integrity/Comments:	Resource 05c is a wellhouse featuring a square footprint, a metal gable roof, metal siding, painted red, and what appears to be a closed window on the east façade.

Camera facing northeast.

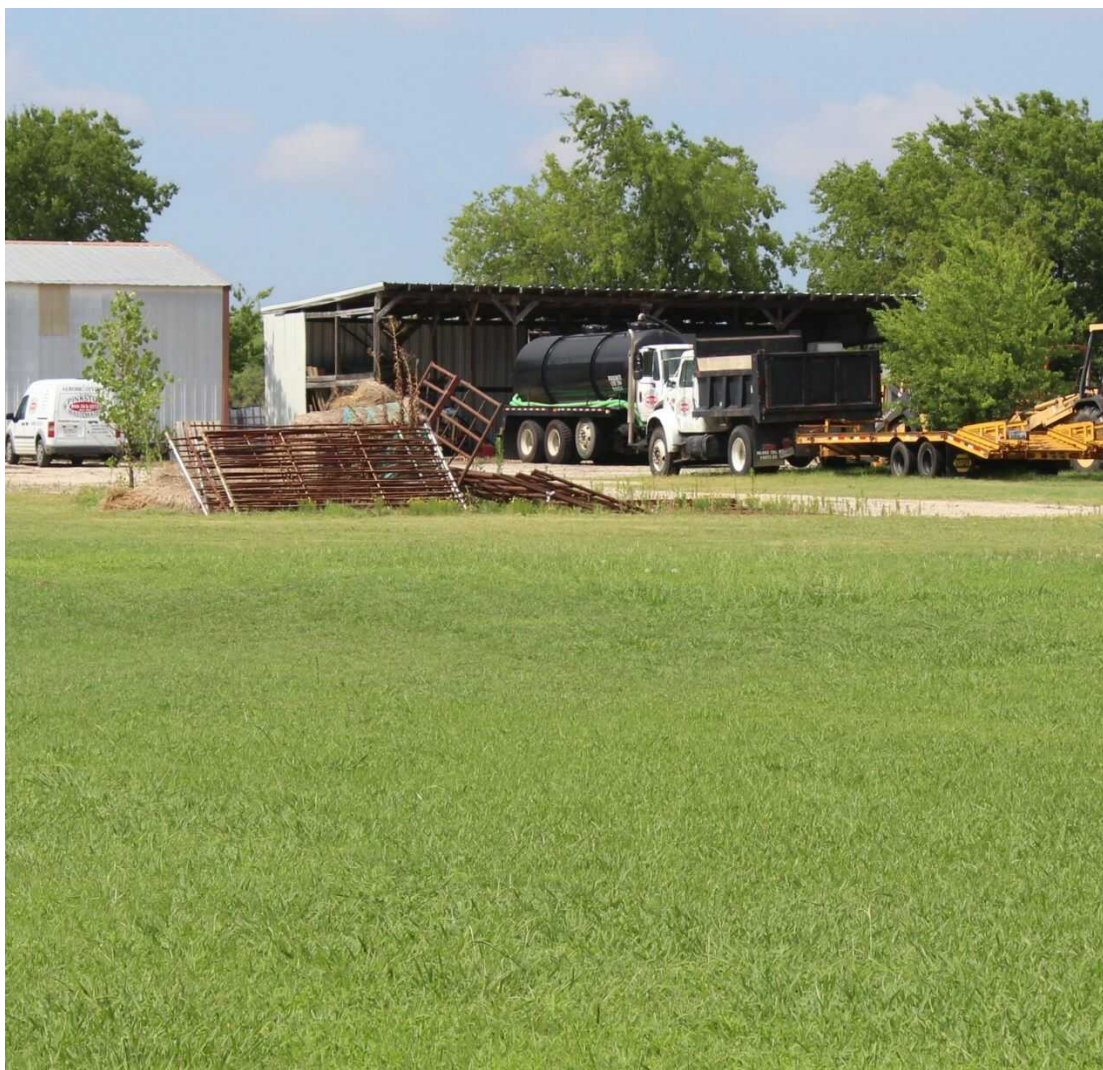
Survey Date:	June 24, 2019
Resource No:	05
Project Location:	Denton County
Project Name and CSJ:	State Loop 288, CSJ 2250-02-014, etc.
Address, Lat/Long:	6430 Jim Christal Road 33.221387, -97.203429
Function/Sub-function:	DOMESTIC/pole barn
Construction Date:	Ca. 2008
NRHP Eligibility:	Not eligible
Integrity/Comments:	Resource 05 includes several non-historic age resources, including a pole barn, a carport, and several storage tanks.

Camera facing northeast.

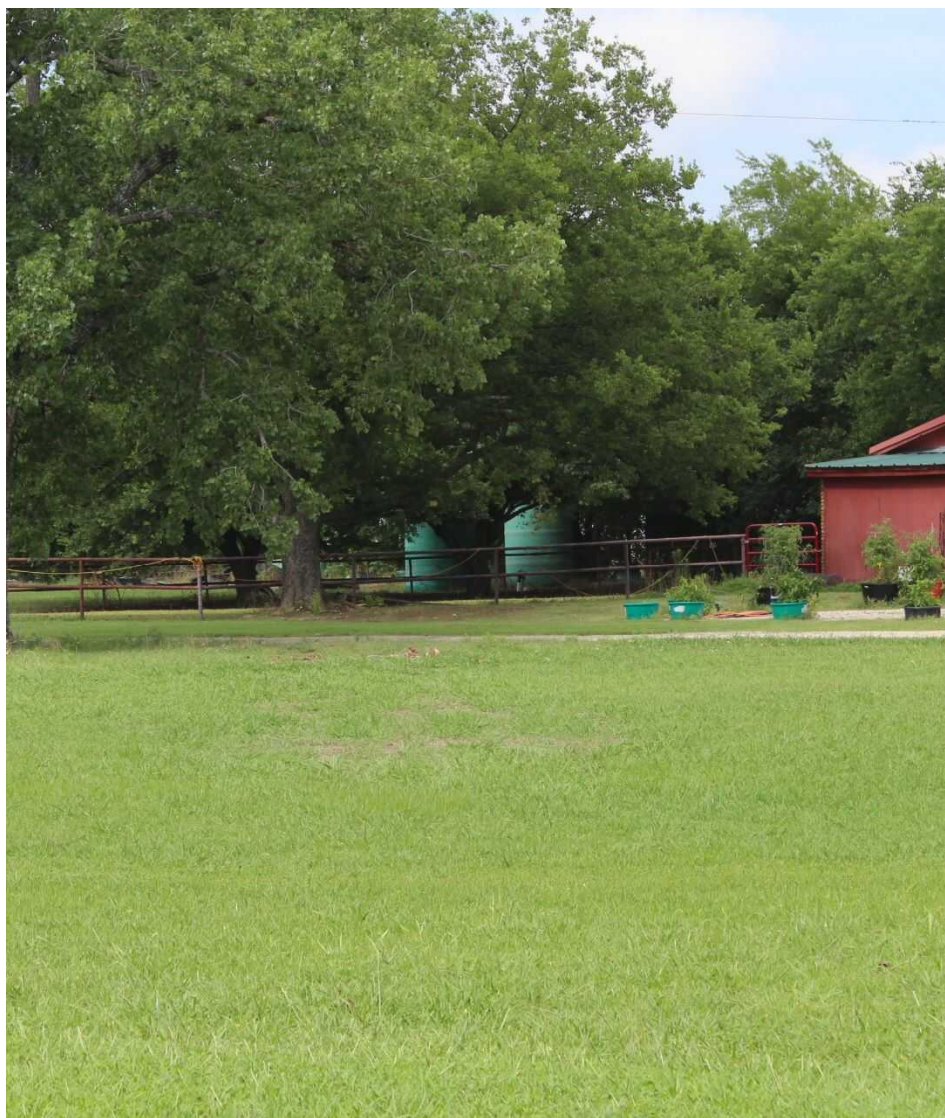
Survey Date:	June 24, 2019
Resource No:	05
Project Location:	Denton County
Project Name and CSJ:	State Loop 288, CSJ 2250-02-014, etc.
Address, Lat/Long:	6430 Jim Christal Road 33.220921, -97.203193
Function/Sub-function:	DOMESTIC/storage tanks
Construction Date:	Ca. 2009
NRHP Eligibility:	Not eligible
Integrity/Comments:	Resource 05 includes several non-historic age resources, including a pole barn, a carport, and several storage tanks.

Camera facing northeast.

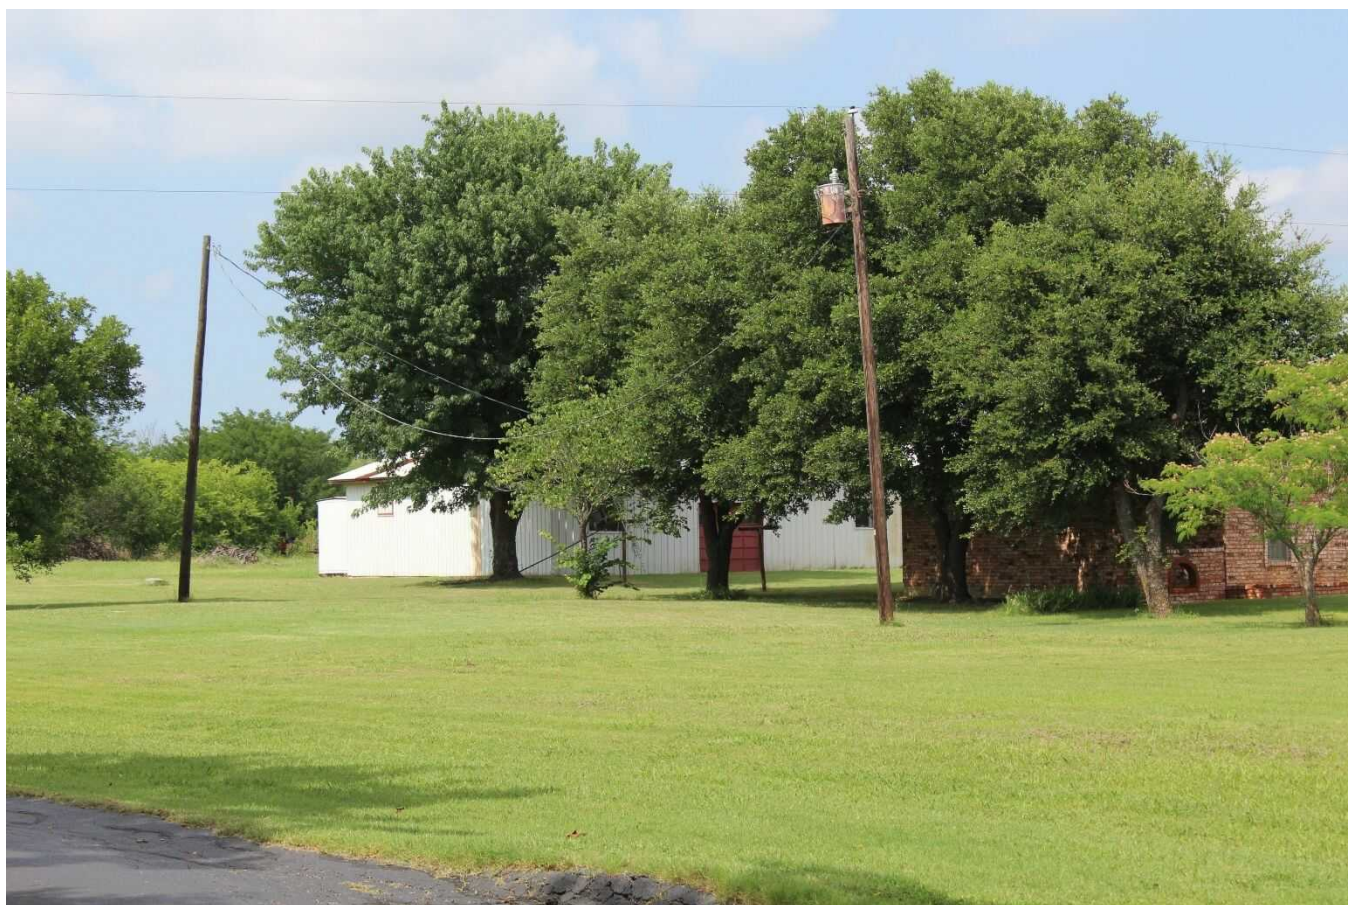
Survey Date:	June 24, 2019
Resource No:	06b
Project Location:	Denton County
Project Name and CSJ:	State Loop 288, CSJ 2250-02-014, etc.
Address, Lat/Long:	6488 Jim Christal Road 33.220913, -97.204392
Function/Sub-function:	DOMESTIC/barn
Construction Date:	Ca. 1977
NRHP Eligibility:	Not eligible
Integrity/Comments:	Resource 06b is the barn. It features a cross-gable, metal roof and metal siding. The barn is six bays wide (east to west), and several additions are attached to the rear giving the originally rectangular footprint an irregular footprint. These additions have metal shed roofs. The barn has slider windows, rolling doors on the south and east façades, and a six-panel door on the south façade.

Camera facing northeast.

06a	6488 Jim Christal Road 33.220632, -97.204413	DOMESTIC/ single-family dwelling	Ranch	Ca.1977	Resource 06a is a single-family dwelling ca. 1977. Aerial images show the house and its outbuildings were not present before 1970 and were present by 1982. The Ranch-style house features an asymmetrical H-shaped footprint, which forms a recessed porch, brick and vertical wood siding, and an asphalt shingle, multiple gable hip roof. The house is on a concrete slab foundation. The chimney is placed on the rear slope of the house. Windows are 4/4 single-hung with a rounded arch. Two brick half-walls flank either side of the front façade, and two brick planters extend from the two outer bays of the front façade. The house is in use.	Not Eligible
06b	6488 Jim Christal Road 33.220913, -97.204392	DOMESTIC/barn	No Style	Ca. 1977	Resource 06b is the barn. It features a cross-gable, metal roof and metal siding. The barn is six bays wide (east to west), and several additions are attached to the rear giving the originally rectangular footprint an irregular footprint. These additions have metal shed roofs. The barn has slider windows, rolling doors on the south and east façades, and a six-panel door on the south façade.	Not Eligible
