# Historical Resources Survey Report

## Reconnaissance Survey

**Project Name:** State Loop 288

**Project Limits:** IH 35W to IH 35

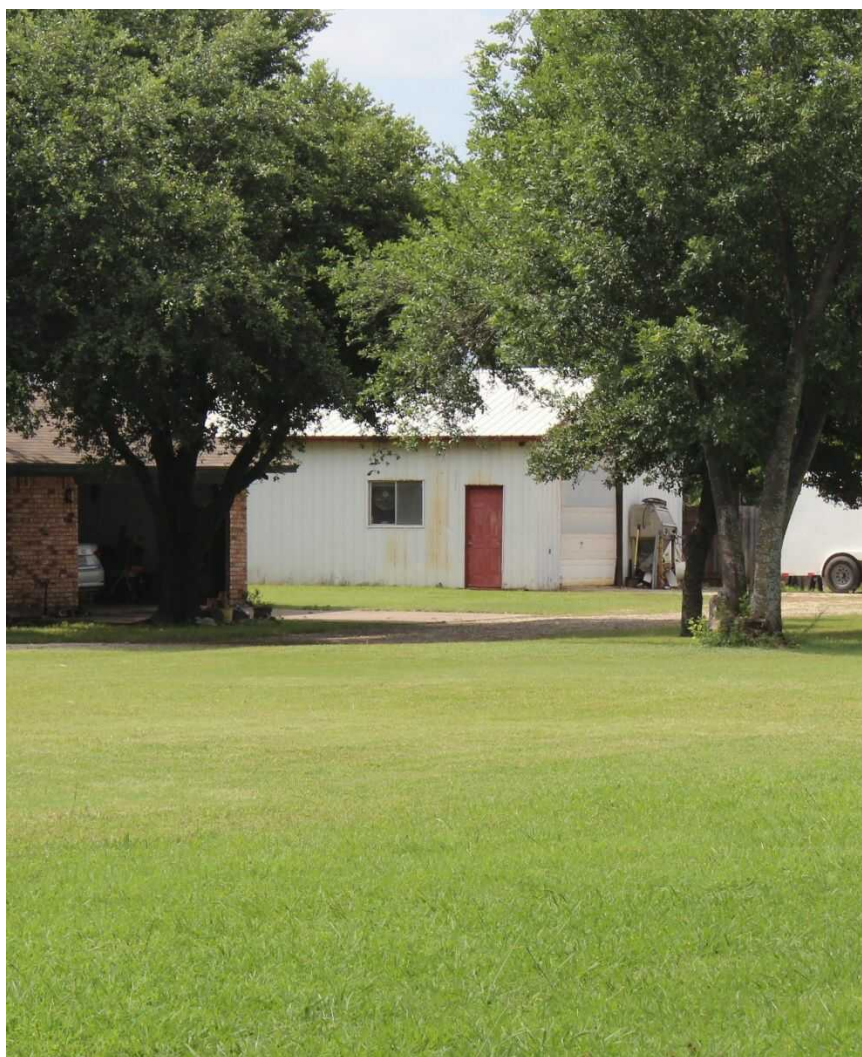
Survey Date:	June 24, 2019
Resource No:	06b
Project Location:	Denton County
Project Name and CSJ:	State Loop 288, CSJ 2250-02-014, etc.
Address, Lat/Long:	6488 Jim Christal Road 33.220913, -97.204392
Function/Sub-function:	DOMESTIC/barn
Construction Date:	Ca. 1977
NRHP Eligibility:	Not eligible
Integrity/Comments:	Resource 06b is the barn. It features a cross-gable, metal roof and metal siding. The barn is six bays wide (east to west), and several additions are attached to the rear giving the originally rectangular footprint an irregular footprint. These additions have metal shed roofs. The barn has slider windows, rolling doors on the south and east façades, and a six-panel door on the south façade.

Camera facing northwest.

06a	6488 Jim Christal Road 33.220632, -97.204413	DOMESTIC/ single-family dwelling	Ranch	Ca.1977	Resource 06a is a single-family dwelling ca. 1977. Aerial images show the house and its outbuildings were not present before 1970 and were present by 1982. The Ranch-style house features an asymmetrical H-shaped footprint, which forms a recessed porch, brick and vertical wood siding, and an asphalt shingle, multiple gable hip roof. The house is on a concrete slab foundation. The chimney is placed on the rear slope of the house. Windows are 4/4 single-hung with a rounded arch. Two brick half-walls flank either side of the front façade, and two brick planters extend from the two outer bays of the front façade. The house is in use.	Not Eligible
06b	6488 Jim Christal Road 33.220913, -97.204392	DOMESTIC/barn	No Style	Ca. 1977	Resource 06b is the barn. It features a cross-gable, metal roof and metal siding. The barn is six bays wide (east to west), and several additions are attached to the rear giving the originally rectangular footprint an irregular footprint. These additions have metal shed roofs. The barn has slider windows, rolling doors on the south and east façades, and a six-panel door on the south façade.	Not Eligible

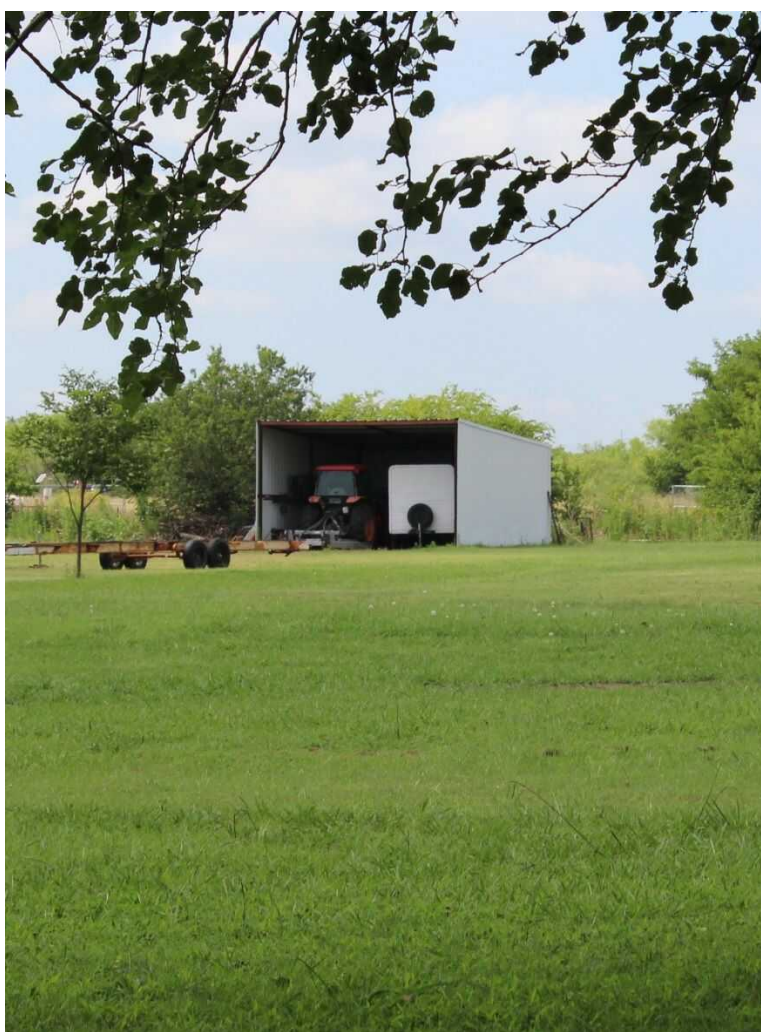
Survey Date:	June 24, 2019
Resource No:	06c
Project Location:	Denton County
Project Name and CSJ:	State Loop 288, CSJ 2250-02-014, etc.
Address, Lat/Long:	6488 Jim Christal Road 33.221278, -97.204199
Function/Sub-function:	DOMESTIC/pole barn
Construction Date:	Ca. 1977
NRHP Eligibility:	Not eligible
Integrity/Comments:	Resource 06c is the pole barn. It features a square footprint, 1:1 bay, with the open bay on the south façade. The pole barn has a metal, shed roof and metal siding. It is currently being used as storage for large machinery.

Camera facing northwest.

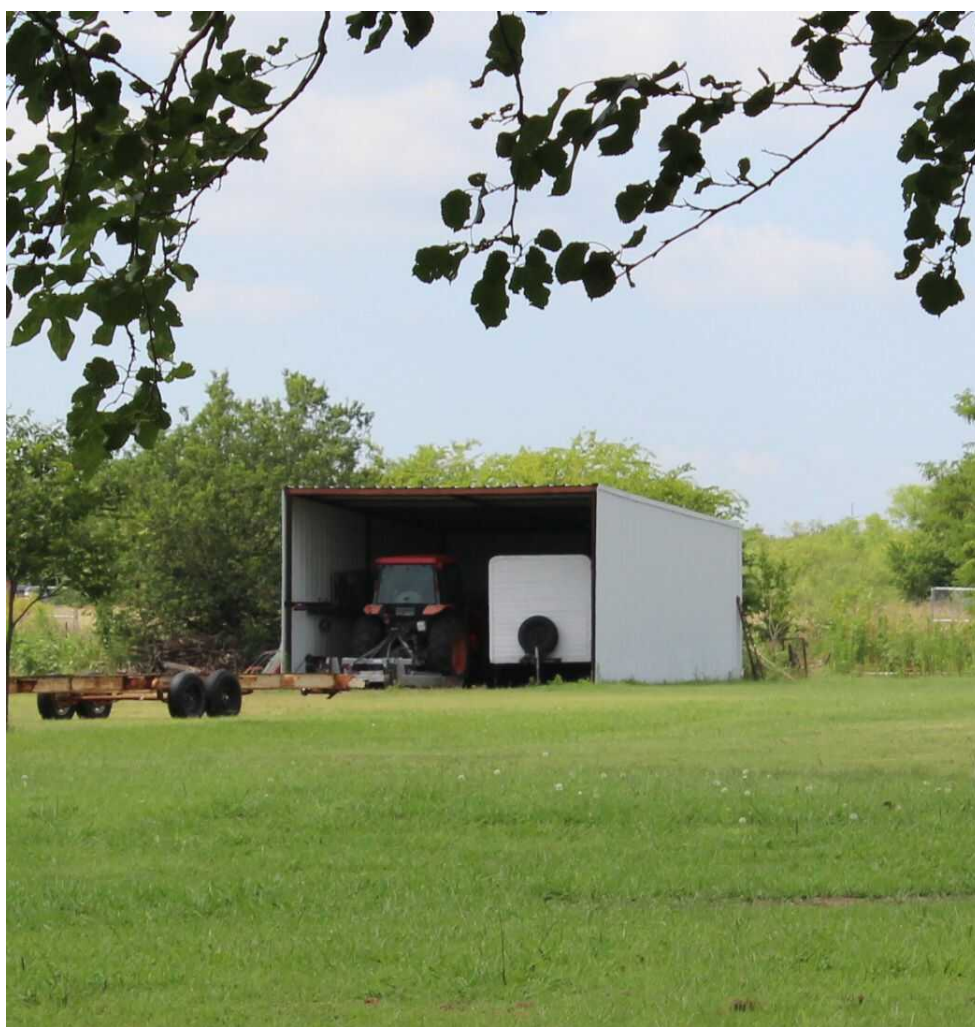
Survey Date:	June 24, 2019
Resource No:	06c
Project Location:	Denton County
Project Name and CSJ:	State Loop 288, CSJ 2250-02-014, etc.
Address, Lat/Long:	6488 Jim Christal Road 33.221278, -97.204199
Function/Sub-function:	DOMESTIC/pole barn
Construction Date:	Ca. 1977
NRHP Eligibility:	Not eligible
Integrity/Comments:	Resource 06c is the pole barn. It features a square footprint, 1:1 bay, with the open bay on the south façade. The pole barn has a metal, shed roof and metal siding. It is currently being used as storage for large machinery.

Camera facing northwest.

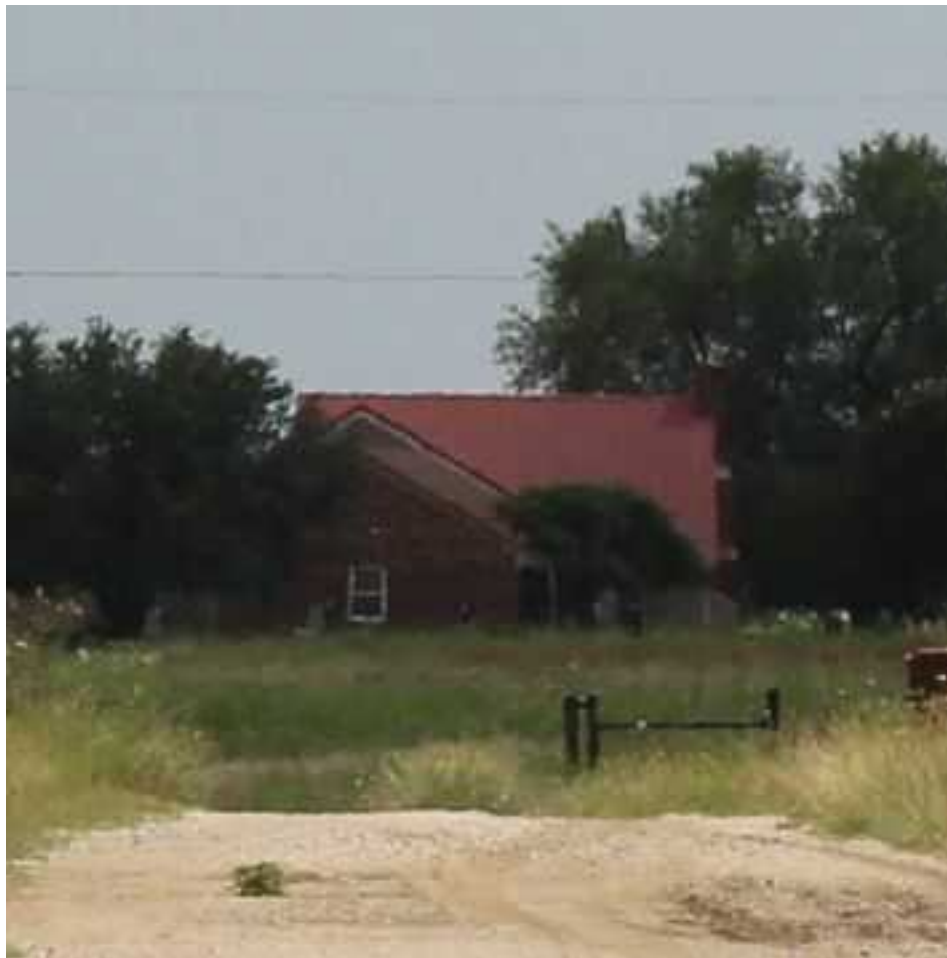
Survey Date:	June 24, 2019
Resource No:	07a
Project Location:	Denton County
Project Name and CSJ:	State Loop 288, CSJ 2250-02-014, etc.
Address, Lat/Long:	No Address, US 380 33.225961, -97.204914
Function/Sub-function:	DOMESTIC/single-family dwelling
Construction Date:	Ca. 1968
NRHP Eligibility:	Not eligible
Integrity/Comments:	Resource 07a is a house with a high-pitched, cross-gable, metal roof and brick and vinyl siding. The house features a rectangular footprint and a partial-width open porch. The two windows visible from the ROW appears to be a 1/1 single or double-hung window. An exterior chimney is located on the west façade. Per 1968 aerial imagery, the house is original to the parcel, however, it appears there have been alterations, including vinyl siding, a new metal roof, and possibly replacement windows.

Camera facing south.

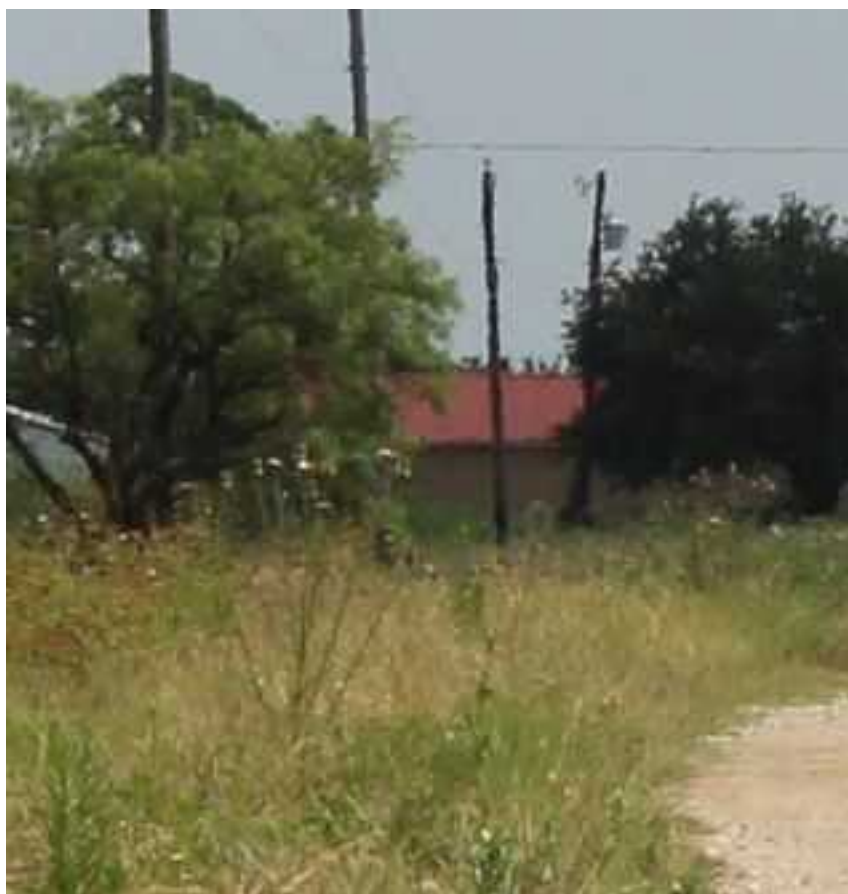
Survey Date:	June 24, 2019
Resource No:	07b
Project Location:	Denton County
Project Name and CSJ:	State Loop 288, CSJ 2250-02-014, etc.
Address, Lat/Long:	No Address, US 380 33.226149, -97.204780
Function/Sub-function:	DOMESTIC/barn
Construction Date:	Ca. 1968
NRHP Eligibility:	Not eligible
Integrity/Comments:	Resource 07b is a barn, which was difficult to analyze from the ROW due to vegetation. It features a rectangular footprint and a metal, gable roof. It appears to have either metal or vinyl siding.

Camera facing south.

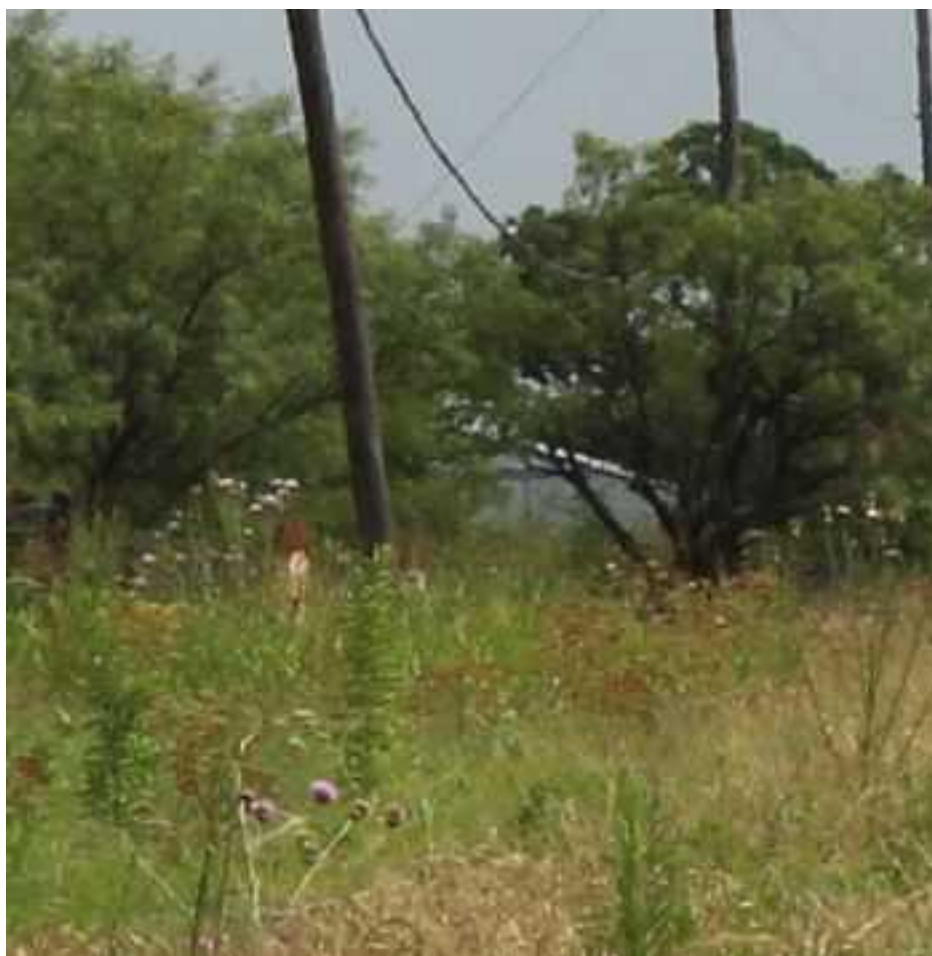
Survey Date:	June 24, 2019
Resource No:	07c
Project Location:	Denton County
Project Name and CSJ:	State Loop 288, CSJ 2250-02-014, etc.
Address, Lat/Long:	No Address, US 380 33226289, -97.204609
Function/Sub-function:	DOMESTIC/barn
Construction Date:	Ca. 1977
NRHP Eligibility:	Not eligible
Integrity/Comments:	Resource 07c is a barn, which was difficult to analyze from the ROW due to vegetation. It features a square footprint, a saltbox or gable with shed-roofed addition along the east façade. It appears to have metal siding.

Camera facing south.

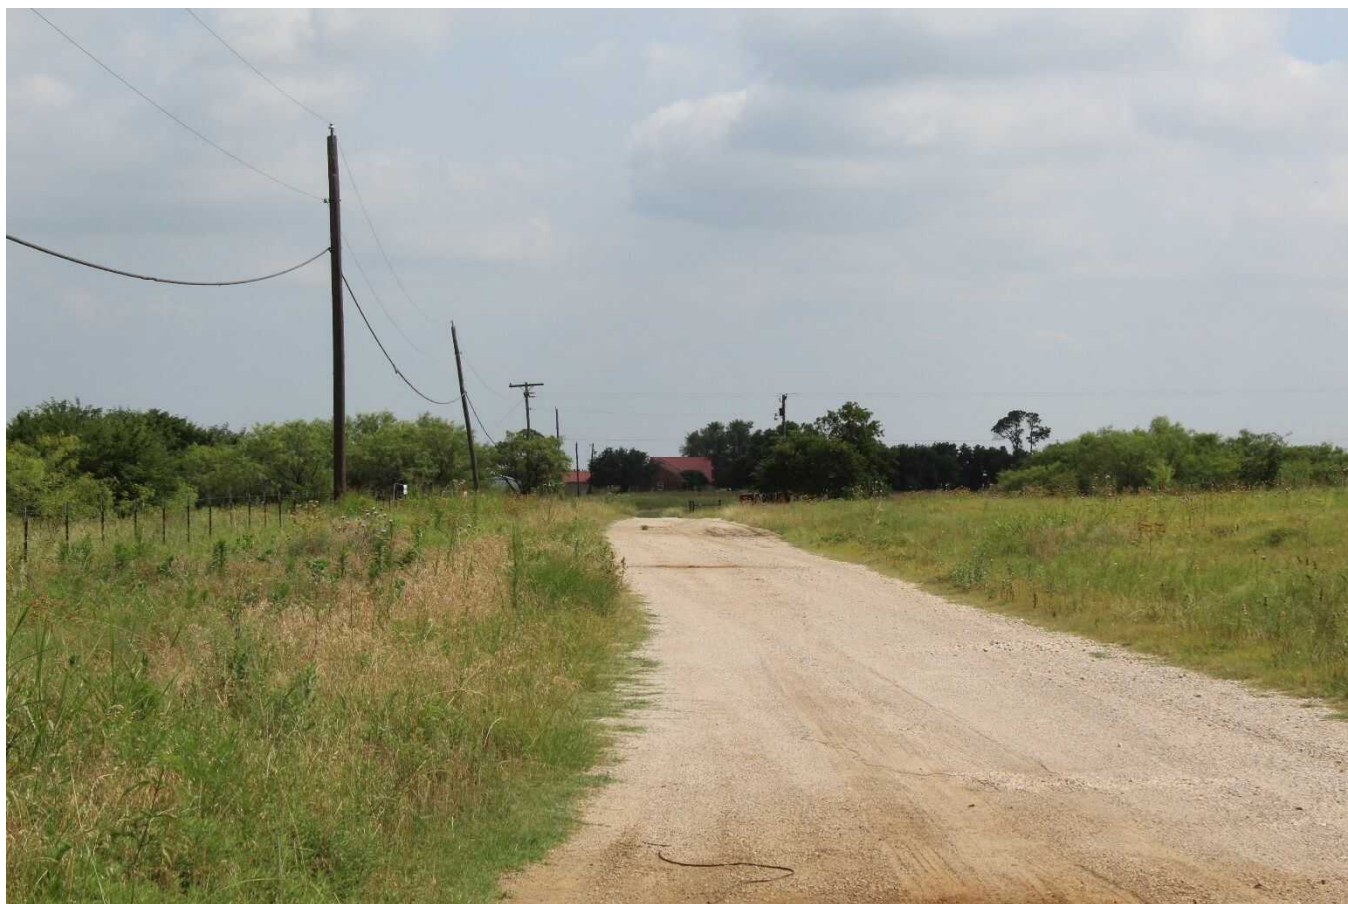
Survey Date:	June 24, 2019
Resource No:	07d
Project Location:	Denton County
Project Name and CSJ:	State Loop 288, CSJ 2250-02-014, etc.
Address, Lat/Long:	No Address, US 380 33.225961, -97.204914
Function/Sub-function:	DOMESTIC/storage tank
Construction Date:	Ca. 1977
NRHP Eligibility:	Not eligible
Integrity/Comments:	Resource 07d is a storage tank. It is identifiable from a 2018 aerial image but is not visible from the ROW. It appears to be an elevated multi-column storage tank.

Camera facing south.

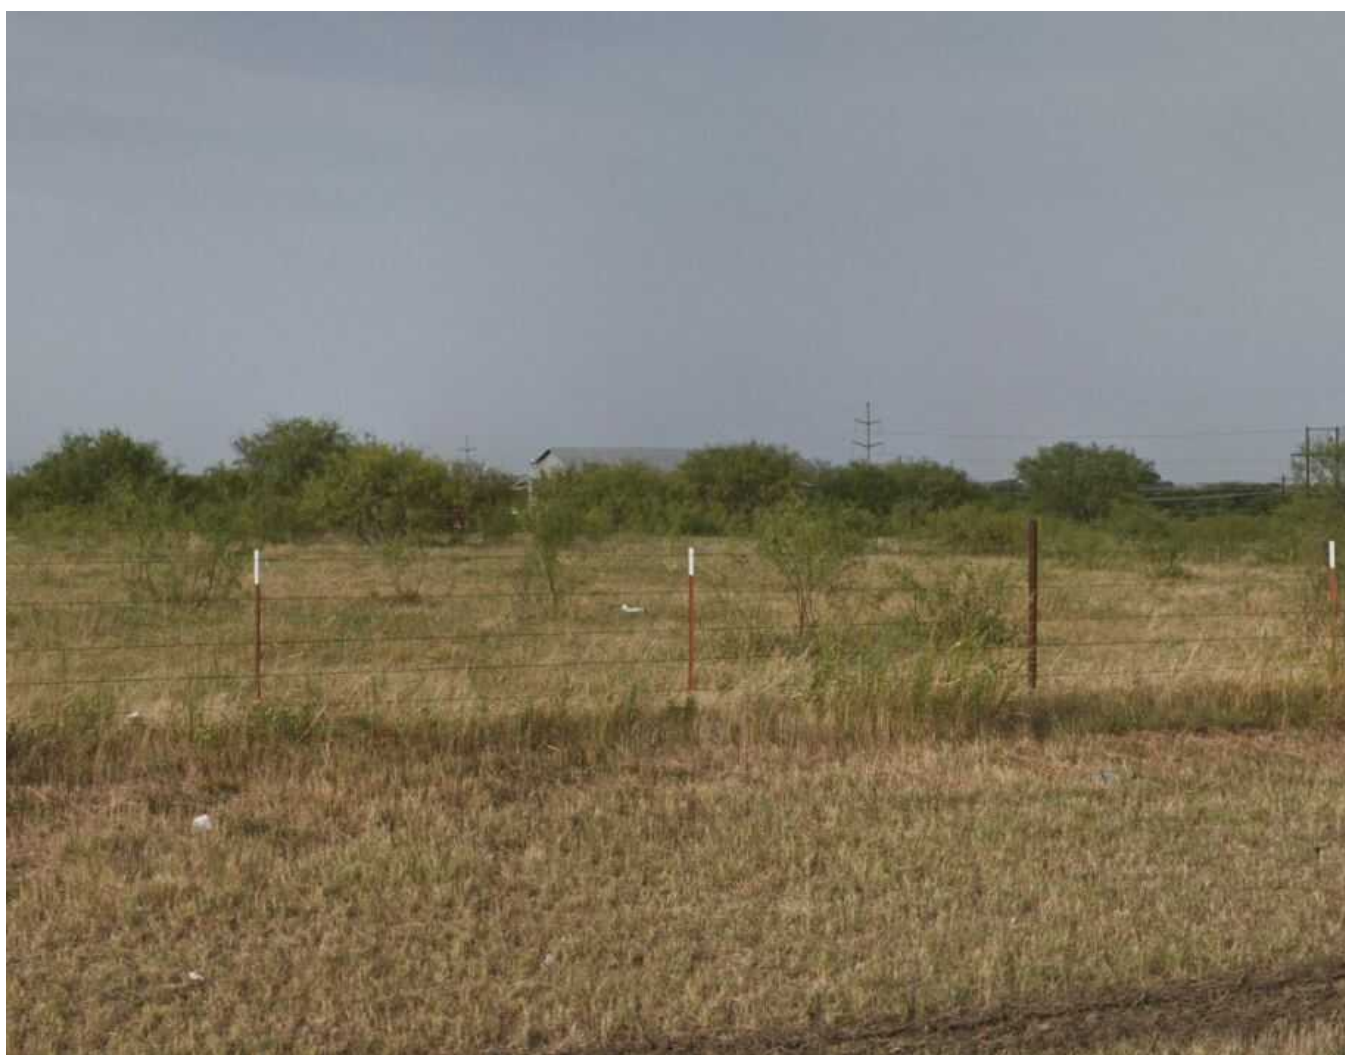
Survey Date:	June 24, 2019
Resource No:	08b
Project Location:	Denton County
Project Name and CSJ:	State Loop 288, CSJ 2250-02-014, etc.
Address, Lat/Long:	7041 W US 380 33.230153, -97.209027
Function/Sub-function:	DOMESTIC/barn
Construction Date:	Ca. 1967
NRHP Eligibility:	Not eligible
Integrity/Comments:	Resource 08b is a barn featuring a metal, gable roof and metal siding. According to aerial imagery, it appears the south side of the roof is missing, exposing the frame construction. The barn is no longer in use.

Facing southwest. Google.

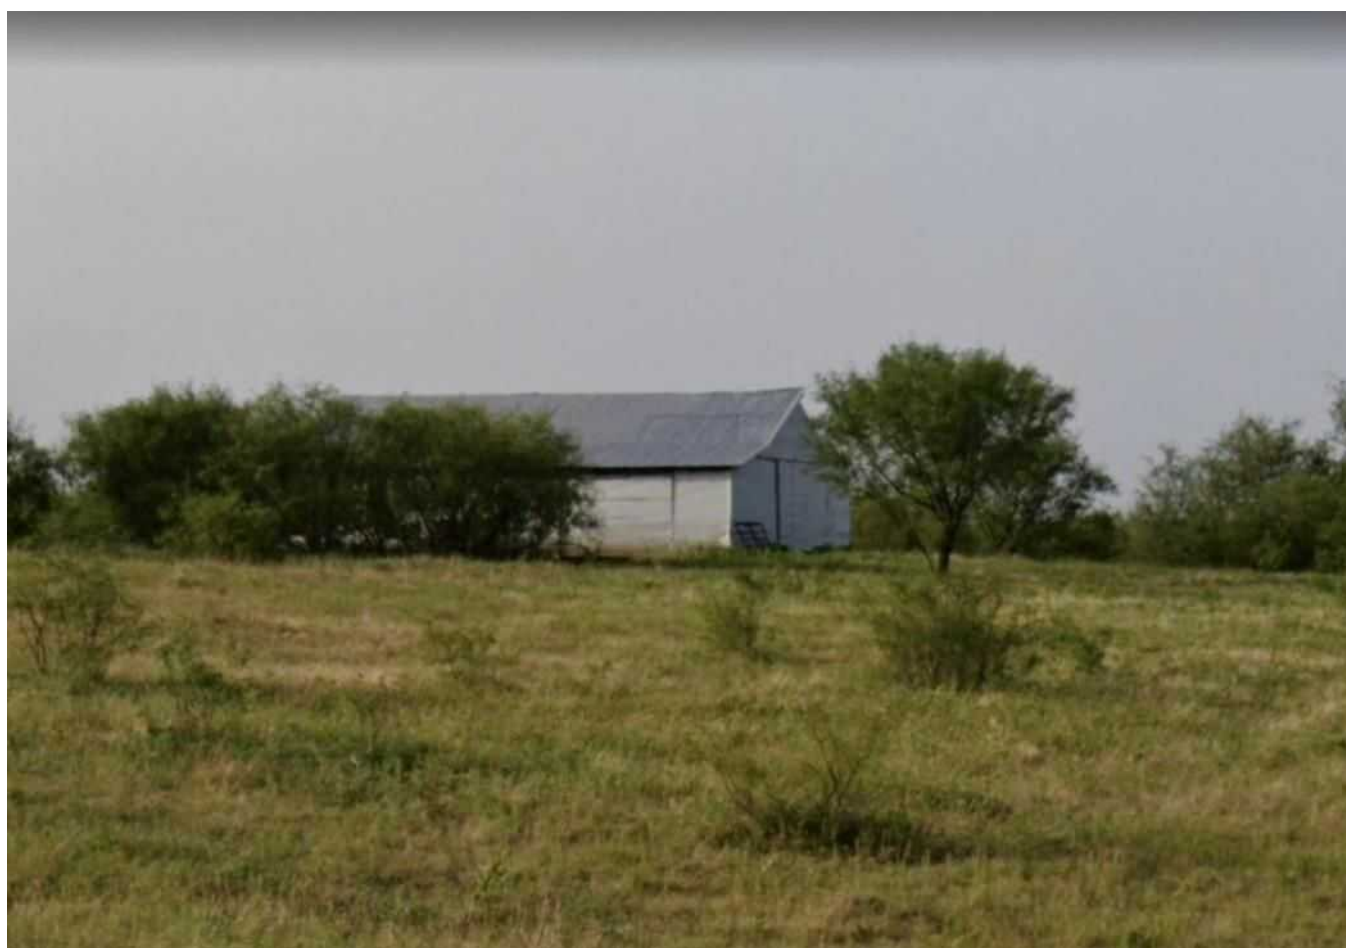
Survey Date:	June 24, 2019
Resource No:	08b
Project Location:	Denton County
Project Name and CSJ:	State Loop 288, CSJ 2250-02-014, etc.
Address, Lat/Long:	7041 W US 380 33.230153, -97.209027
Function/Sub-function:	DOMESTIC/barn
Construction Date:	Ca. 1967
NRHP Eligibility:	Not eligible
Integrity/Comments:	Resource 08b is a barn featuring a metal, gable roof and metal sliding. According to aerial imagery, it appears the south side of the roof is missing, exposing the frame construction. The barn is no longer in use.

Facing southeast. Google.

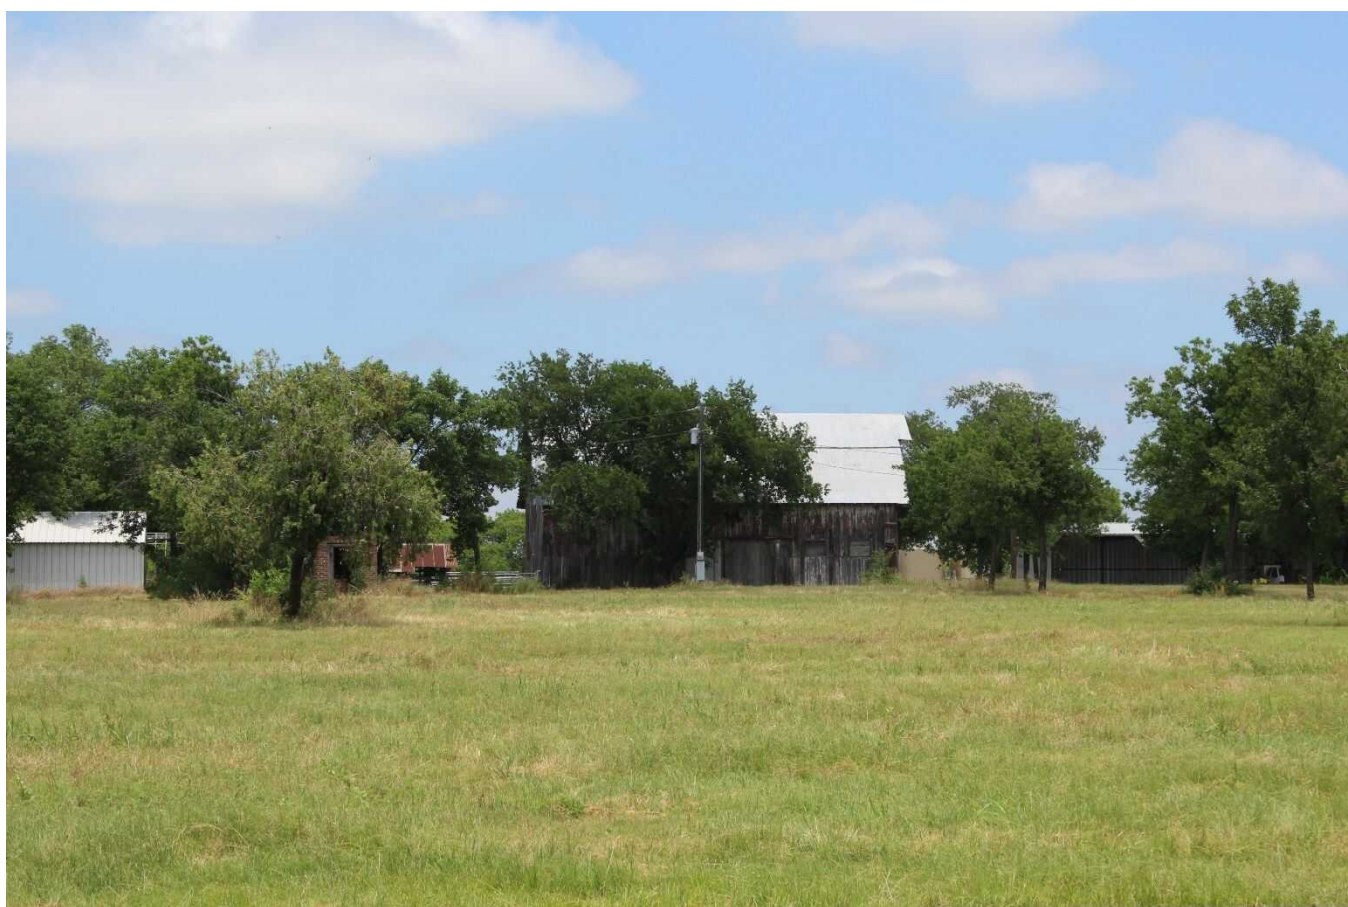
Survey Date:	June 24, 2019
Resource No:	09a
Project Location:	Denton County
Project Name and CSJ:	State Loop 288, CSJ 2250-02-014, etc.
Address, Lat/Long:	No Address, N. Masch Branch Road 33.240408, -97.195857
Function/Sub-function:	AGRICULTURE/barn
Construction Date:	Ca. 1935
NRHP Eligibility:	Not eligible
Integrity/Comments:	Resource 09a is one of the barns associated with the Texas Agricultural Experiment Station No. 6. The experiment station was opened at this location in 1913 under the Hatch Act of 1887, which promoted scientific experimentation in the agricultural industry. The experiment station specialized in researching the best methods for producing weather and disease resistant grains, and several new varieties of grain were developed. The station was closed in 1972. The hay barn features a rectangular footprint, a modern metal gambrel roof, and vertical wood siding. The barn has gable and gable-side entries and features a hay hood. The barn, along with the other resources part of Experiment Station No. 6 are vacant/not in use. Many original agricultural outbuildings are nonextant.

Camera facing north.

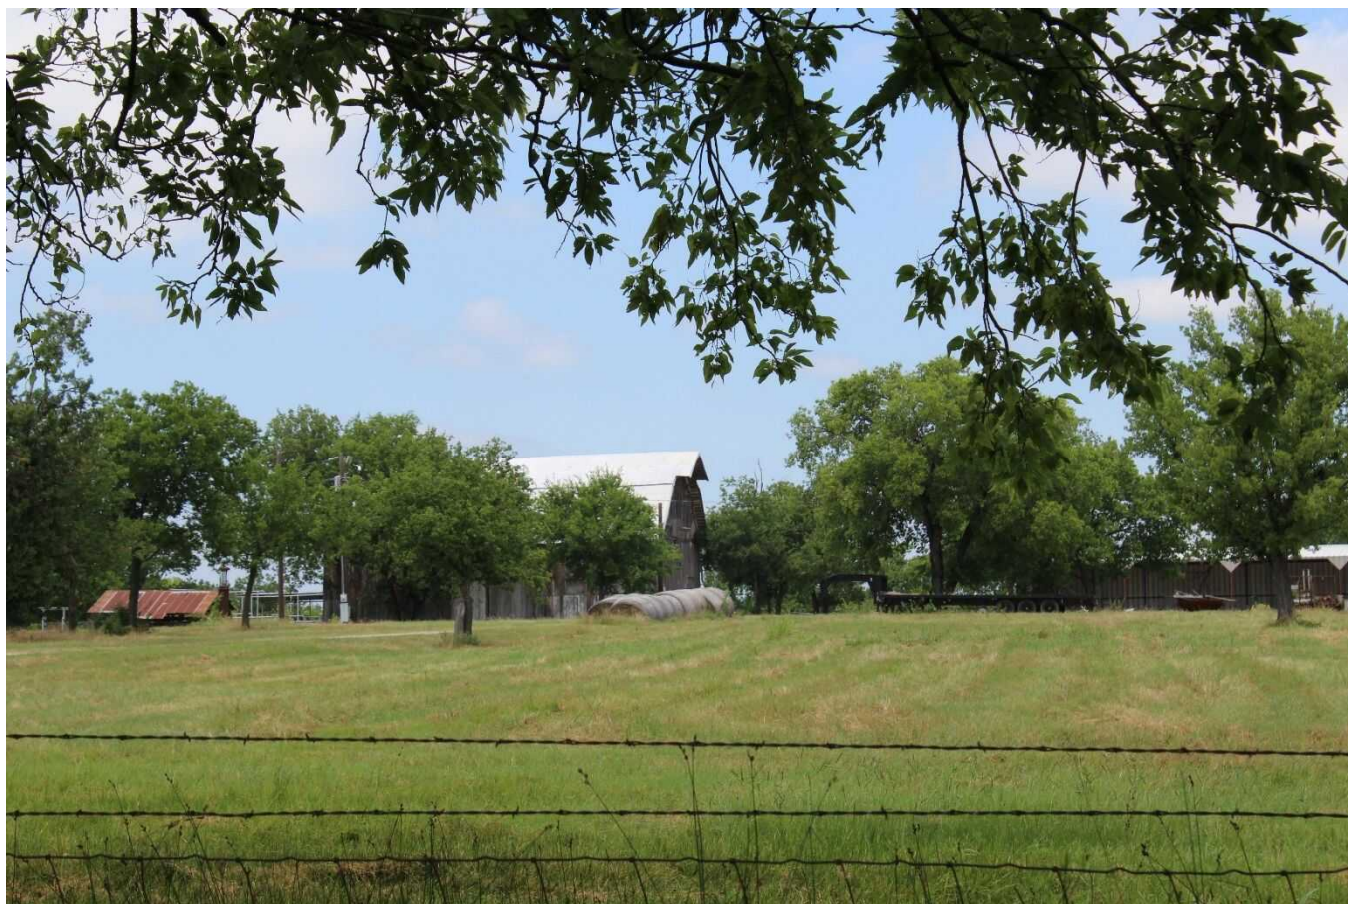
Survey Date:	June 24, 2019
Resource No:	09a
Project Location:	Denton County
Project Name and CSJ:	State Loop 288, CSJ 2250-02-014, etc.
Address, Lat/Long:	No address, N. Masch Branch Road 33.240408, -97.195857
Function/Sub-function:	AGRICULTURE/barn
Construction Date:	Ca. 1935
NRHP Eligibility:	Not eligible
Integrity/Comments:	Resource 09a is one of the barns associated with the Texas Agricultural Experiment Station No. 6. The experiment station was opened at this location in 1913 under the Hatch Act of 1887, which promoted scientific experimentation in the agricultural industry. The experiment station specialized in researching the best methods for producing weather and disease resistant grains, and several new varieties of grain were developed. The station was closed in 1972. The hay barn features a rectangular footprint, a modern metal gambrel roof, and vertical wood siding. The barn has gable and gable-side entries and features a hay hood. The barn, along with the other resources part of Experiment Station No. 6 are vacant/not in use. Many original agricultural outbuildings are nonextant.

Camera facing northwest.

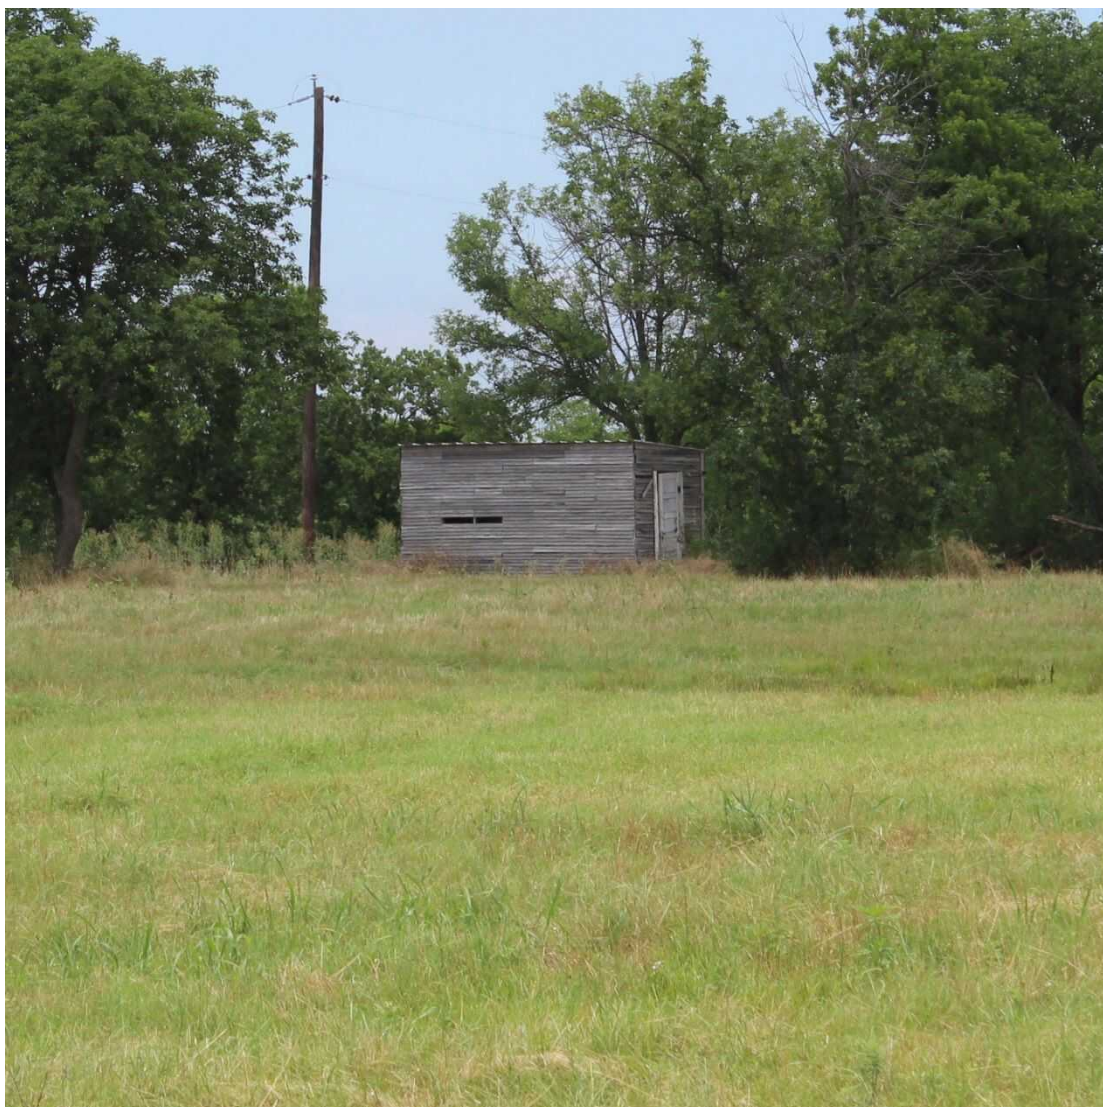
Survey Date:	June 24, 2019
Resource No:	09b
Project Location:	Denton County
Project Name and CSJ:	State Loop 288, CSJ 2250-02-014, etc.
Address, Lat/Long:	No Address, N. Masch Branch Road 33.240071, -97.196331
Function/Sub-function:	AGRICULTURE/shed
Construction Date:	Ca. 1935
NRHP Eligibility:	Not eligible
Integrity/Comments:	Resource 09b is a shed with a rectangular footprint, metal shed roof, vertical wood siding, and a 5-panel door on the east façade. The shed is vacant/not in use.

Camera facing northwest.

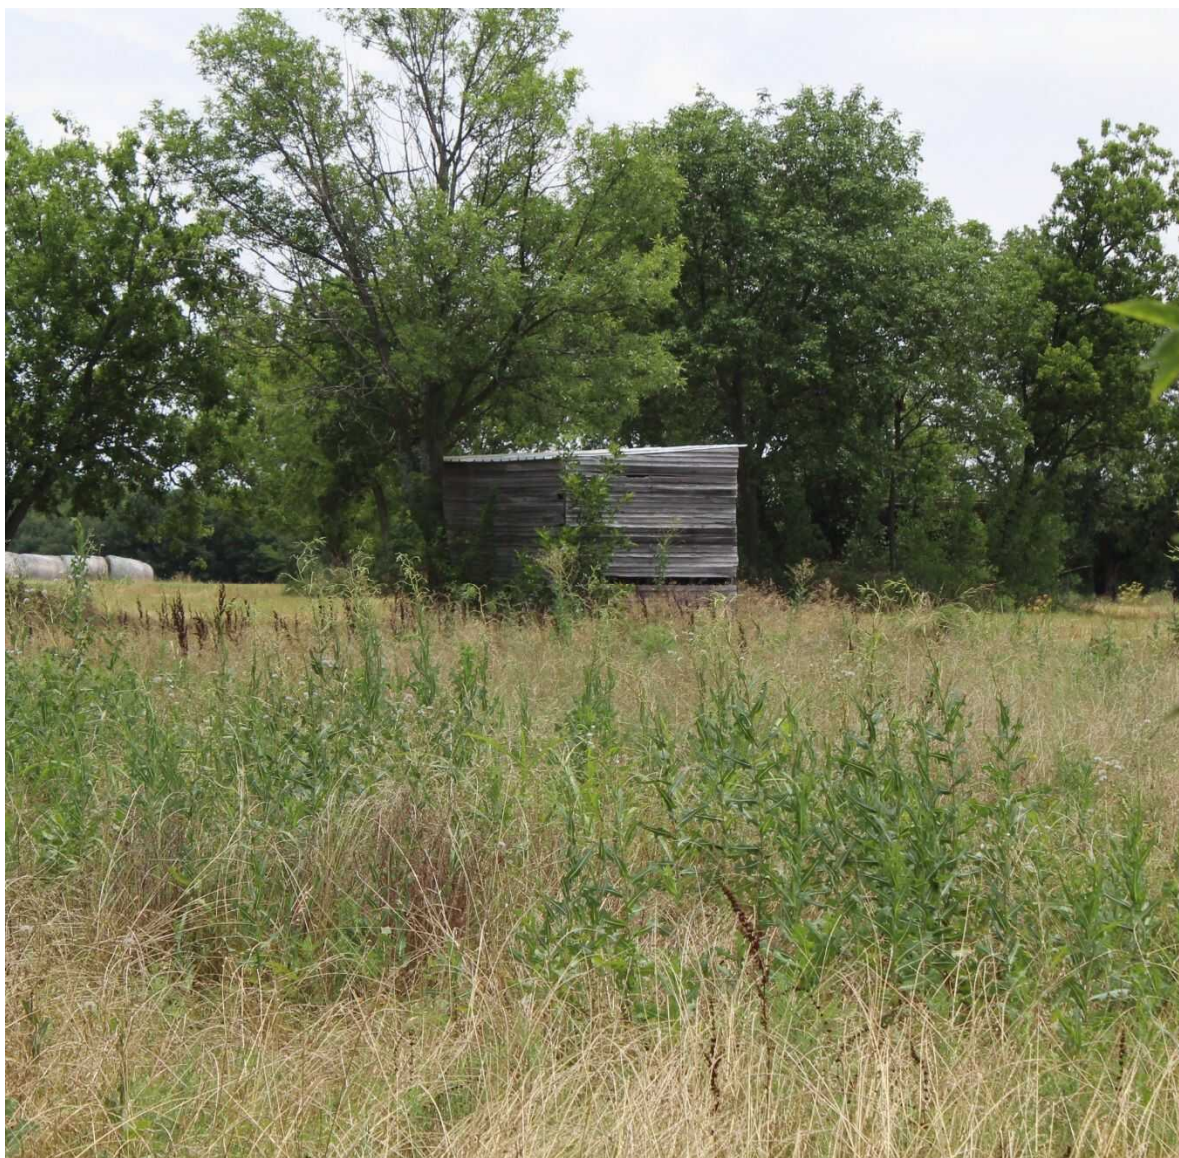
Survey Date:	June 24, 2019
Resource No:	09b
Project Location:	Denton County
Project Name and CSJ:	State Loop 288, CSJ 2250-02-014, etc.
Address, Lat/Long:	No address, N. Masch Branch Road 33.240071, -97.196331
Function/Sub-function:	AGRICULTURE/shed
Construction Date:	Ca. 1935
NRHP Eligibility:	Not eligible
Integrity/Comments:	Resource 09b is a shed with a rectangular footprint, metal shed roof, vertical wood siding, and a 5-panel door on the east façade. The shed is vacant/not in use.

Camera facing southeast.

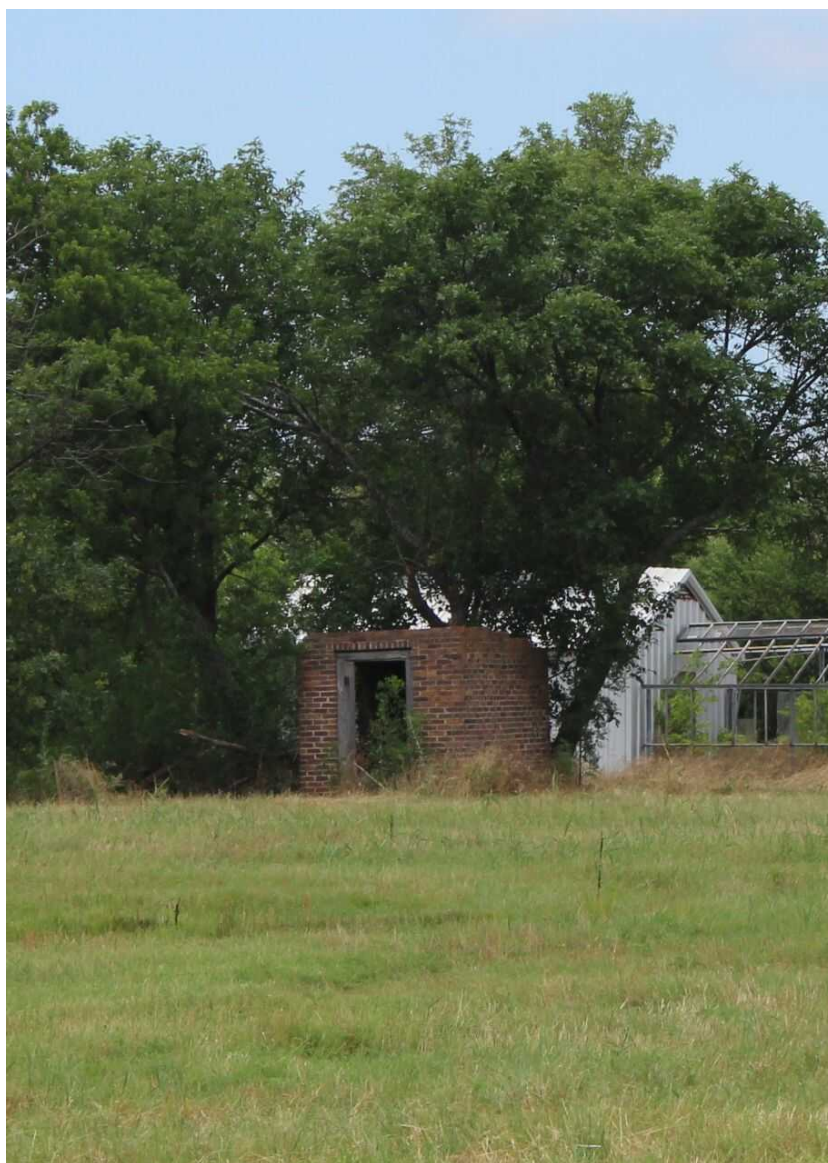
Survey Date:	June 24, 2019
Resource No:	09c
Project Location:	Denton County
Project Name and CSJ:	State Loop 288, CSJ 2250-02-014, etc.
Address, Lat/Long:	No Address, N. Masch Branch Road 33.239935, -97.196114
Function/Sub-function:	AGRICULTURE/wellhouse
Construction Date:	Ca. 1945
NRHP Eligibility:	Not eligible
Integrity/Comments:	Resource 09c is a wellhouse. It features a square footprint, four brick facades, and an entry on the south façade. The roof is missing, as well as several rows of bricks. The wellhouse is currently vacant/not in use.

Camera facing northwest.

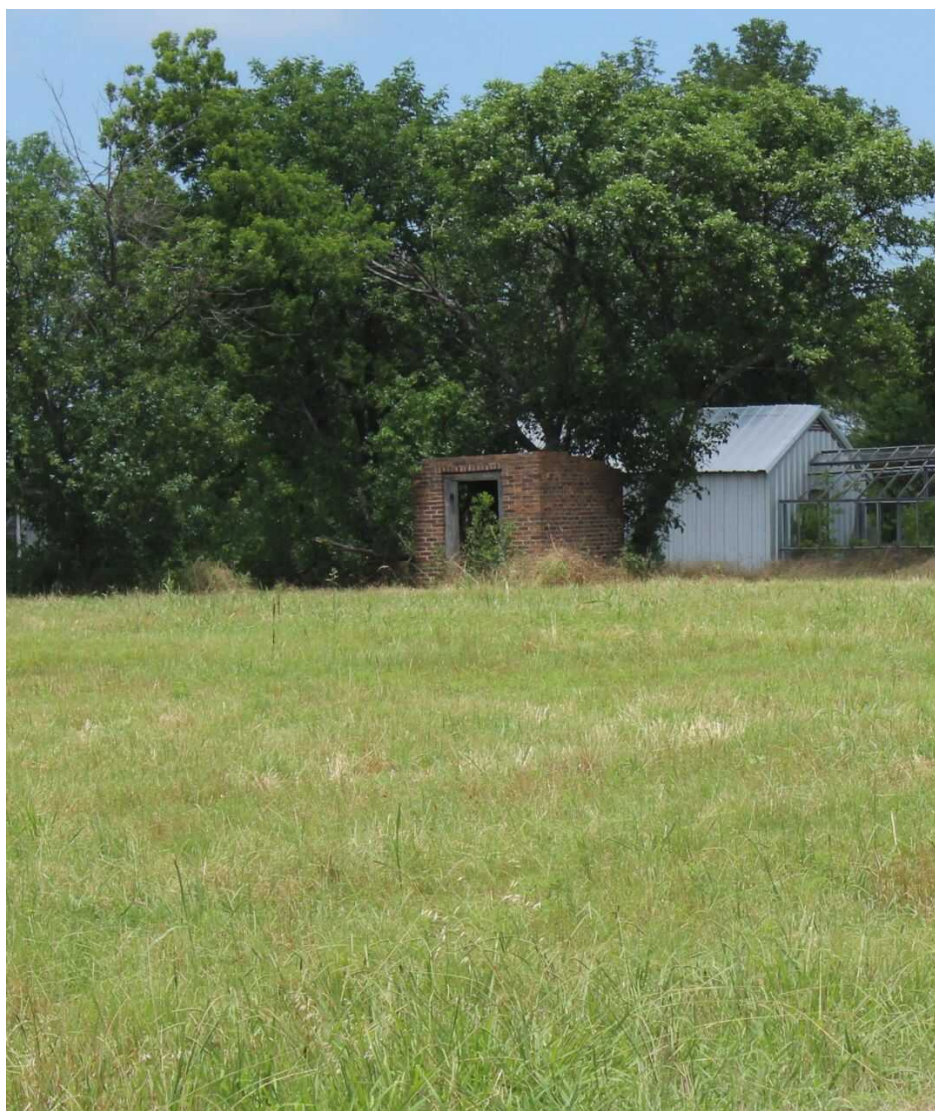
Survey Date:	June 24, 2019
Resource No:	09c
Project Location:	Denton County
Project Name and CSJ:	State Loop 288, CSJ 2250-02-014, etc.
Address, Lat/Long:	No address, N. Masch Branch Road 33.239935, -97.196114
Function/Sub-function:	AGRICULTURE/wellhouse
Construction Date:	Ca. 1945
NRHP Eligibility:	Not eligible
Integrity/Comments:	Resource 09c is a wellhouse. It features a square footprint, four brick facades, and an entry on the south façade. The roof is missing, as well as several rows of bricks. The wellhouse is currently vacant/not in use.

Camera facing northwest.

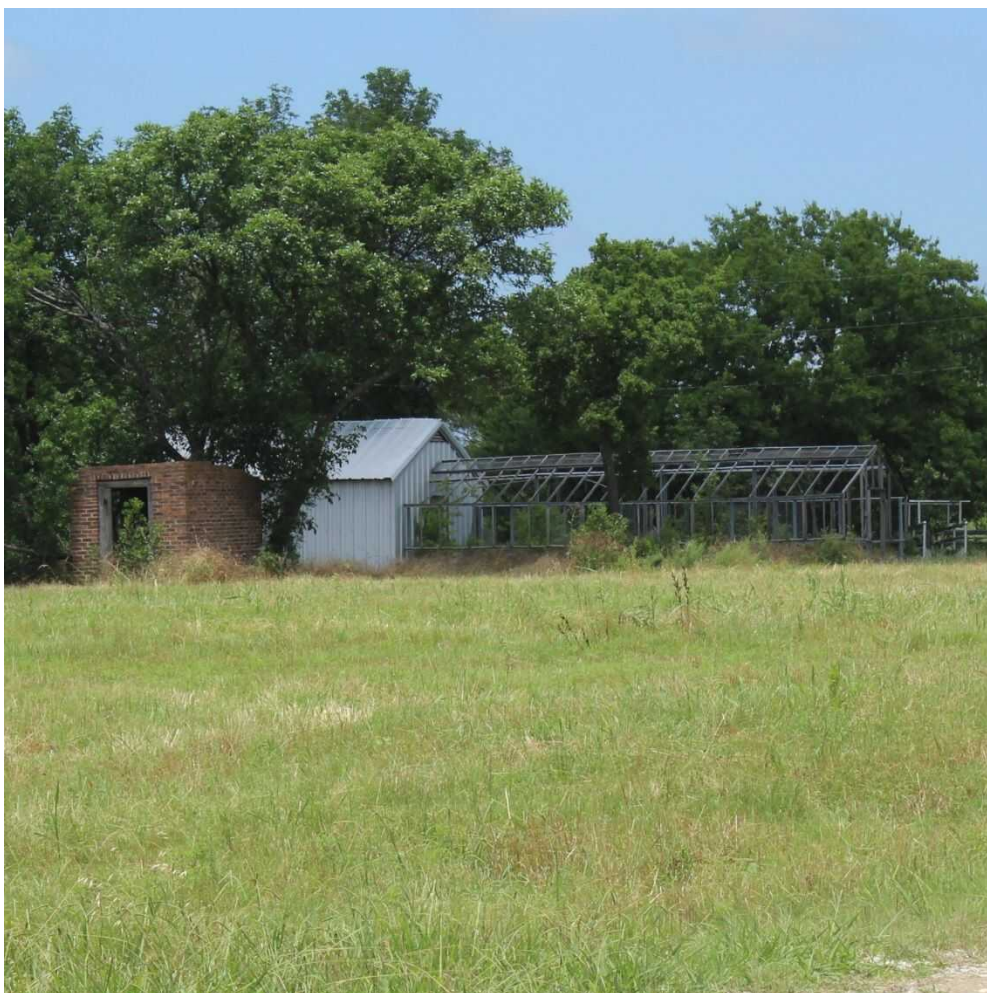
Survey Date:	June 24, 2019
Resource No:	09d
Project Location:	Denton County
Project Name and CSJ:	State Loop 288, CSJ 2250-02-014, etc.
Address, Lat/Long:	No Address, N. Masch Branch Road 33.240174, -97.196165
Function/Sub-function:	AGRICULTURE/shed and greenhouse
Construction Date:	Ca. 1965
NRHP Eligibility:	Not eligible
Integrity/Comments:	Resource 09d includes a shed with an attached greenhouse along its east façade. The shed features a rectangular footprint with a metal gable roof, metal siding, and a gable entry. The entry leads into the greenhouse, which features a metal frame and a gable roof. Several glass panes are present along the roof ridge. It appears the metal siding on the shed is placed over the original horizontal wood siding, which is exposed at the peak of the gable. The shed and greenhouse are vacant/not in use.

Camera facing northwest.

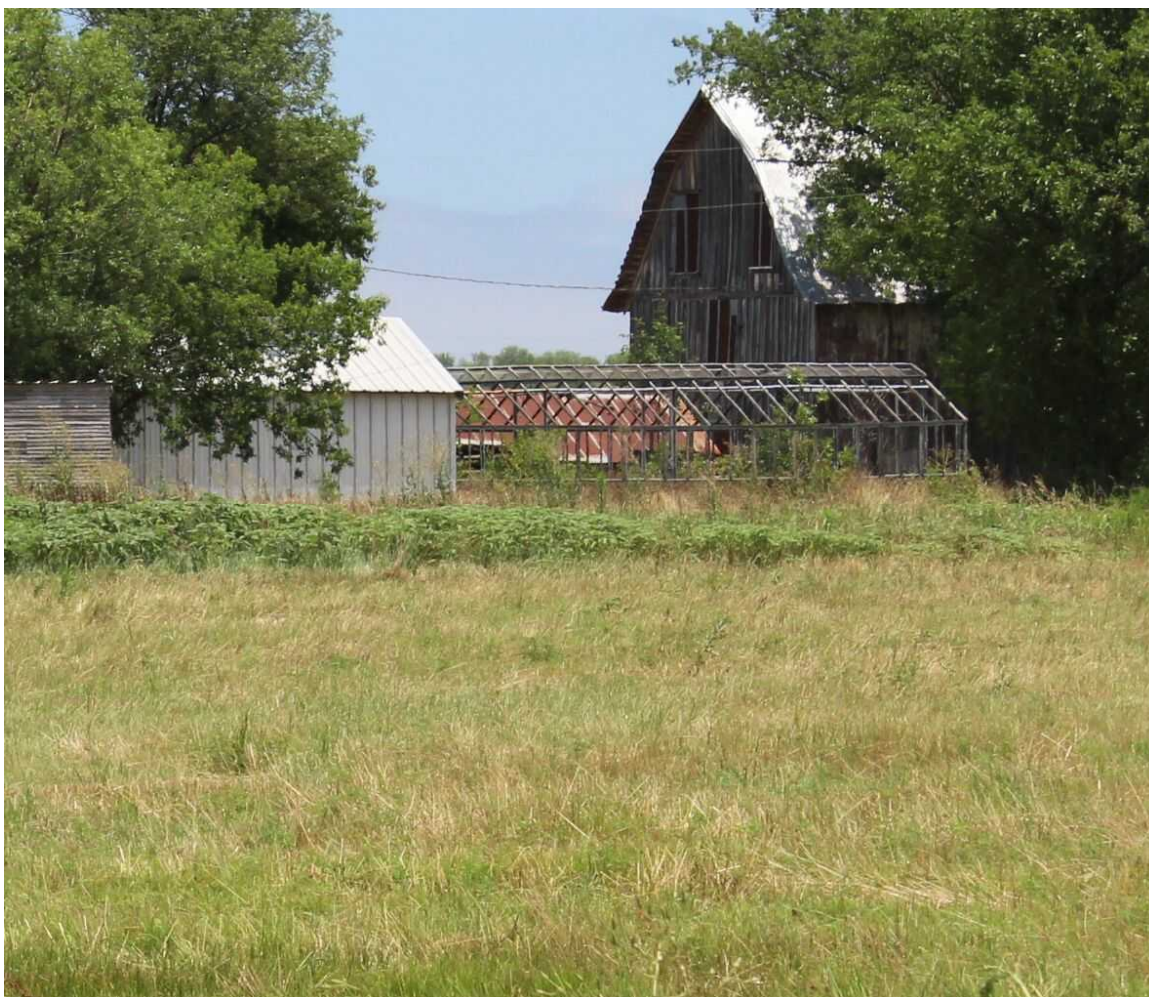
Survey Date:	June 24, 2019
Resource No:	09d
Project Location:	Denton County
Project Name and CSJ:	State Loop 288, CSJ 2250-02-014, etc.
Address, Lat/Long:	No address, N. Masch Branch Road 33.240174, -97.196165
Function/Sub-function:	AGRICULTURE/barn and greenhouse
Construction Date:	Ca. 1965
NRHP Eligibility:	Not eligible
Integrity/Comments:	Resource 09d includes a shed with an attached greenhouse along its east façade. The shed features a rectangular footprint with a metal gable roof, metal siding, and a gable entry. The entry leads into the greenhouse, which features a metal frame and a gable roof. Several glass panes are present along the roof ridge. It appears the metal siding on the shed is placed over the original horizontal wood siding, which is exposed at the peak of the gable. The shed and greenhouse are vacant/not in use.

Camera facing northeast.
