# Historical Resources Survey Report

## Reconnaissance Survey

**Project Name:** State Loop 288

**Project Limits:** IH 35W to IH 35

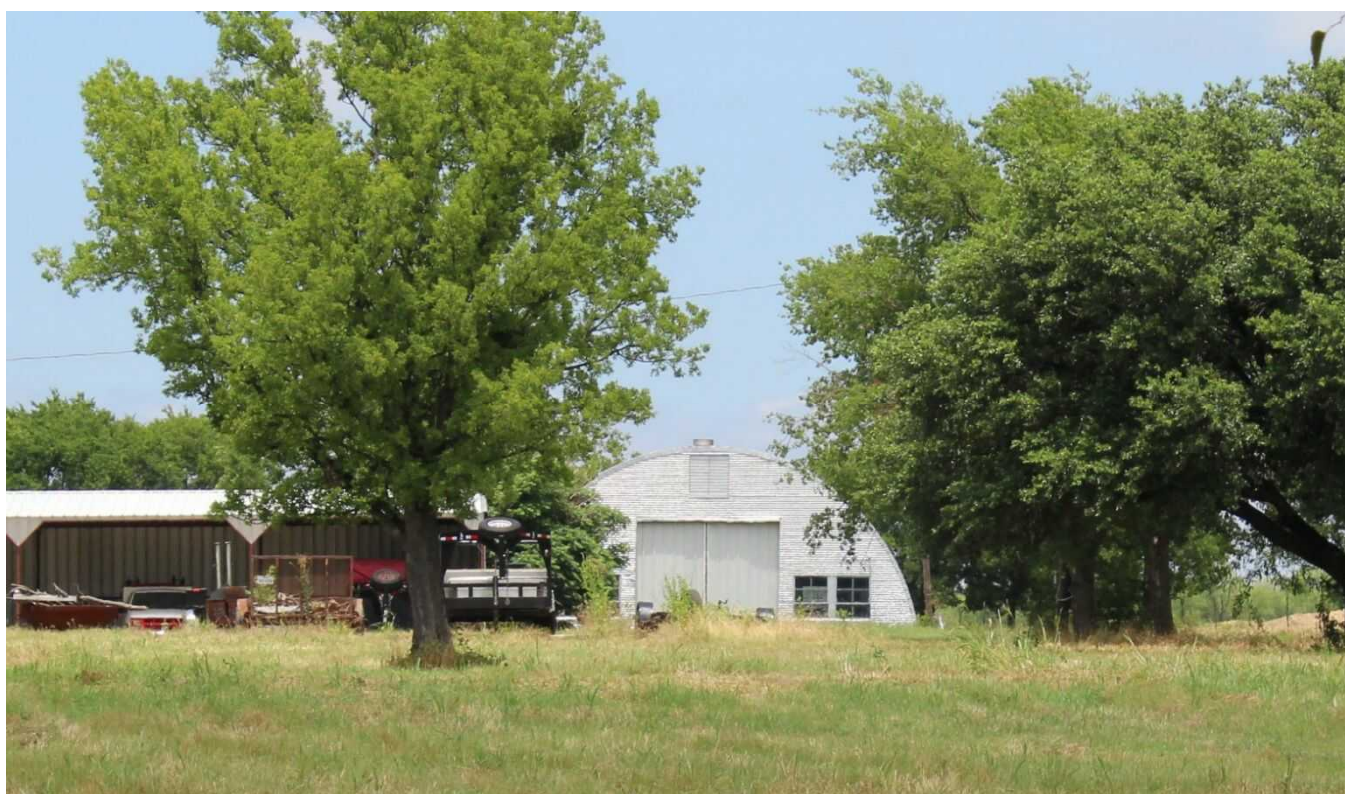
Survey Date:	June 24, 2019
Resource No:	09e
Project Location:	Denton County
Project Name and CSJ:	State Loop 288, CSJ 2250-02-014, etc.
Address, Lat/Long:	No Address, N. Masch Branch Road 33.240856, -97.195324
Function/Sub-function:	AGRICULTURE/Quonset hut
Construction Date:	Ca. 1950
NRHP Eligibility:	Not eligible
Integrity/Comments:	Resource 09e is a Quonset hut. It features a rectangular footprint, a metal barrel roof, and metal siding. Its front (south) façade is four bays wide (east to west) and includes four 4/4 windows, two metal doors, and a vent. It is unclear if the Quonset hut is still in use.

Camera facing north.

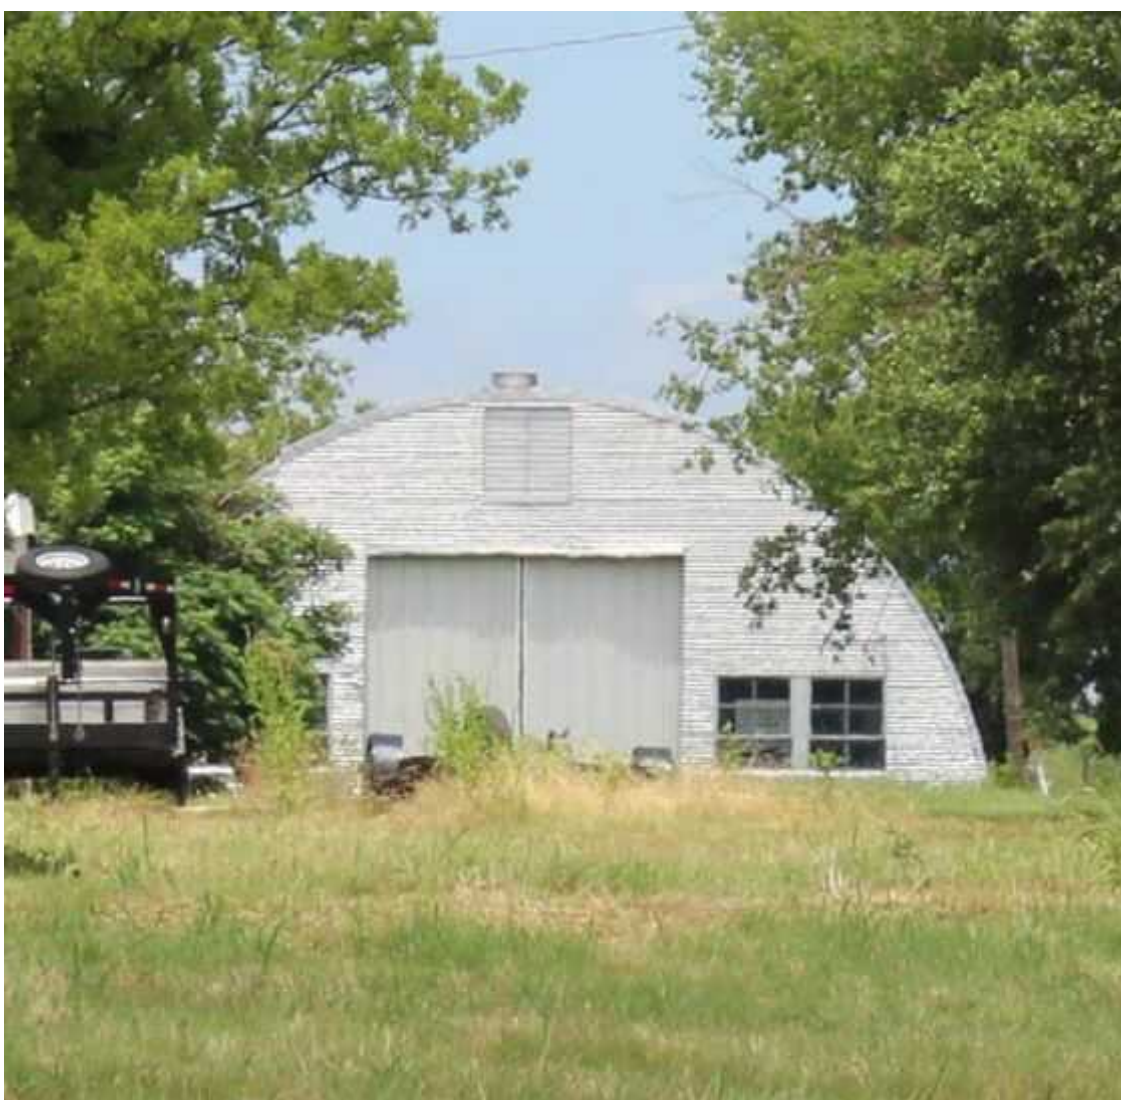
Survey Date:	June 24, 2019
Resource No:	09e
Project Location:	Denton County
Project Name and CSJ:	State Loop 288, CSJ 2250-02-014, etc.
Address, Lat/Long:	No address, N. Masch Branch Road 33.240856, -97.195324
Function/Sub-function:	AGRICULTURE/quonset hut
Construction Date:	Ca. 1950
NRHP Eligibility:	Not eligible
Integrity/Comments:	Resource 09e is a Quonset hut. It features a rectangular footprint, a metal barrel roof, and metal siding. Its front (south) façade is four bays wide (east to west) and includes four 4/4 windows, two metal doors, and a vent. It is unclear if the Quonset hut is still in use.

Camera facing north.

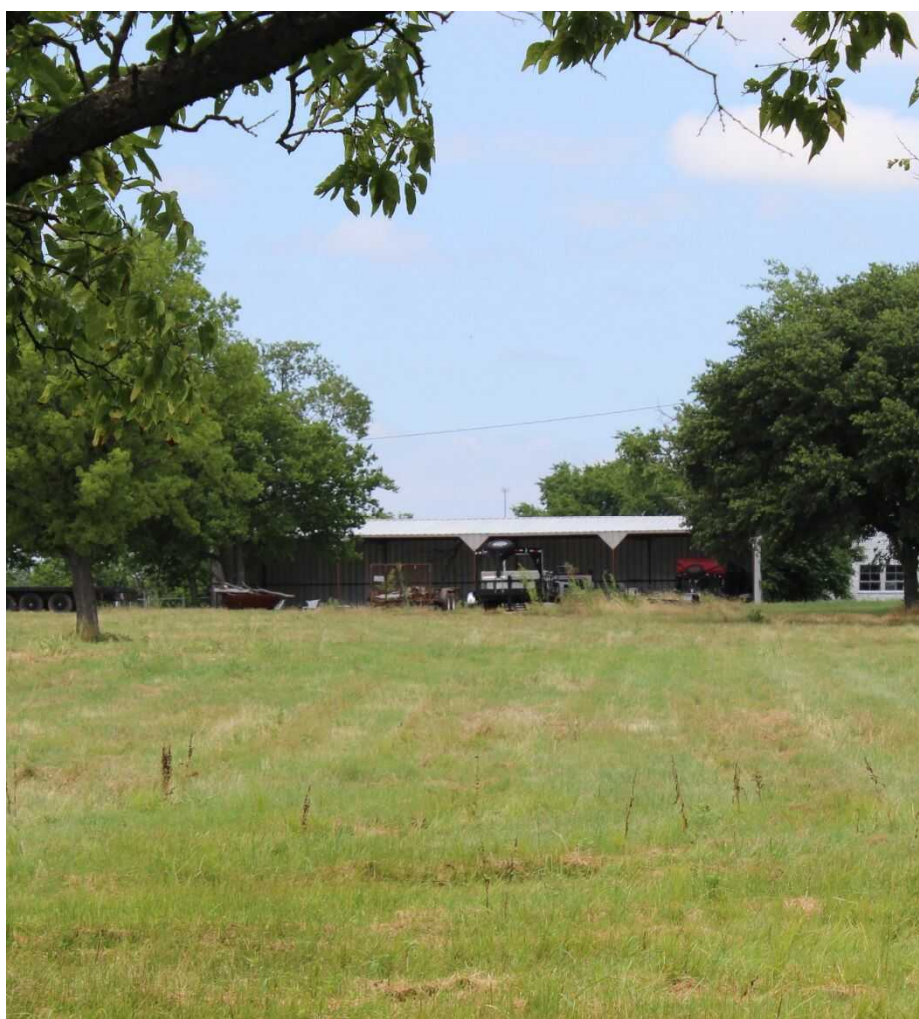
Survey Date:	June 24, 2019
Resource No:	09f
Project Location:	Denton County
Project Name and CSJ:	State Loop 288, CSJ 2250-02-014, etc.
Address, Lat/Long:	No Address, N. Masch Branch Road 33.240649, -97.195480
Function/Sub-function:	AGRICULTURE/pole barn
Construction Date:	Ca. 1970
NRHP Eligibility:	Not eligible
Integrity/Comments:	Resource 09f is a pole barn, which features a rectangular footprint, a metal shed roof, and metal siding. The front (south) façade has four open bays, divided by metal poles. The interior space is open. The pole barn is currently in use as storage for large machinery.

Camera facing north.

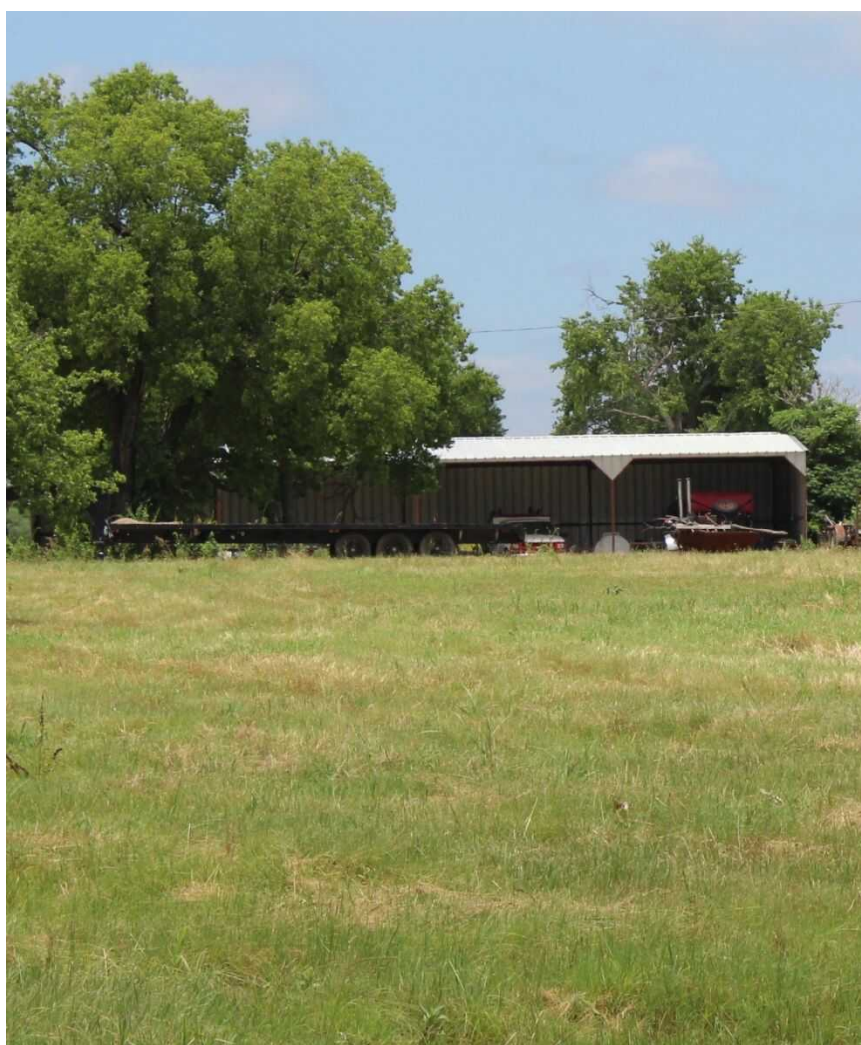
Survey Date:	June 24, 2019
Resource No:	09f
Project Location:	Denton County
Project Name and CSJ:	State Loop 288, CSJ 2250-02-014, etc.
Address, Lat/Long:	No address, N. Masch Branch Road 33.240649, -97.195480
Function/Sub-function:	AGRICULTURE/pole barn
Construction Date:	Ca. 1970
NRHP Eligibility:	Not eligible
Integrity/Comments:	Resource 09f is a pole barn, which features a rectangular footprint, a metal shed roof, and metal siding. The front (south) façade has four open bays, divided by metal poles. The interior space is open. The pole barn is currently in use as storage for large machinery.

Camera facing north.

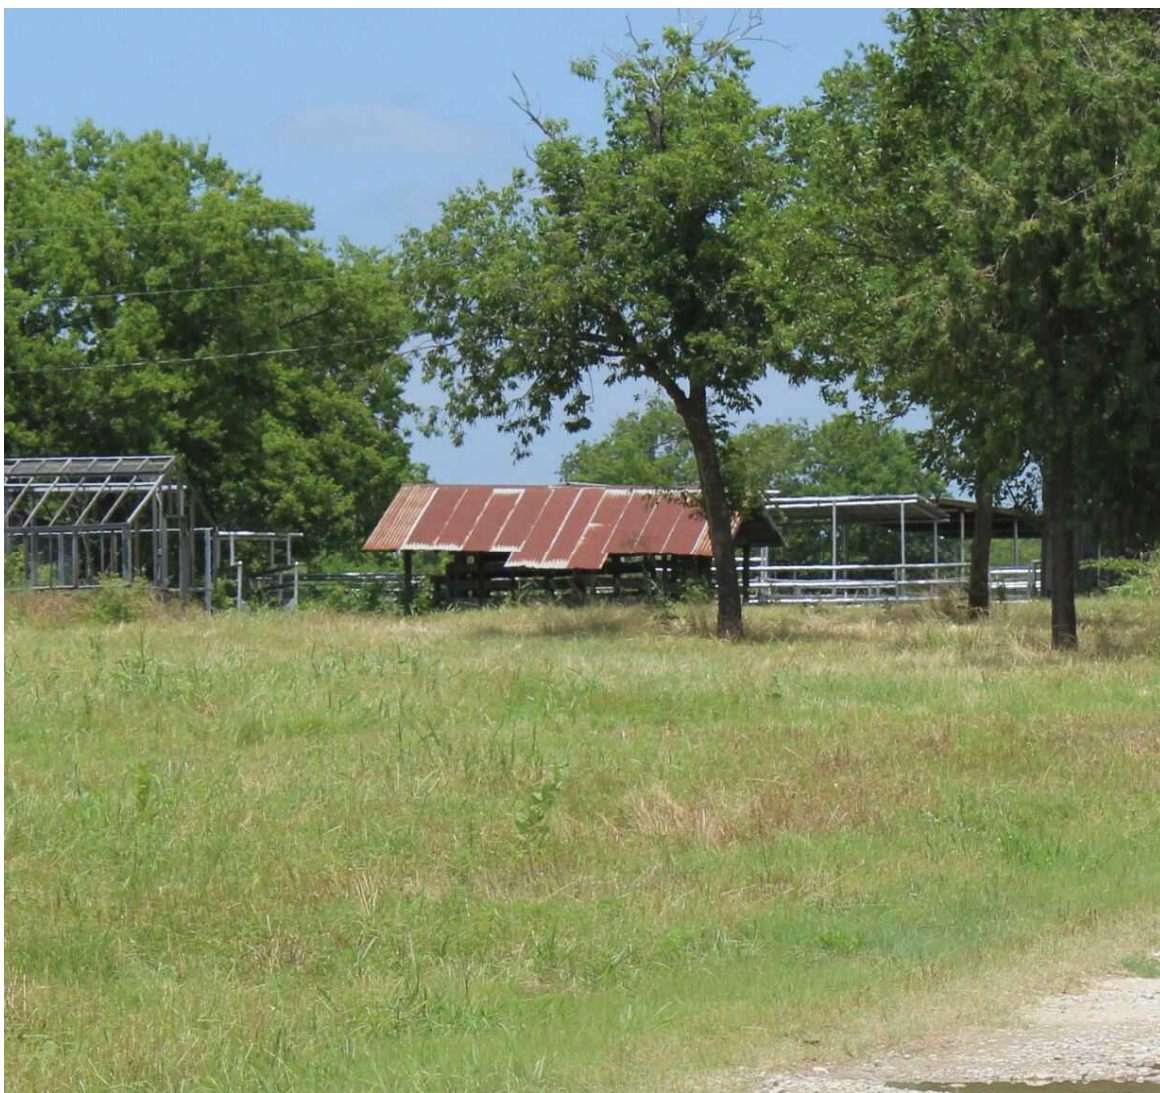
Survey Date:	June 24, 2019
Resource No:	09g
Project Location:	Denton County
Project Name and CSJ:	State Loop 288, CSJ 2250-02-014, etc.
Address, Lat/Long:	No Address, N. Masch Branch Road 33.240353, -97.196063
Function/Sub-function:	AGRICULTURE/hay shed
Construction Date:	Ca. 1965
NRHP Eligibility:	Not eligible
Integrity/Comments:	Resource 09g is a hay shed. It features a metal gable roof and an exposed wooden frame. It is vacant/not in use.

Camera facing northwest.

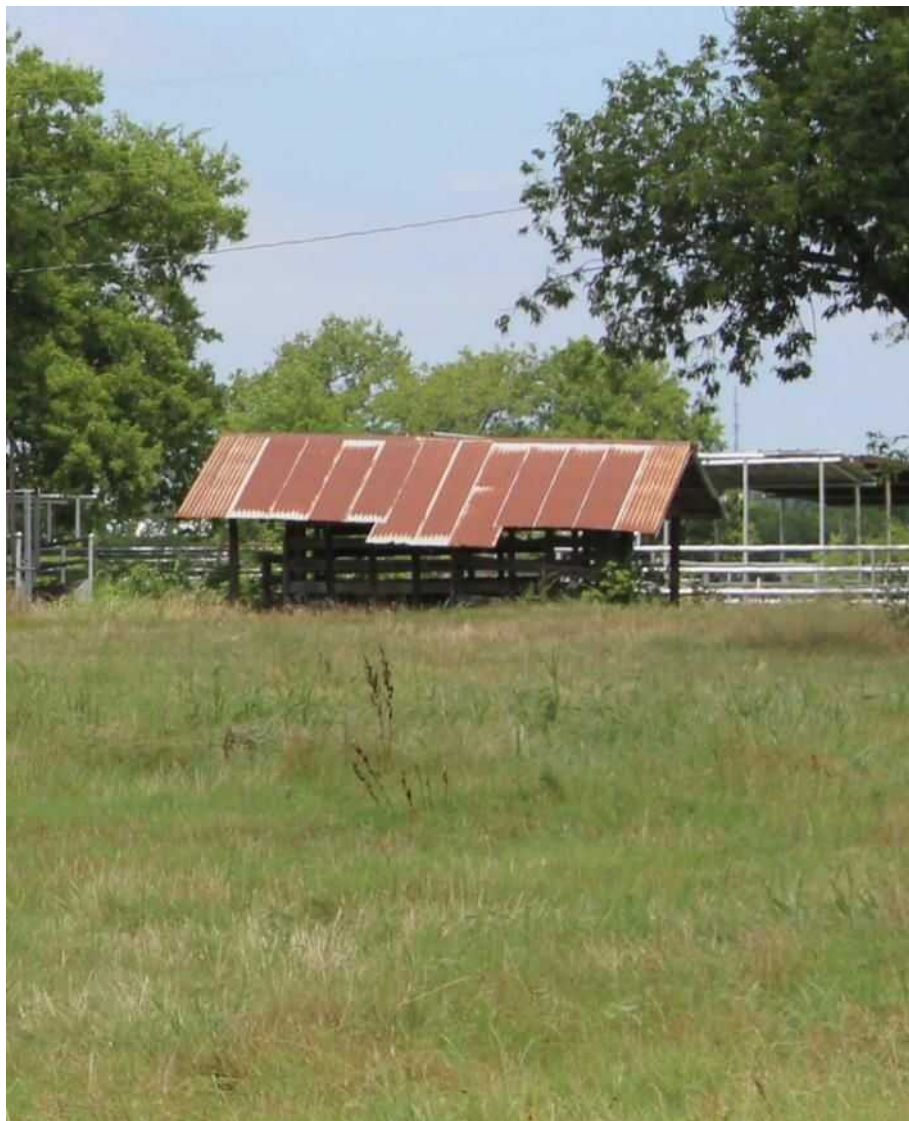
Camera facing northwest.

Survey Date:	June 24, 2019
Resource No:	09g
Project Location:	Denton County
Project Name and CSJ:	State Loop 288, CSJ 2250-02-014, etc.
Address, Lat/Long:	No address, N. Masch Branch Road 33.240353, -97.196063
Function/Sub-function:	AGRICULTURE/hay shed
Construction Date:	Ca. 1965
NRHP Eligibility:	Not eligible
Integrity/Comments:	Resource 09g is a hay shed. It features a metal gable roof and an exposed wooden frame. It is vacant/not in use.

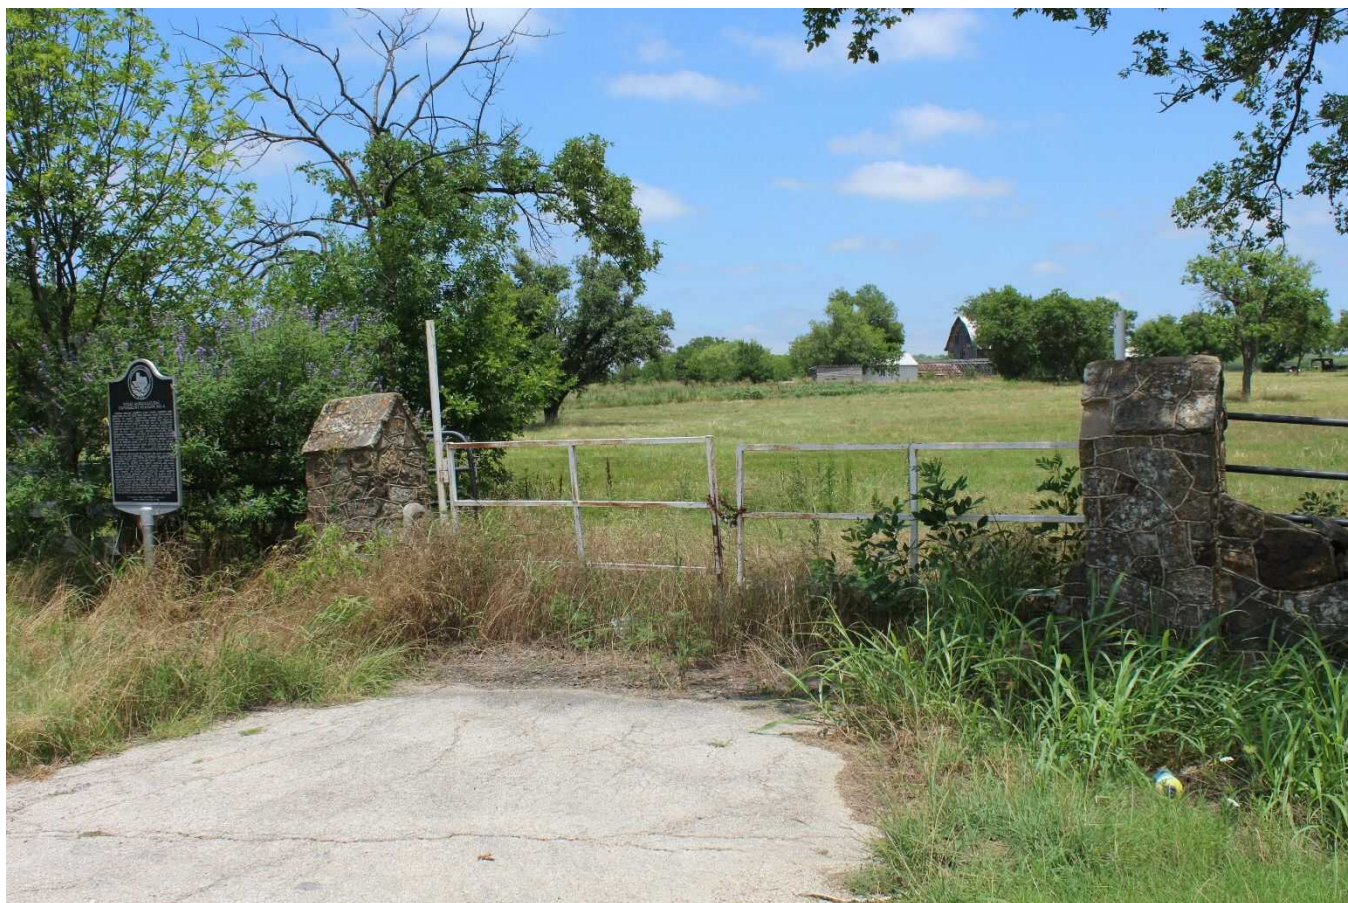
Camera facing northwest.

Survey Date:	June 24, 2019
Resource No:	09h
Project Location:	Denton County
Project Name and CSJ:	State Loop 288, CSJ 2250-02-014, etc.
Address, Lat/Long:	No Address, N. Masch Branch Road 33.239005, -97.196834
Function/Sub-function:	AGRICULTURE/gate
Construction Date:	Ca. 1935
NRHP Eligibility:	Not eligible
Integrity/Comments:	Resource 09h is the stone walled/gated entrance to Experiment Station No. 6. It includes two pillars on either side of the driveway and the historical marker for the property.

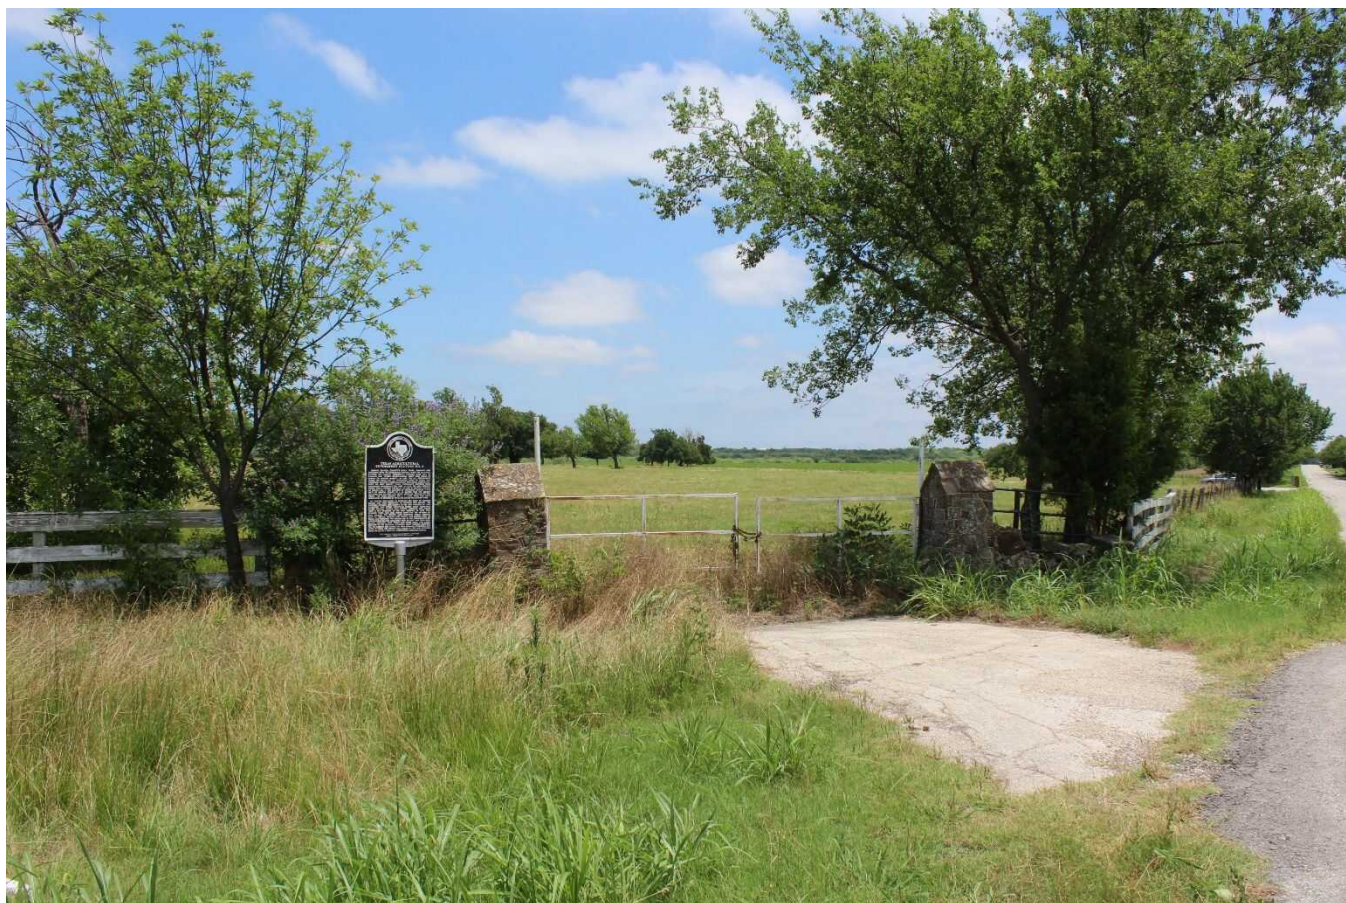
Camera facing northeast.

Survey Date:	June 24, 2019
Resource No:	09h
Project Location:	Denton County
Project Name and CSJ:	State Loop 288, CSJ 2250-02-014, etc.
Address, Lat/Long:	No address, N. Masch Branch Road 33.239005, -97.196834
Function/Sub-function:	AGRICULTURE/gate
Construction Date:	Ca. 1935
NRHP Eligibility:	Not eligible
Integrity/Comments:	Resource 09h is the stone walled/gated entrance to Experiment Station No. 6. It includes two pillars on either side of the driveway and the historical marker for the property.

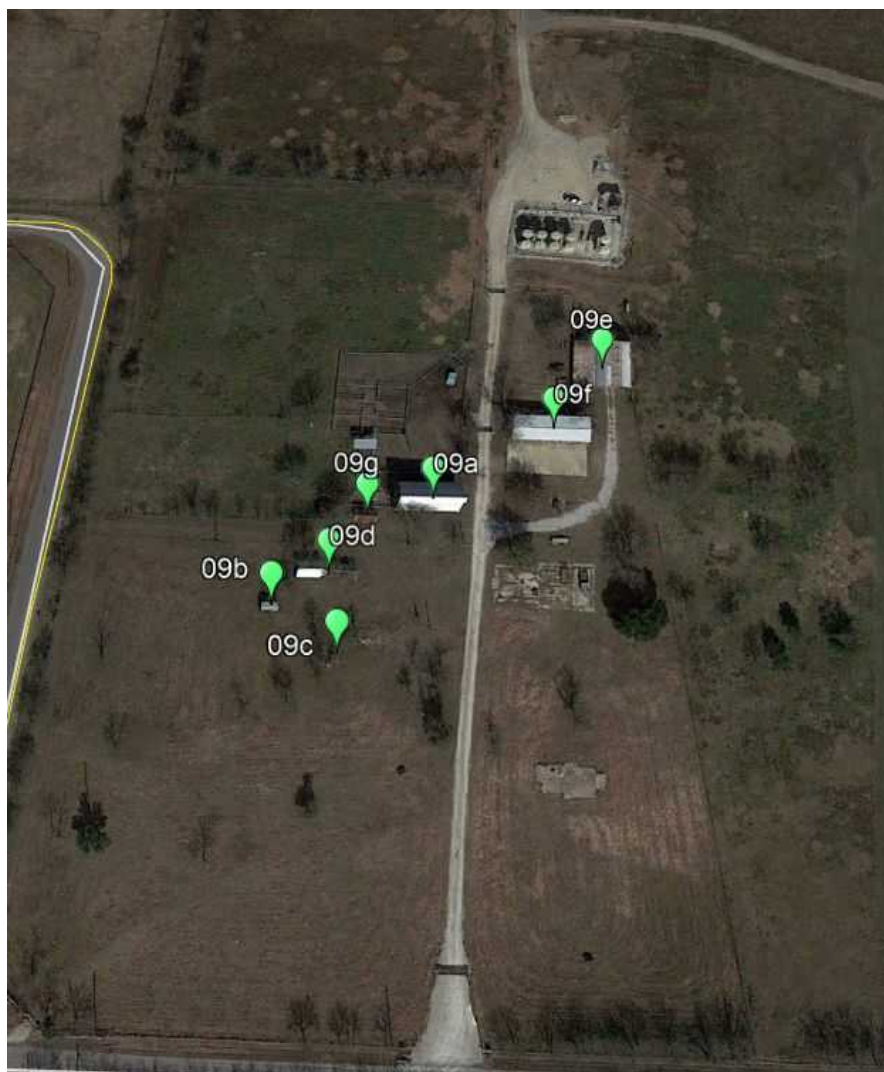
Aerial view, facing north.

Survey Date:	June 24, 2019
Resource No:	09
Project Location:	Denton County
Project Name and CSJ:	State Loop 288, CSJ 2250-02-014, etc.
Address, Lat/Long:	No address, N. Masch Branch Road 33.239005, -97.196834
Function/Sub-function:	AGRICULTURE
Construction Date:	Ca. 1935-1972
NRHP Eligibility:	Not eligible
Integrity/Comments:	Resource 09 is the former Texas Agricultural Experiment Station No. 6. The experiment station was opened in this location in 1913 under the Hatch Act of 1887, which promoted scientific experimentation in the agricultural industry. The experiment station specialized in researching the best methods for producing weather and disease resistant grains, and several new varieties of grain were developed. The station was closed in 1972.

While many superintendents, who played important roles in agricultural research at Station No. 6 and elsewhere are closely associated with Resource 09, the complex does not maintain sufficient integrity among its three components as previously mentioned. Due to the subdivision of the parcel acreage and the current state of several buildings and structures, integrity of feeling, setting, design, materials, and workmanship. Therefore, Resource 09 is not recommended eligible under Criterion B. Resource 09 does not contain any noteworthy examples of architecture and lacks integrity of design, workmanship, and materials, as required for eligibility under Criterion C according to the TxDOT “Agricultural Theme Study for Central Texas.” The integrity of design of the complex is compromised due to the demolition of several buildings and experimental plots, which has comprised spatial organization and the agricultural landscape. The remaining buildings and structures are in poor condition, negatively impacting integrity of materials and workmanship. As such, Resource 09 is recommended not eligible under Criterion C.

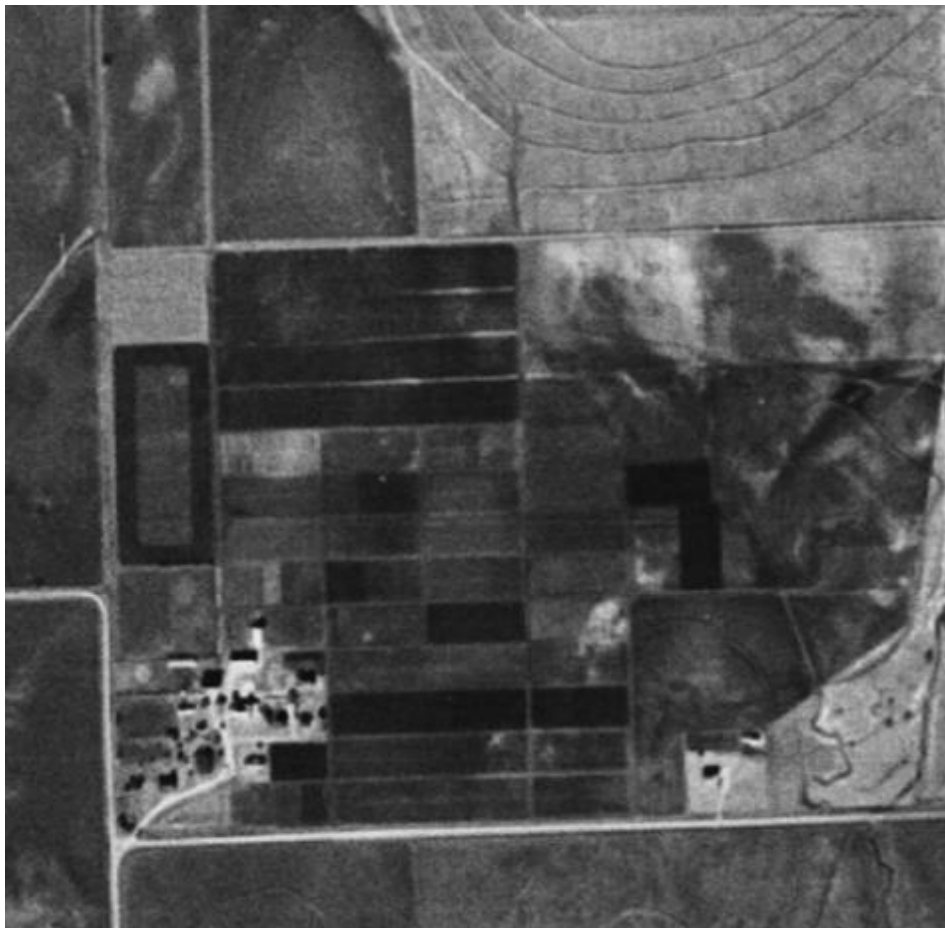
1952 aerial view, facing north.

Survey Date:	June 24, 2019
Resource No:	09
Project Location:	Denton County
Project Name and CSJ:	State Loop 288, CSJ 2250-02-014, etc.
Address, Lat/Long:	No address, N. Masch Branch Road 33.239005, -97.196834
Function/Sub-function:	AGRICULTURE
Construction Date:	Ca. 1935-1972
NRHP Eligibility:	Not eligible
Integrity/Comments:	Resource 09 is the former Texas Agricultural Experiment Station No. 6. The experiment station was opened in this location in 1913 under the Hatch Act of 1887, which promoted scientific experimentation in the agricultural industry. The experiment station specialized in researching the best methods for producing weather and disease resistant grains, and several new varieties of grain were developed. The station was closed in 1972. A 1952 aerial image of the experiment station shows a number of agricultural outbuildings which no longer exist and the experimental farming plots.

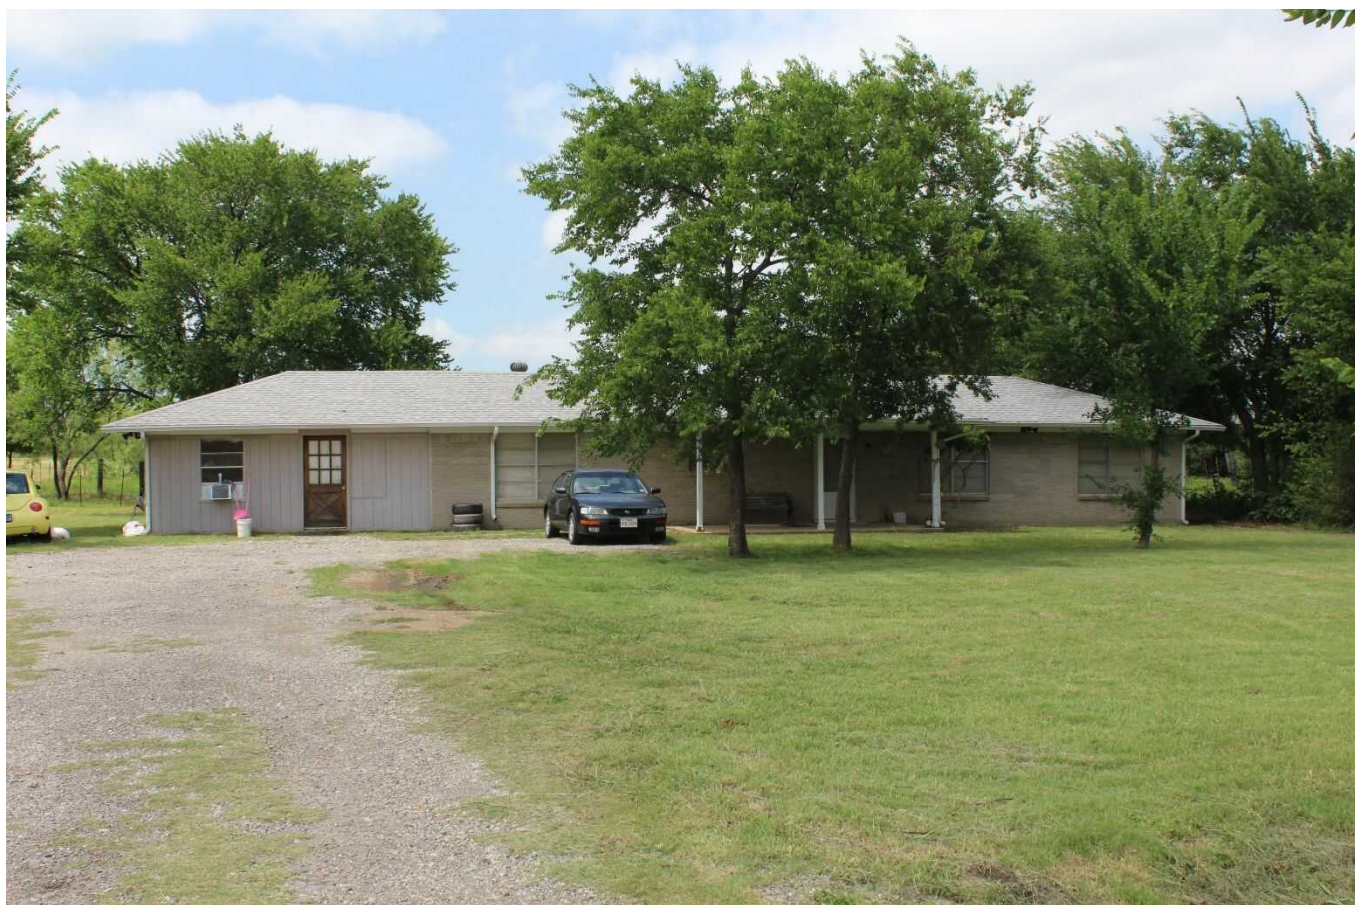
Camera facing northeast.

Survey Date:	June 24, 2019
Resource No:	10a
Project Location:	Denton County
Project Name and CSJ:	State Loop 288, CSJ 2250-02-014, etc.
Address, Lat/Long:	3288 N. Masch Branch Road 33.241811, -97.202169
Function/Sub-function:	DOMESTIC/single-family dwelling
Construction Date:	Ca. 1970
NRHP Eligibility:	Not eligible
Integrity/Comments:	Resource 10a is a Ranch-style house ca. 1970. It features a cross-shape footprint, an asphalt shingle cross gable roof, and a concrete slab foundation. The original footprint is brick, while the renovated carport to the west has vertical wood siding. The brick is capped by a single row of large, square stones, which are located beneath the cornice. The windows are 2/2, possibly single or double-hung, and the front (south) façade features a partial-width porch and entry, while the enclosed carport has a half-panel and glass door on the south façade. The house is currently in use.

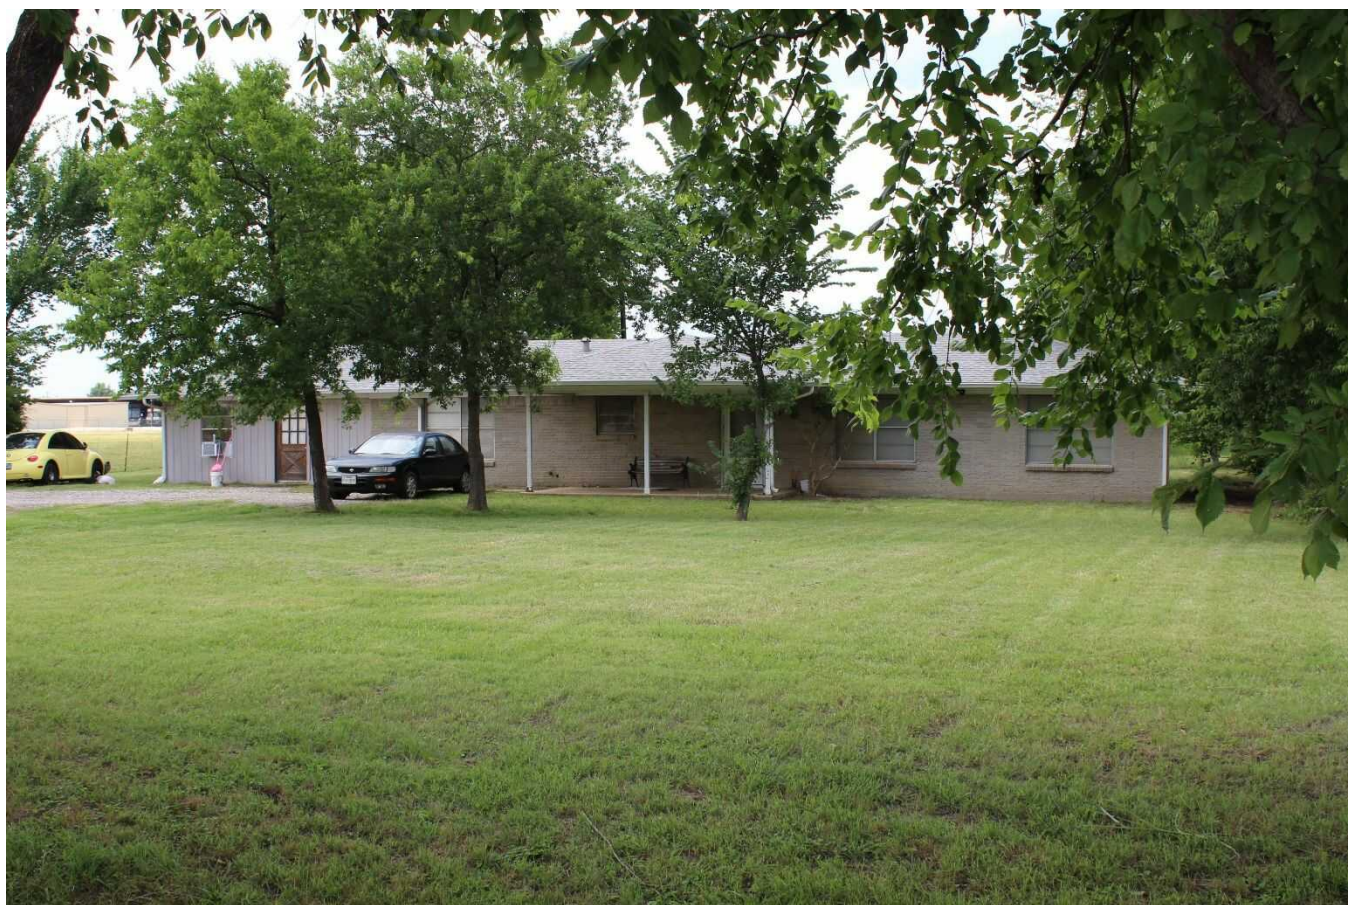
Camera facing northwest.

Survey Date:	June 24, 2019
Resource No:	10a
Project Location:	Denton County
Project Name and CSJ:	State Loop 288, CSJ 2250-02-014, etc.
Address, Lat/Long:	3288 N. Masch Branch Road 33.241811, -97.202169
Function/Sub-function:	DOMESTIC/single dwelling
Construction Date:	Ca. 1970
NRHP Eligibility:	Not eligible
Integrity/Comments:	Resource 10a is a Ranch-style house ca. 1970. It features a cross-shape footprint, an asphalt shingle cross gable roof, and a concrete slab foundation. The original footprint is brick, while the renovated carport to the west has vertical wood siding. The brick is capped by a single row of large, square stones, which are located beneath the cornice. The windows are 2/2, possibly single or double-hung, and the front (south) façade features a partial-width porch and entry, while the enclosed carport has a half-panel and glass door on the south façade. The house is currently in use.

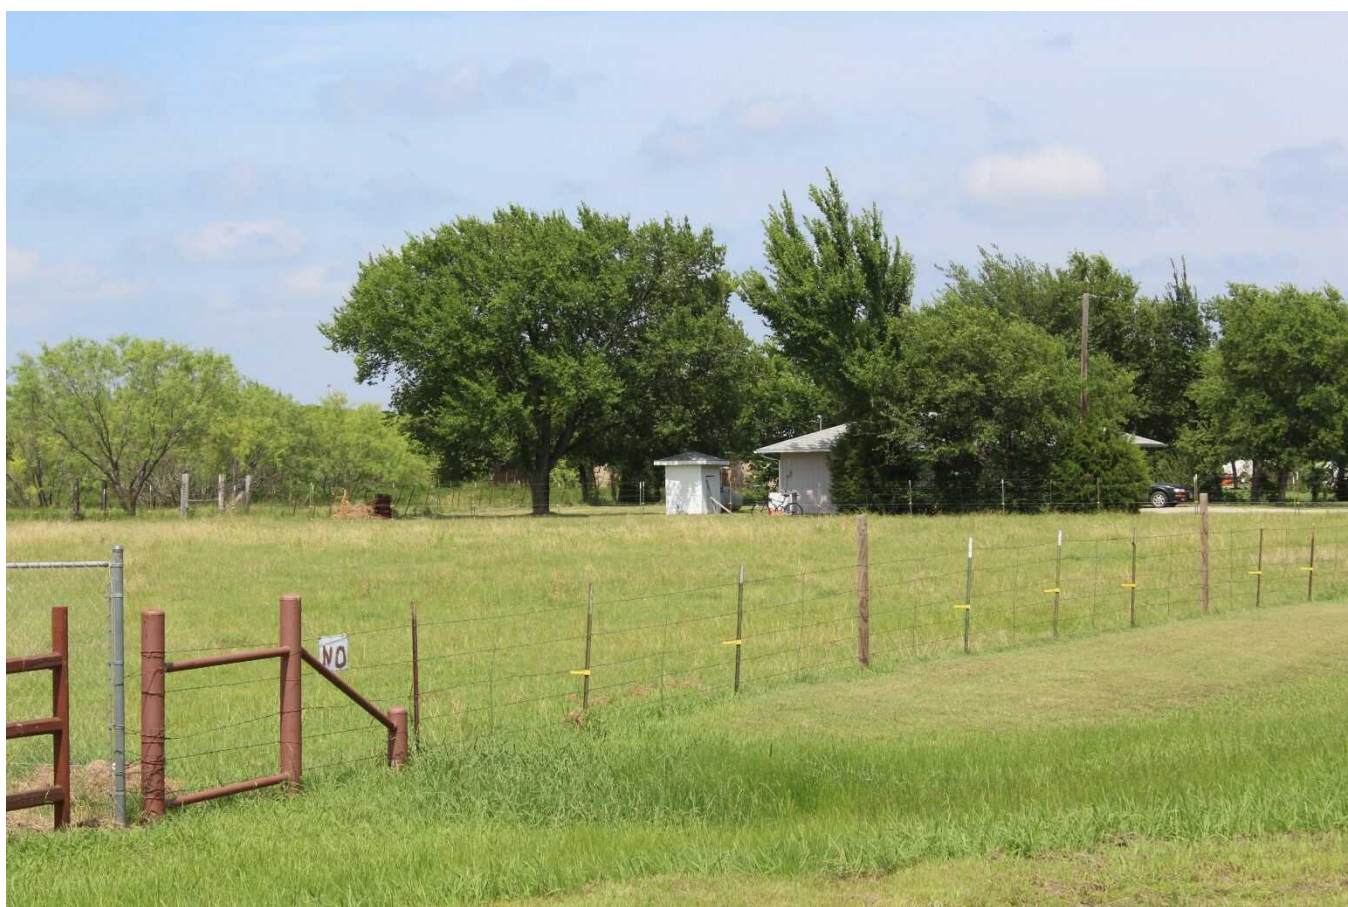
Camera facing northeast.

Survey Date:	June 24, 2019
Resource No:	10b
Project Location:	Denton County
Project Name and CSJ:	State Loop 288, CSJ 2250-02-014, etc.
Address, Lat/Long:	3288 N. Masch Branch Road 33.239005, -97.196834
Function/Sub-function:	DOMESTIC/wellhouse
Construction Date:	Ca. 1970
NRHP Eligibility:	Not eligible
Integrity/Comments:	Resource 10b is a well-house which features a square footprint, a low hip roof with asphalt shingles and vertical wood siding. The entry is on the south façade. It appears the wellhouse is currently being used for storage.

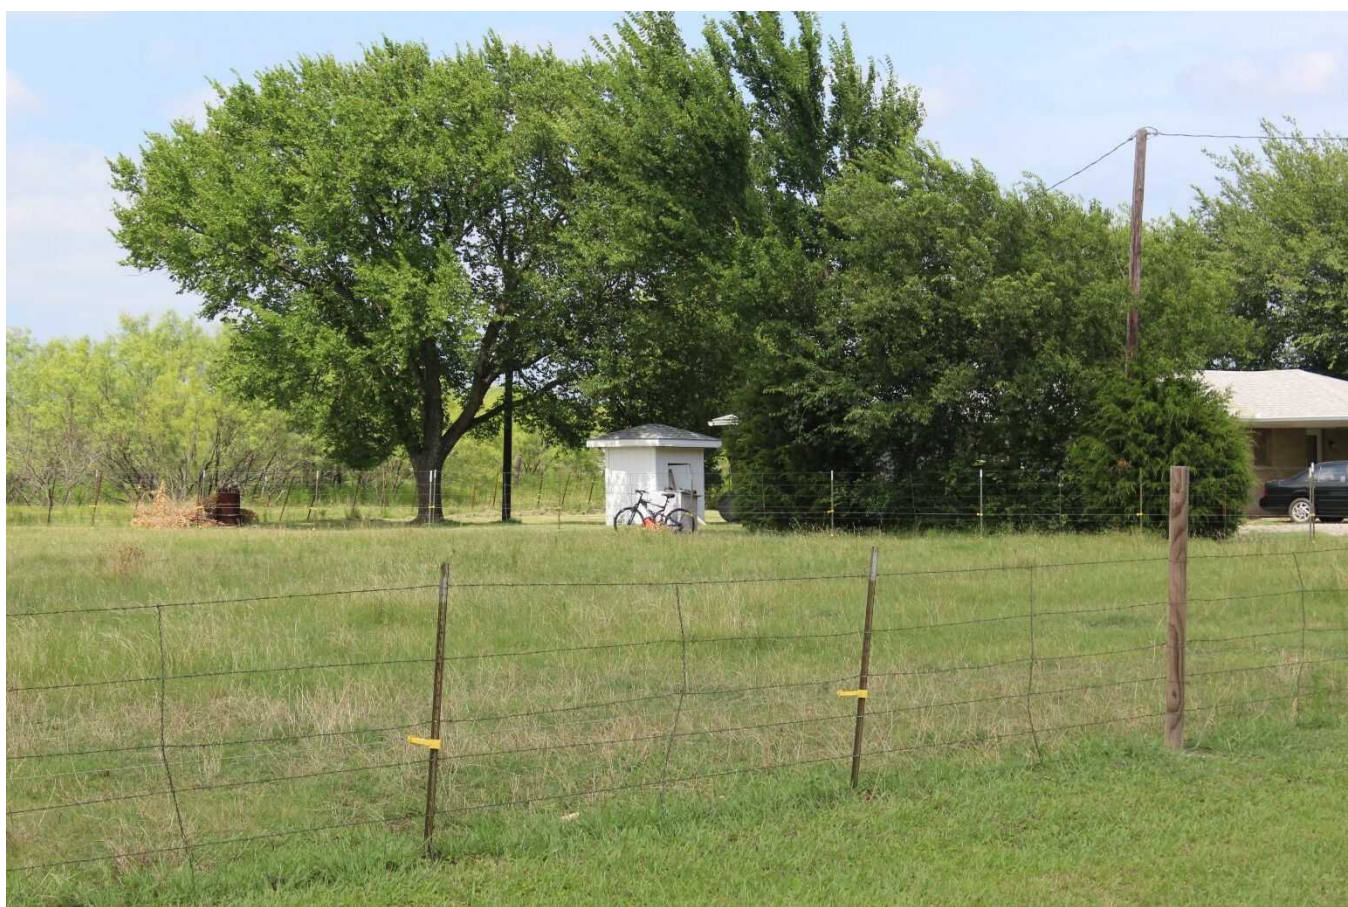
Camera facing northeast.

Survey Date:	June 24, 2019
Resource No:	10b
Project Location:	Denton County
Project Name and CSJ:	State Loop 288, CSJ 2250-02-014, etc.
Address, Lat/Long:	3288 N. Masch Branch Road 33.239005, -97.196834
Function/Sub-function:	DOMESTIC/wellhouse
Construction Date:	Ca. 1970
NRHP Eligibility:	Not eligible
Integrity/Comments:	Resource 10b is a well-house which features a square footprint, a low hip roof with asphalt shingles and vertical wood siding. The entry is on the south façade. It appears the wellhouse is currently being used for storage.

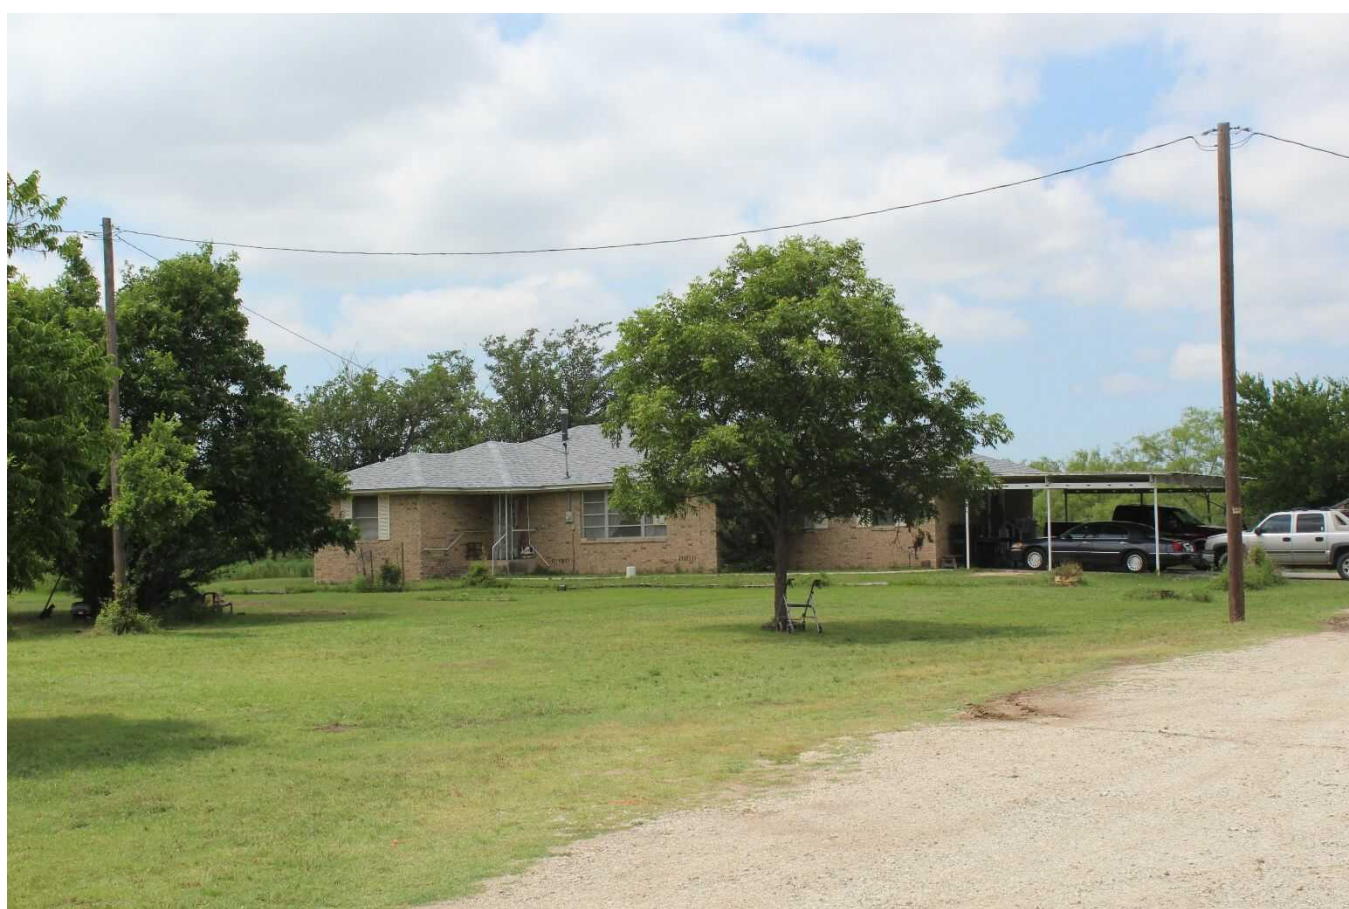
Camera facing northwest.

Survey Date:	June 24, 2019
Resource No:	11a
Project Location:	Denton County
Project Name and CSJ:	State Loop 288, CSJ 2250-02-014, etc.
Address, Lat/Long:	3278 N. Masch Branch Road 33.242055, -97.201639
Function/Sub-function:	DOMESTIC/single-family dwelling
Construction Date:	Ca. 1970
NRHP Eligibility:	Not eligible
Integrity/Comments:	Resource 11a is a brick, Ranch-style house ca. 1970. It features a rambling footprint with three setbacks and a concrete slab foundation and a low hip roof with asphalt shingles. Windows include 1/1 with louvred shutters and a large picture window. A covered stoop supported by a decorative iron column is located on the front (south) façade, while an additional entry is located on the east façade, leading to the carport. A chimney is placed offset left (west) on the front slope. The house is still in use.

Resource No.	Address/ Location	Function/ Sub-function	Architectural Style	Date(s)	Integrity/Comments	NRHP Eligibility
11a	3278 N. Masch Branch Road 33.242055, -97.201639	DOMESTIC/single-family dwelling	Ranch	Ca. 1970	Resource 11a is a brick, Ranch-style house ca. 1970. It features a rambling footprint with three setbacks and a concrete slab foundation and a low hip roof with asphalt shingles. Windows include 1/1 with louvred shutters and a large picture window. A covered stoop supported by a decorative iron column is located on the front (south) façade, while an additional entry is located on the east façade, leading to the carport. A chimney is placed offset left (west) on the front slope. The house is still in use.	Not Eligible
11b	3278 N. Masch Branch Road 32.712123°, -96.316124°	DOMESTIC/machine shed	No Style	Ca. 1970	Resource 11b is a machine shed. It features a rectangular footprint and is two bays wide. The machine shed has a flat, metal roof and metal siding. Two rolling doors are located on the front (south) façade. An open addition with a shed roof is attached to the east façade. The machine shed is currently being used as storage for large machinery.	Not Eligible

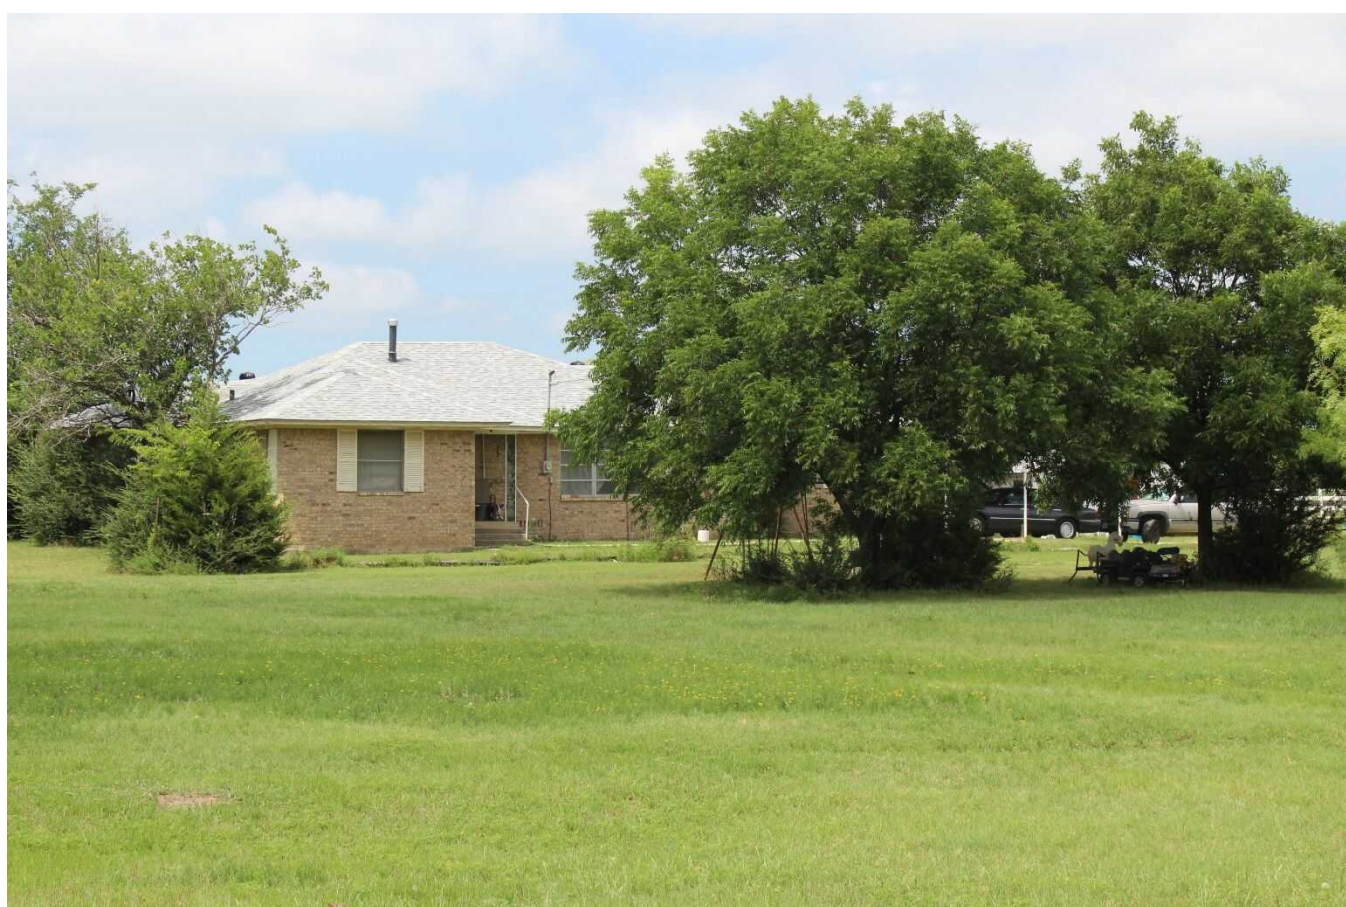
Camera facing northeast.

Survey Date:	June 24, 2019
Resource No:	11a
Project Location:	Denton County
Project Name and CSJ:	State Loop 288, CSJ 2250-02-014, etc.
Address, Lat/Long:	3278 N. Masch Branch Road 33.242055, -97.201639
Function/Sub-function:	DOMESTIC/single dwelling
Construction Date:	Ca. 1970
NRHP Eligibility:	Not eligible
Integrity/Comments:	Resource 11a is a brick, Ranch-style house ca. 1970. It features a rambling footprint with three setbacks and a concrete slab foundation and a low hip roof with asphalt shingles. Windows include 1/1 with louvred shutters and a large picture window. A covered stoop supported by a decorative iron column is located on the front (south) façade, while an additional entry is located on the east façade, leading to the carport. A chimney is placed offset left (west) on the front slope. The house is still in use.
