# Historical Resources Survey Report

## Reconnaissance Survey

**Project Name:** State Loop 288

**Project Limits:** IH 35W to IH 35

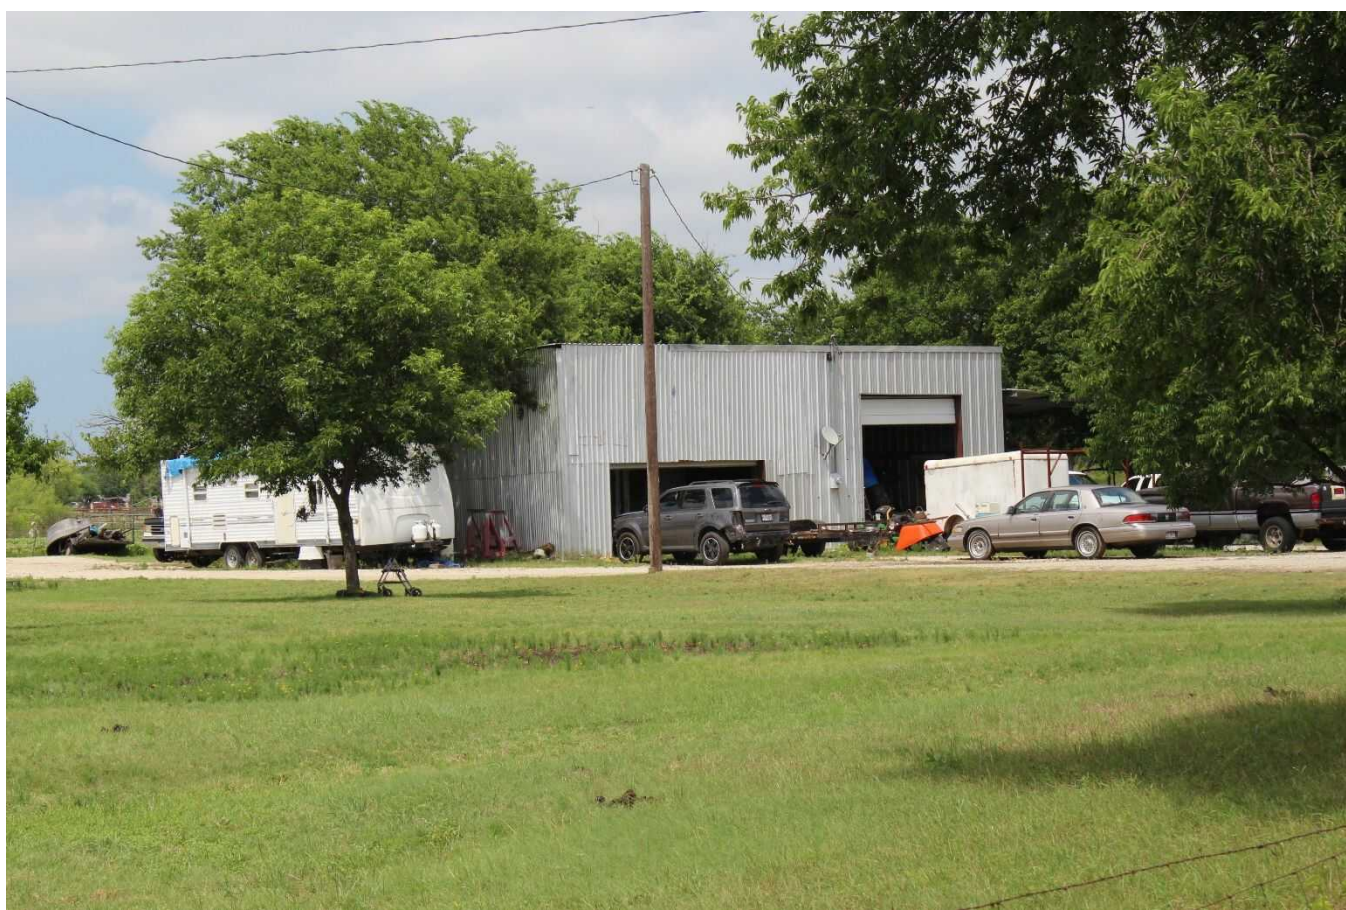
Camera facing northeast.

Survey Date:	June 24, 2019
Resource No:	11b
Project Location:	Denton County
Project Name and CSJ:	State Loop 288, CSJ 2250-02-014, etc.
Address, Lat/Long:	3278 N. Masch Branch Road 33.241946, -97.201201
Function/Sub-function:	DOMESTIC/machine shed
Construction Date:	Ca. 1970
NRHP Eligibility:	Not eligible
Integrity/Comments:	Resource 11b is a machine shed. It features a rectangular footprint and is two bays wide. The machine shed has a flat, metal roof and metal siding. Two rolling doors are located on the front (south) façade. An open addition with a shed roof is attached to the east façade. The machine shed is currently being used as storage for large machinery.

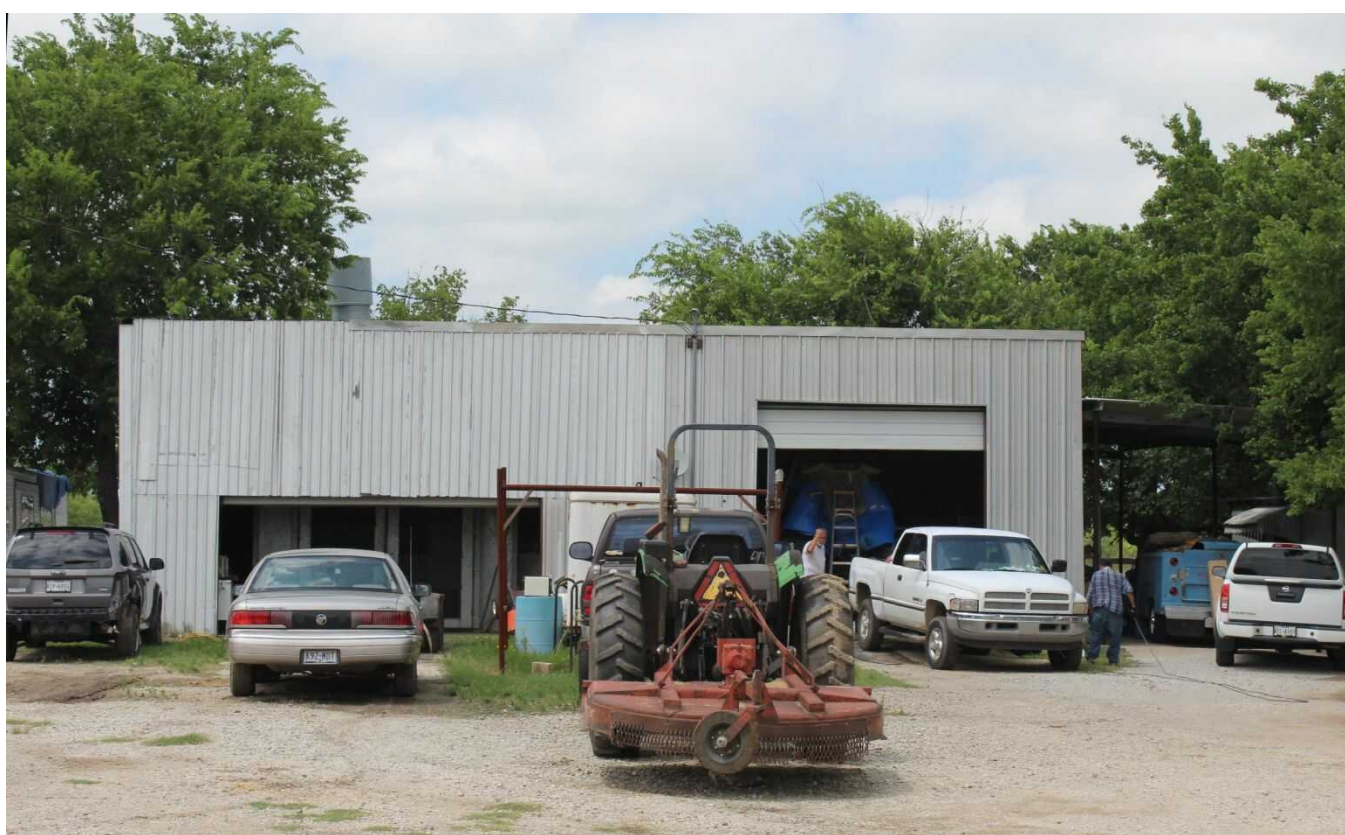
Camera facing north.

Survey Date:	June 24, 2019
Resource No:	11b
Project Location:	Denton County
Project Name and CSJ:	State Loop 288, CSJ 2250-02-014, etc.
Address, Lat/Long:	3278 N. Masch Branch Road 33.241946, -97.201201
Function/Sub-function:	AGRICULTURE/machine shed
Construction Date:	Ca. 1970
NRHP Eligibility:	Not eligible
Integrity/Comments:	Resource 11b is a machine shed. It features a rectangular footprint and is two bays wide. The machine shed has a flat, metal roof and metal siding. Two rolling doors are located on the front (south) façade. An open addition with a shed roof is attached to the east façade. The machine shed is currently being used as storage for large machinery.

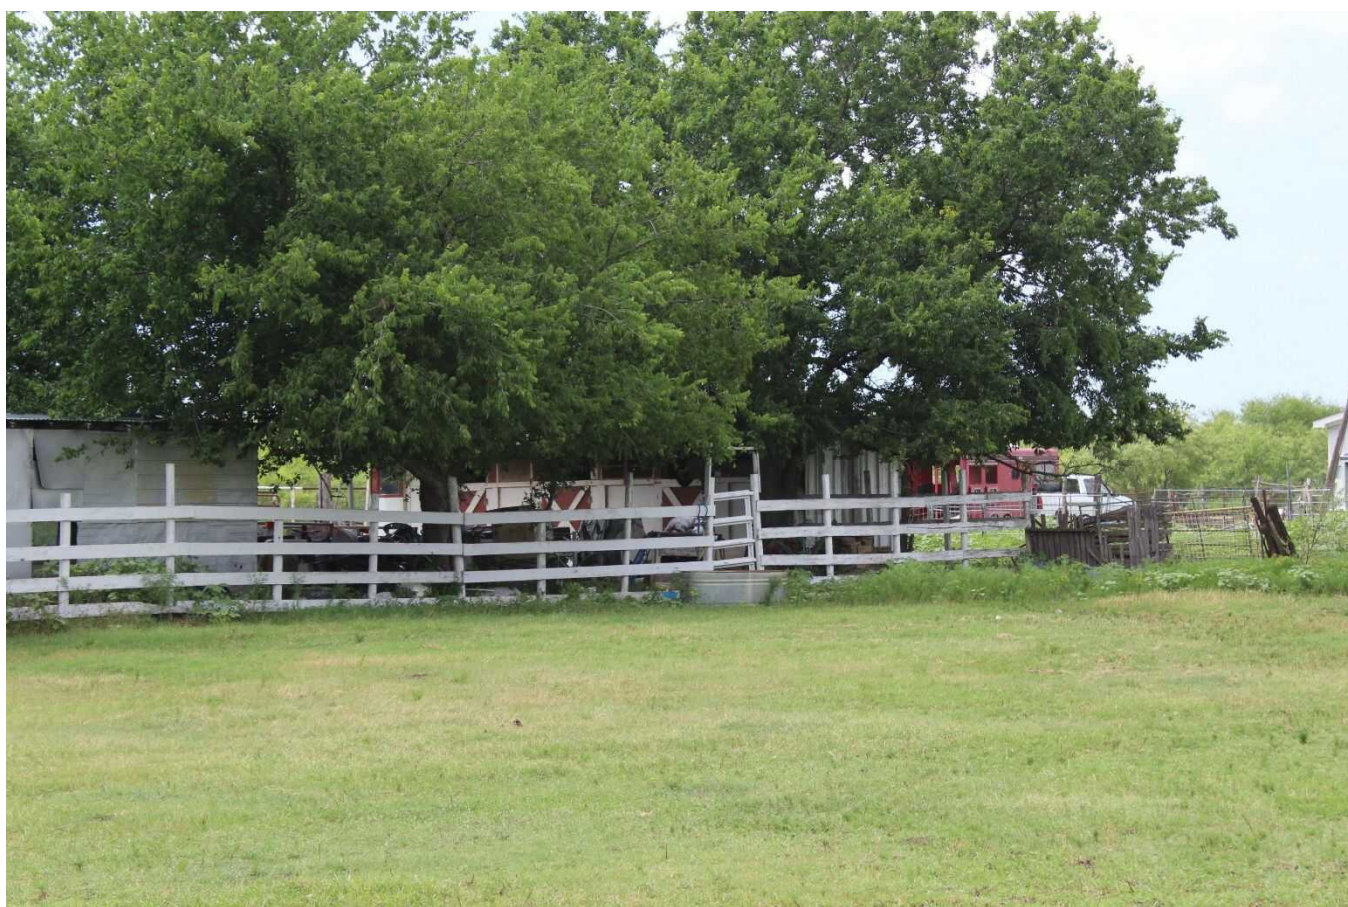
Camera facing northwest.

Survey Date:	June 24, 2019
Resource No:	11c
Project Location:	Denton County
Project Name and CSJ:	State Loop 288, CSJ 2250-02-014, etc.
Address, Lat/Long:	3278 N. Masch Branch Road 33.242147, -97.201080
Function/Sub-function:	DOMESTIC/stable
Construction Date:	Ca. 1970
NRHP Eligibility:	Not eligible
Integrity/Comments:	Resource 11c is the stable. It features a flat, metal roof, metal siding, and Dutch doors across the eight bays on the front (south) façade. It is unclear whether the stable is still in use due to vegetation cover.

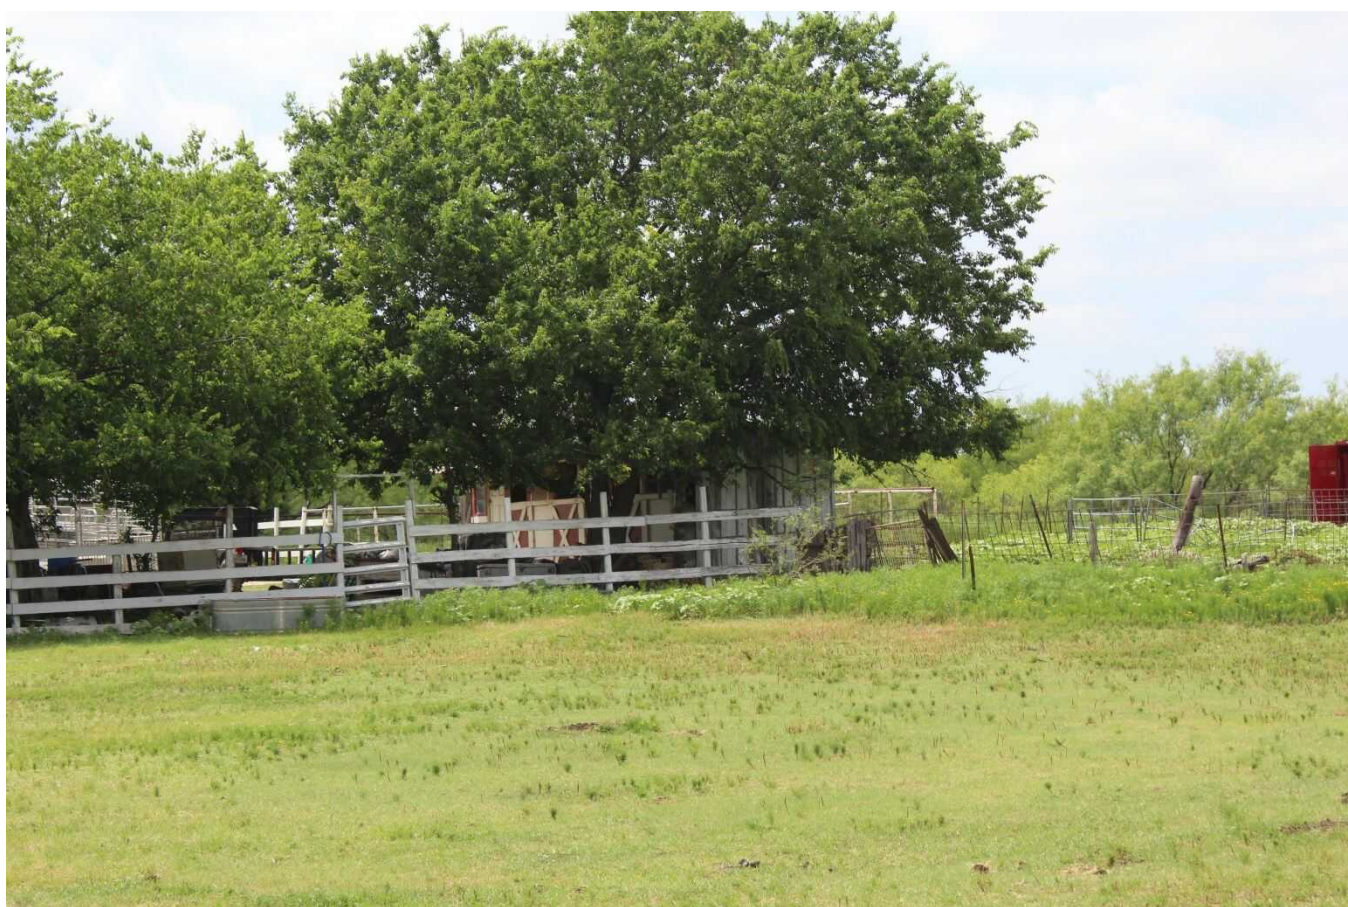
Camera facing northwest.

Survey Date:	June 24, 2019
Resource No:	11c
Project Location:	Denton County
Project Name and CSJ:	State Loop 288, CSJ 2250-02-014, etc.
Address, Lat/Long:	3278 N. Masch Branch Road 33.242147, -97.201080
Function/Sub-function:	DOMESTIC/stable
Construction Date:	Ca. 1970
NRHP Eligibility:	Not eligible
Integrity/Comments:	Resource 11c is the stable. It features a flat, metal roof, metal siding, and Dutch doors across the eight bays on the front (south) façade. It is unclear whether the stable is still in use due to vegetation cover.

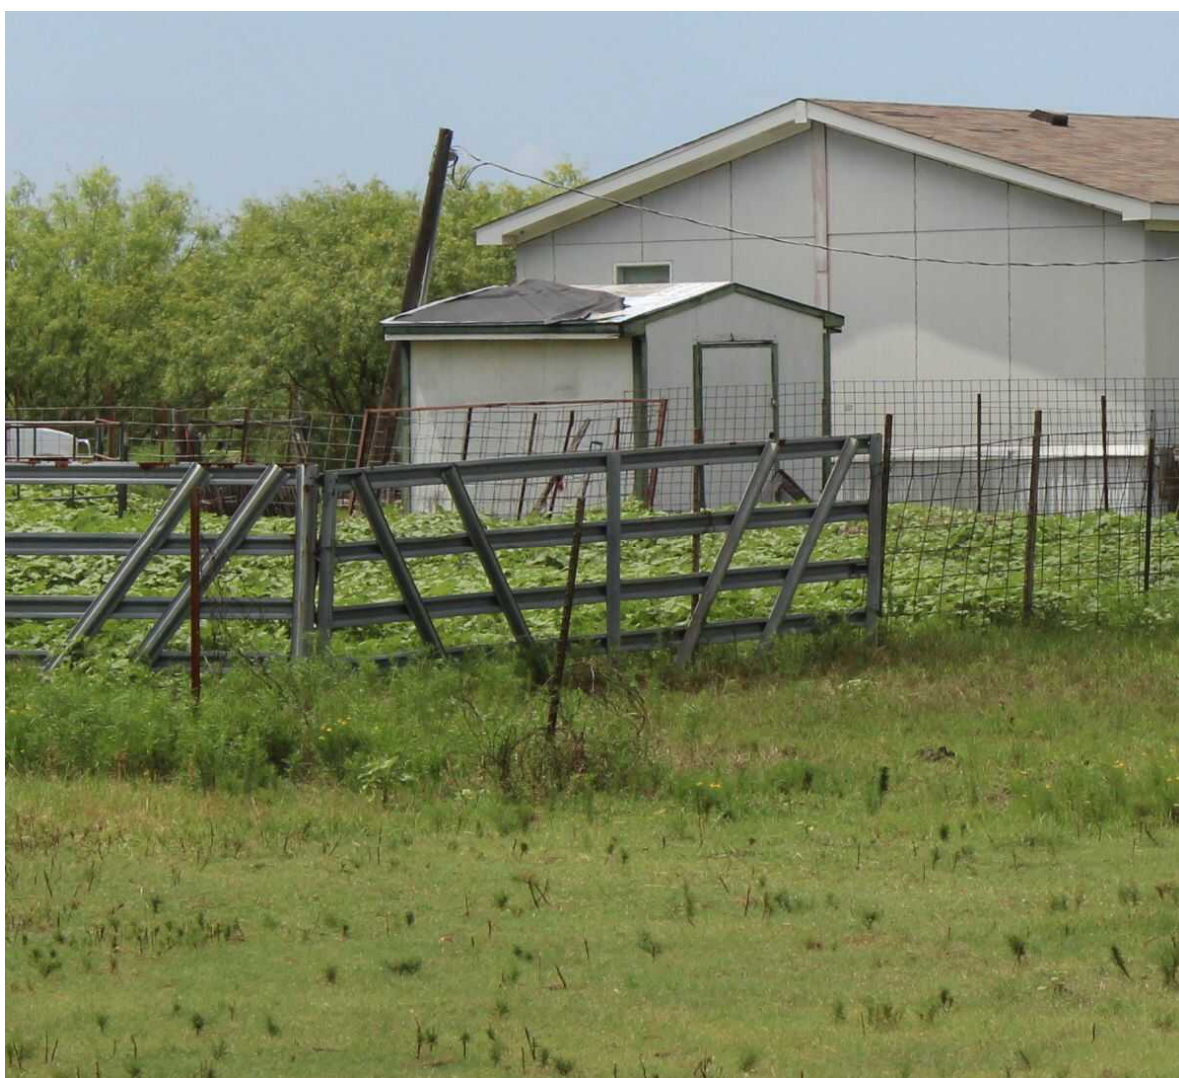
Camera facing northwest.

Survey Date:	June 24, 2019
Resource No:	11
Project Location:	Denton County
Project Name and CSJ:	State Loop 288, CSJ 2250-02-014, etc.
Address, Lat/Long:	3278 N. Masch Branch Road 33.242453, -97.201060
Function/Sub-function:	AGRICULTURE/shed
Construction Date:	Ca. 2005
NRHP Eligibility:	Not eligible
Integrity/Comments:	Resource 11 includes three historic-age resources and several non-historic age resources. Most resources on the parcel are still in agricultural or domestic use. Aerial imagery provides evidence non-historic age resources were constructed ca. 2005.

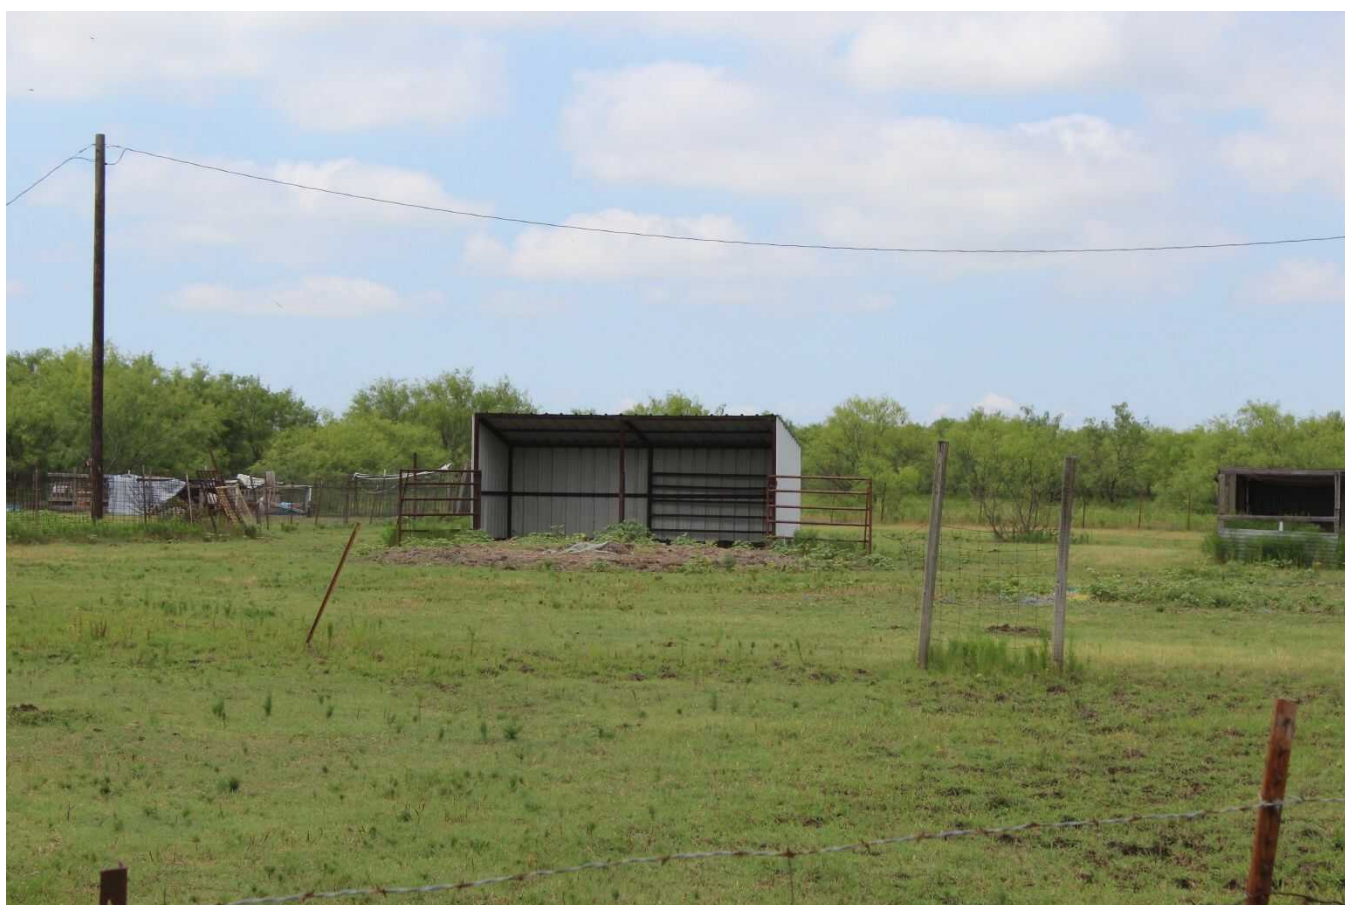
Camera facing northwest.

Survey Date:	June 24, 2019
Resource No:	11
Project Location:	Denton County
Project Name and CSJ:	State Loop 288, CSJ 2250-02-014, etc.
Address, Lat/Long:	3278 N. Masch Branch Road 33.242430, -97.200682
Function/Sub-function:	AGRICULTURE/pole barn
Construction Date:	Ca. 2005
NRHP Eligibility:	Not eligible
Integrity/Comments:	Resource 11 includes three historic-age resources and several non-historic age resources. Most resources on the parcel are still in agricultural or domestic use. Aerial imagery provides evidence non-historic age resources were constructed ca. 2005.

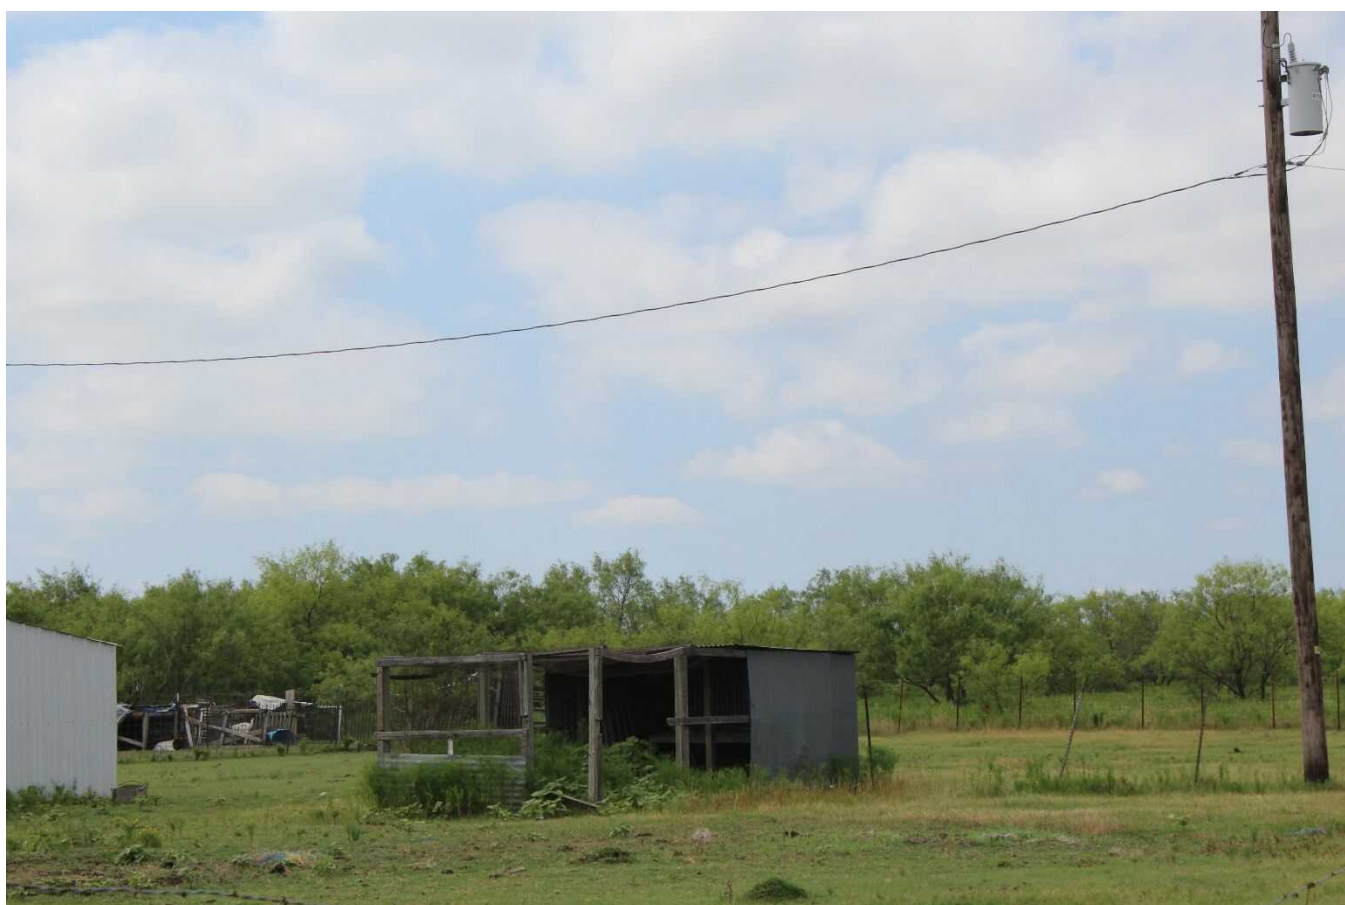
Camera facing northwest.

Survey Date:	June 24, 2019
Resource No:	11
Project Location:	Denton County
Project Name and CSJ:	State Loop 288, CSJ 2250-02-014, etc.
Address, Lat/Long:	3278 N. Masch Branch Road 33.242438, -97.200544
Function/Sub-function:	AGRICULTURE/loafing shed
Construction Date:	Ca. 2005
NRHP Eligibility:	Not eligible
Integrity/Comments:	Resource 11 includes three historic-age resources and several non-historic age resources. Most resources on the parcel are still in agricultural or domestic use. Aerial imagery provides evidence non-historic age resources were constructed ca. 2005.

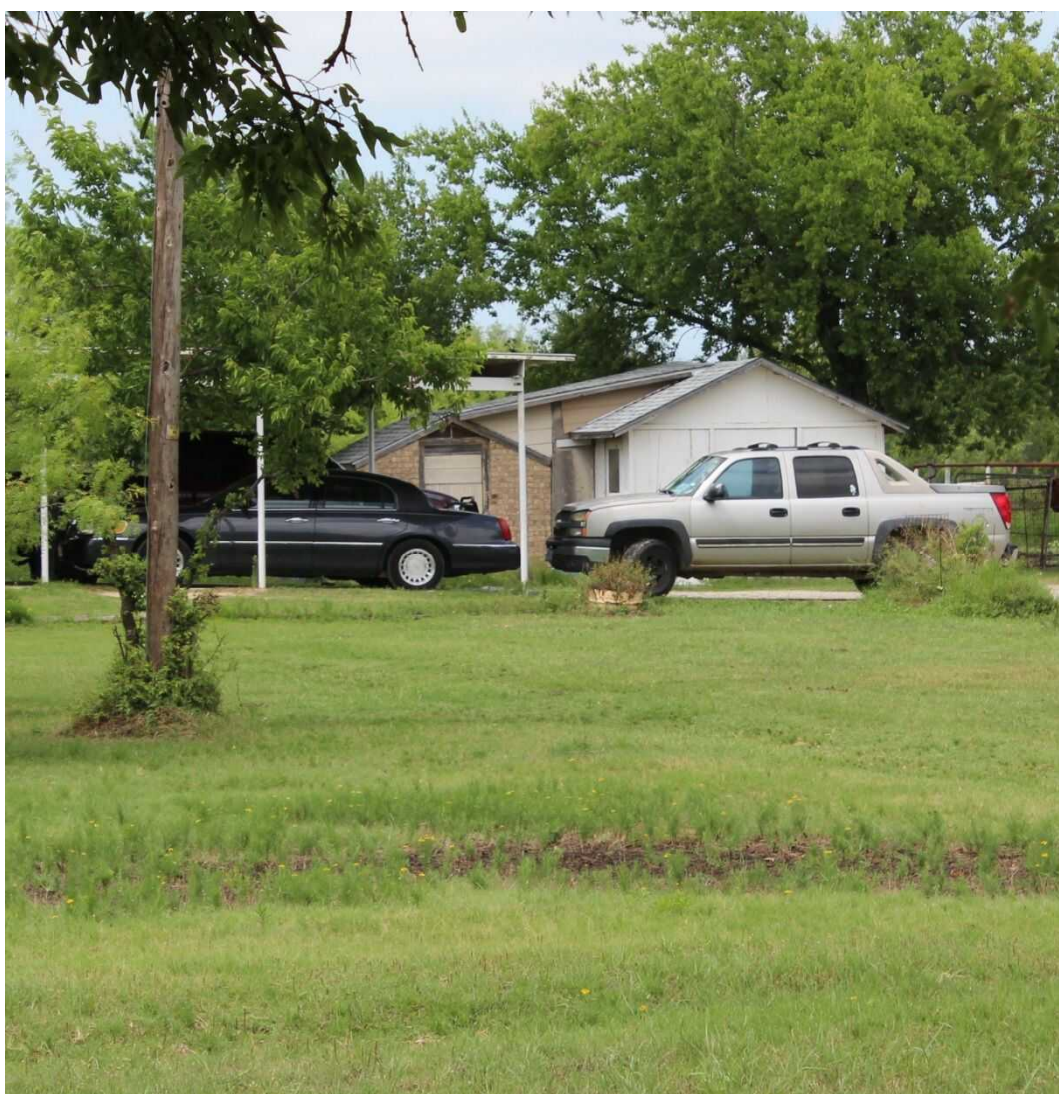
Camera facing north.

Survey Date:	June 24, 2019
Resource No:	11
Project Location:	Denton County
Project Name and CSJ:	State Loop 288, CSJ 2250-02-014, etc.
Address, Lat/Long:	3278 N. Masch Branch Road 33.242130, -97.201421
Function/Sub-function:	AGRICULTURE/shed
Construction Date:	Ca. 2005
NRHP Eligibility:	Not eligible
Integrity/Comments:	Resource 11 includes three historic-age resources and several non-historic age resources. Most resources on the parcel are still in agricultural or domestic use. Aerial imagery provides evidence non-historic age resources were constructed ca. 2005.

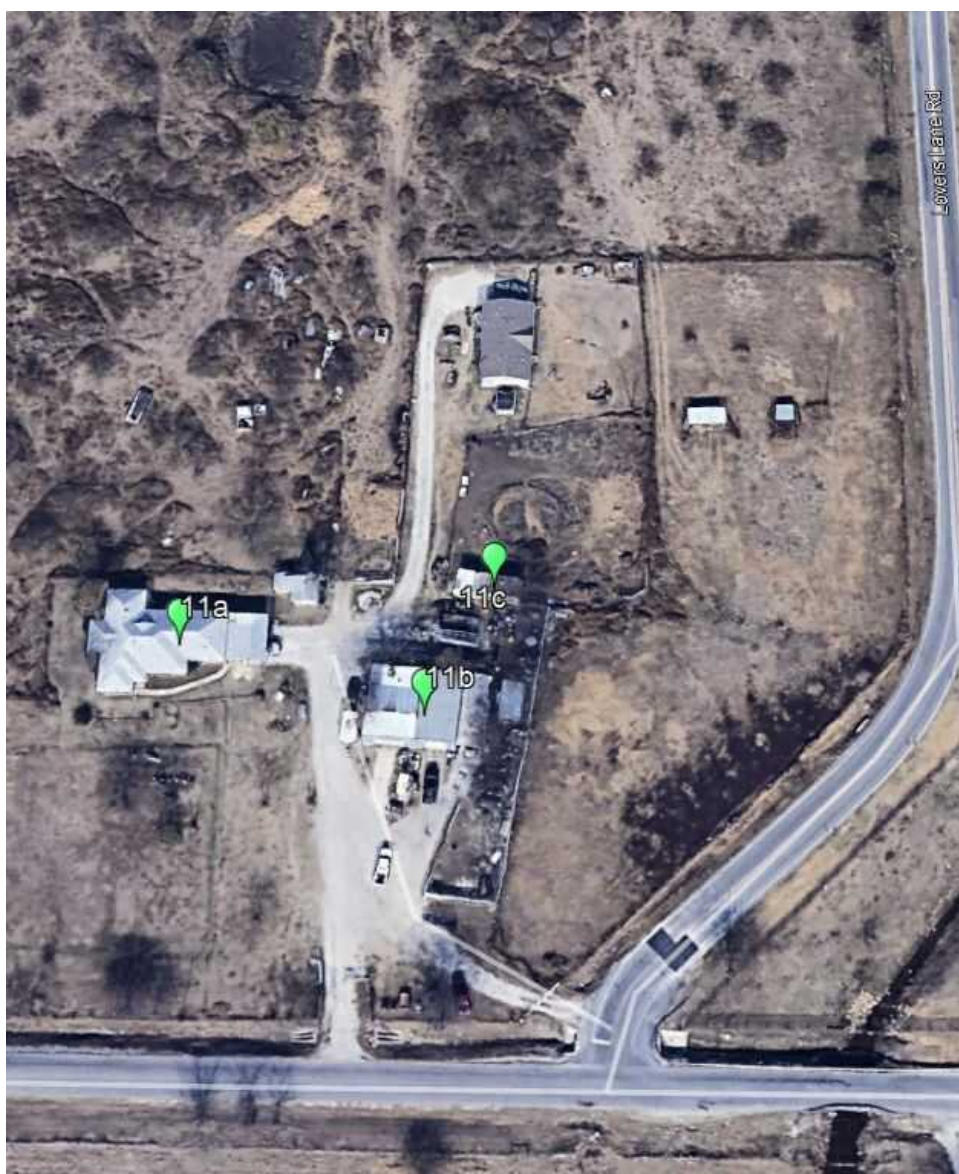
Aerial view, facing north.

Survey Date:	June 24, 2019
Resource No:	11
Project Location:	Denton County
Project Name and CSJ:	State Loop 288, CSJ 2250-02-014, etc.
Address, Lat/Long:	3278 N. Masch Branch Road 33.242055, -97.201639
Function/Sub-function:	AGRICULTURE/shed
Construction Date:	Ca. 2005
NRHP Eligibility:	Not eligible
Integrity/Comments:	Resource 11 includes three historic-age resources and several non-historic age resources. Most resources on the parcel are still in agricultural or domestic use. Aerial imagery provides evidence non-historic age resources were constructed ca. 2005.

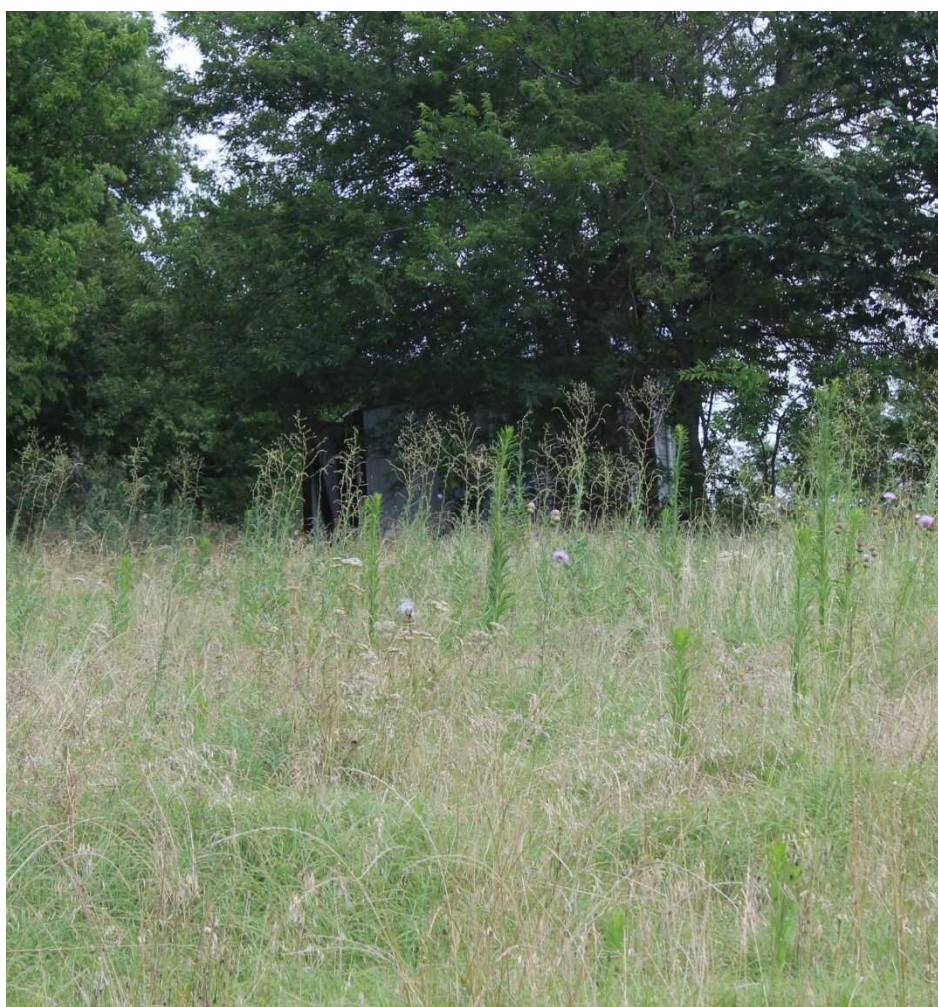
Camera facing east.

Survey Date:	June 24, 2019
Resource No:	12a
Project Location:	Denton County
Project Name and CSJ:	State Loop 288, CSJ 2250-02-014, etc.
Address, Lat/Long:	4081 Harrison Court 33.255155, -97.199262
Function/Sub-function:	AGRICULTURE/shed
Construction Date:	Ca. 1970
NRHP Eligibility:	Not eligible
Integrity/Comments:	Resource 12a is a shed. It features a metal gable roof, metal siding, and a paneled door and single pane window on the south façade. It appears to be vacant/not in use due to the overgrown vegetation and boarded window.

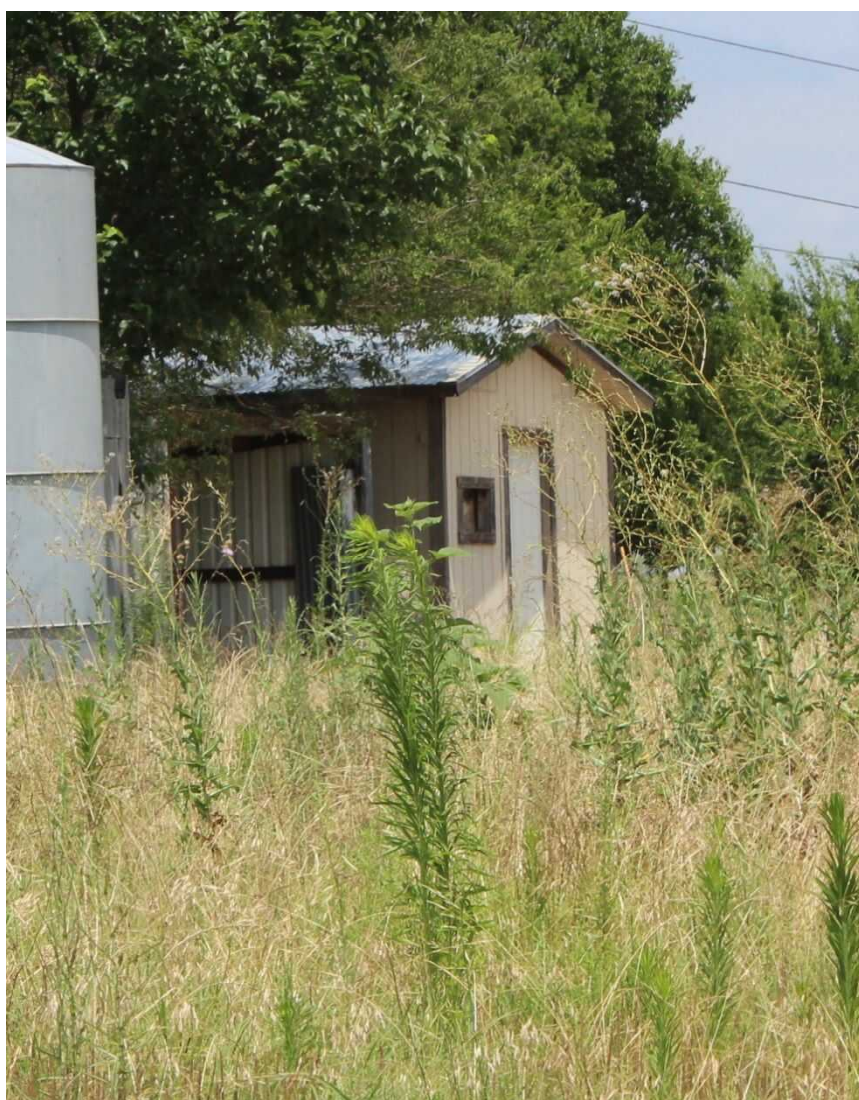
Camera facing northeast.

Survey Date:	June 24, 2019
Resource No:	12a
Project Location:	Denton County
Project Name and CSJ:	State Loop 288, CSJ 2250-02-014, etc.
Address, Lat/Long:	4081 Harrison Court 33.255155, -97.199262
Function/Sub-function:	AGRICULTURE/shed
Construction Date:	Ca. 1970
NRHP Eligibility:	Not eligible
Integrity/Comments:	Resource 12a is a shed. It features a metal gable roof, metal siding, and a paneled door and single pane window on the south façade. It appears to be vacant/not in use due to the overgrown vegetation and boarded window.

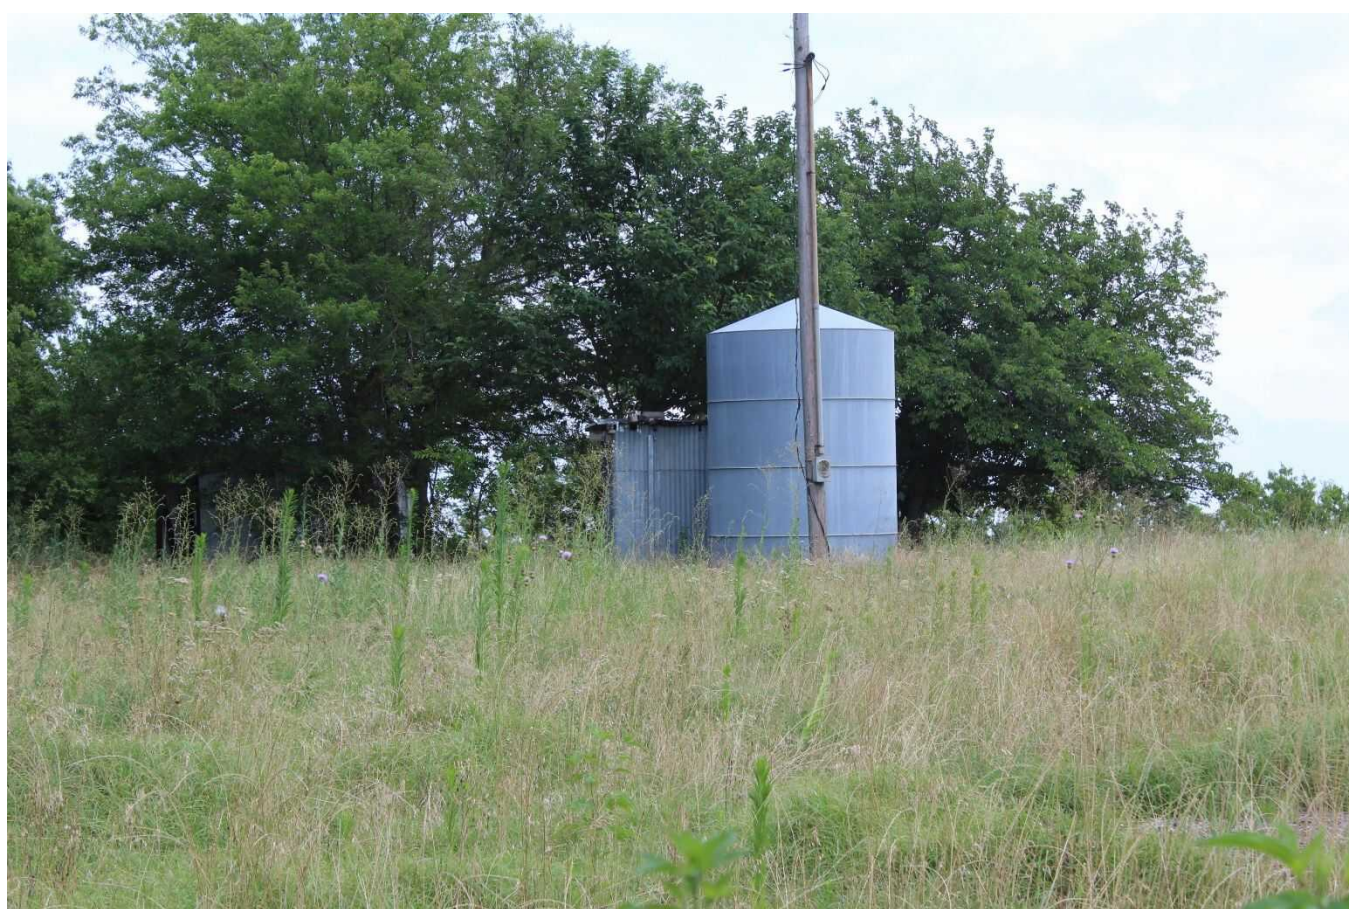
Camera facing southeast.

Survey Date:	June 24, 2019
Resource No:	12
Project Location:	Denton County
Project Name and CSJ:	State Loop 288, CSJ 2250-02-014, etc.
Address, Lat/Long:	4081 Harrison Court 33.255116, -97.199425
Function/Sub-function:	AGRICULTURE/shed
Construction Date:	Ca. 2015
NRHP Eligibility:	Not eligible
Integrity/Comments:	Resource 12 is a shed which did not appear in aerial imagery until ca. 2015. It features a flat metal roof and metal siding. Due to vegetation, it is difficult to distinguish additional features from the ROW.

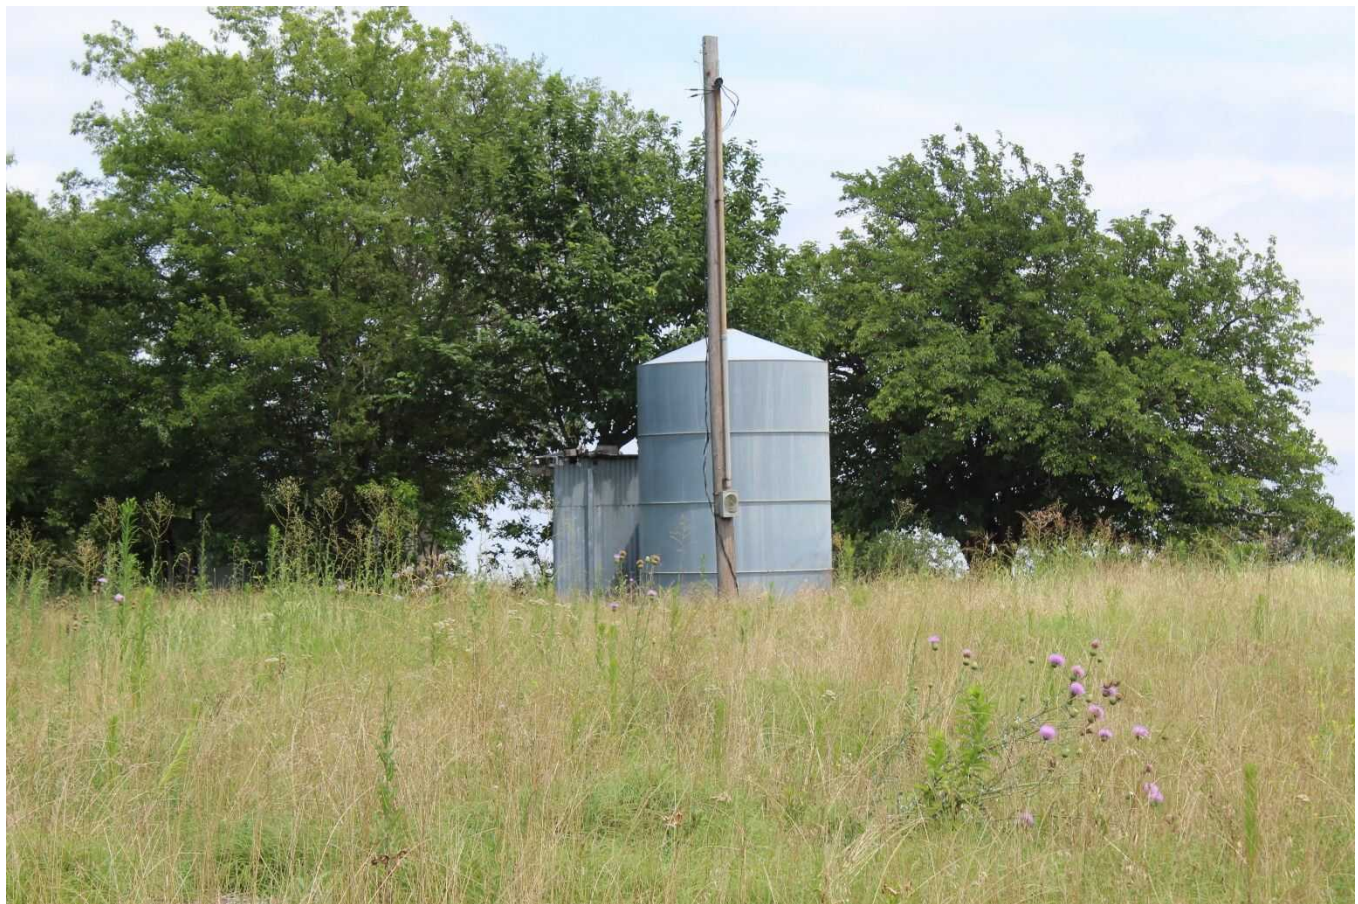
Camera facing east.

Survey Date:	June 24, 2019
Resource No:	12
Project Location:	Denton County
Project Name and CSJ:	State Loop 288, CSJ 2250-02-014, etc.
Address, Lat/Long:	4081 Harrison Court 33.255106, -97.199449
Function/Sub-function:	AGRICULTURE/storage tank
Construction Date:	Ca. 2005
NRHP Eligibility:	Not eligible
Integrity/Comments:	Resource 12 is a fixed-roof storage tank. It does not appear in aerial imagery until ca. 2005.

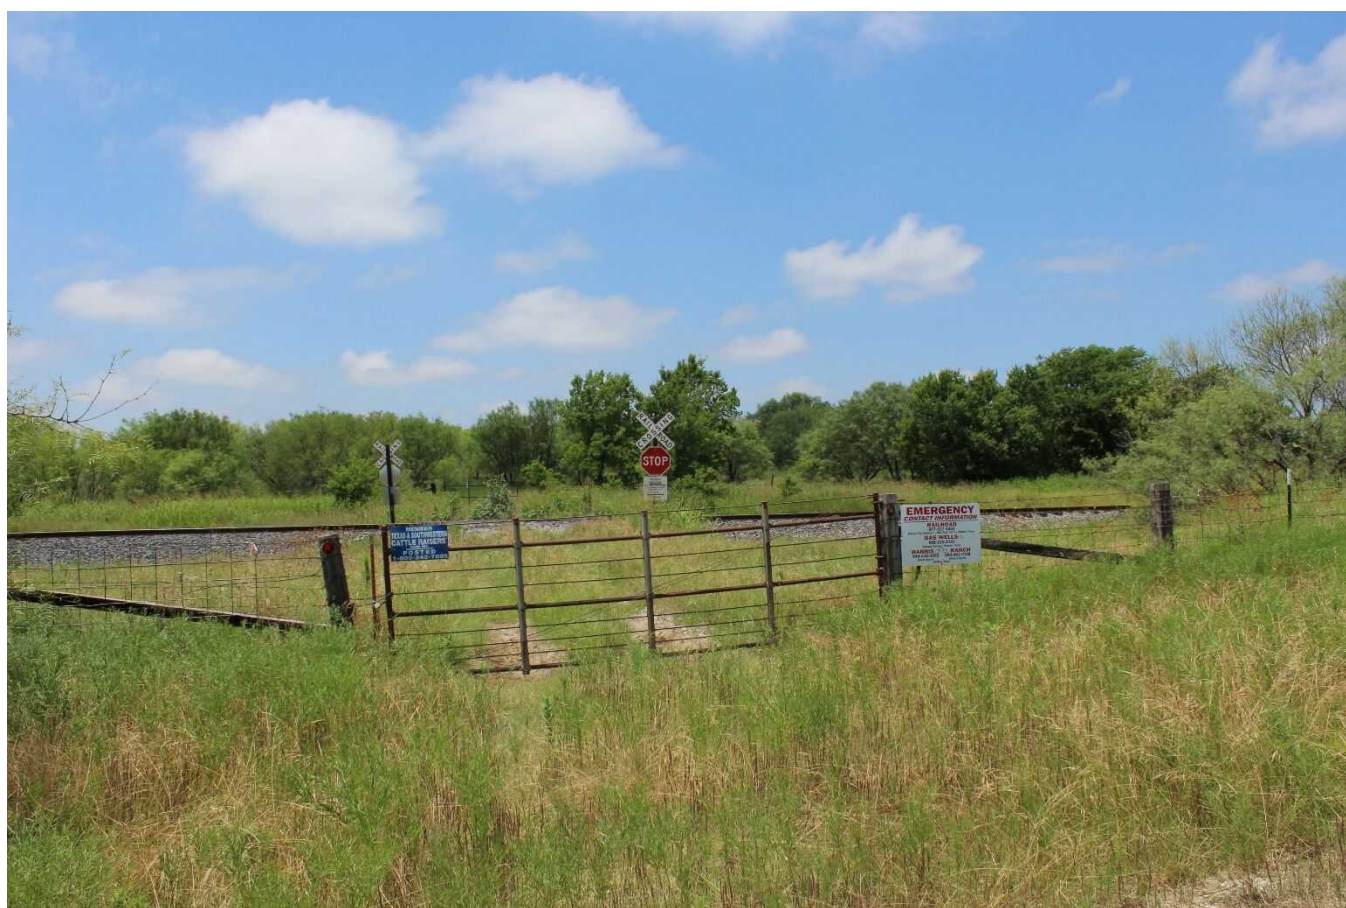
Camera facing north.

Survey Date:	June 24, 2019
Resource No:	13a
Project Location:	Denton County
Project Name and CSJ:	State Loop 288, CSJ 2250-02-014, etc.
Address, Lat/Long:	No Address 33.251020, -97.188331
Function/Sub-function:	AGRICULTURE/storage tank
Construction Date:	Ca. 1977
NRHP Eligibility:	Not eligible
Integrity/Comments:	Resource 13a is a tool shed. Although ROE was granted, surveyors were limited due to safety concerns (railroad tracks) and vegetation. Per the owner's information, the shed still exists behind the tree line. Aerial imagery shows a building with a metal gable roof and a rectangular footprint.

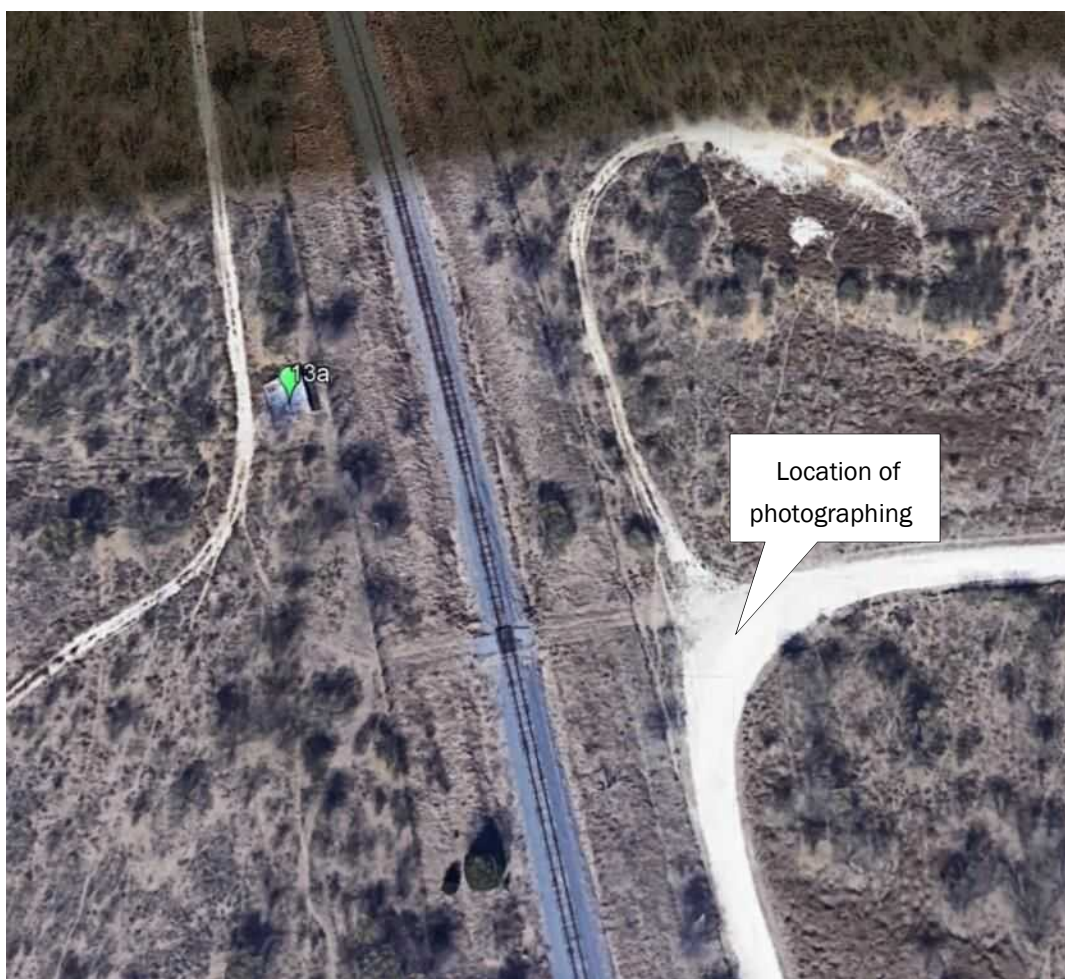
Aerial image, facing north.

Survey Date:	June 24, 2019
Resource No:	13a
Project Location:	Denton County
Project Name and CSJ:	State Loop 288, CSJ 2250-02-014, etc.
Address, Lat/Long:	No Address 33.251469, -97.189240
Function/Sub-function:	AGRICULTURE/shed
Construction Date:	Ca. 1977
NRHP Eligibility:	Not eligible
Integrity/Comments:	Resource 13a is a tool shed. Although ROE was granted, surveyors were limited due to safety concerns (railroad tracks) and vegetation. Per the owner's information, the shed still exists behind the tree line. Aerial imagery shows a building with a metal gable roof and a rectangular footprint.

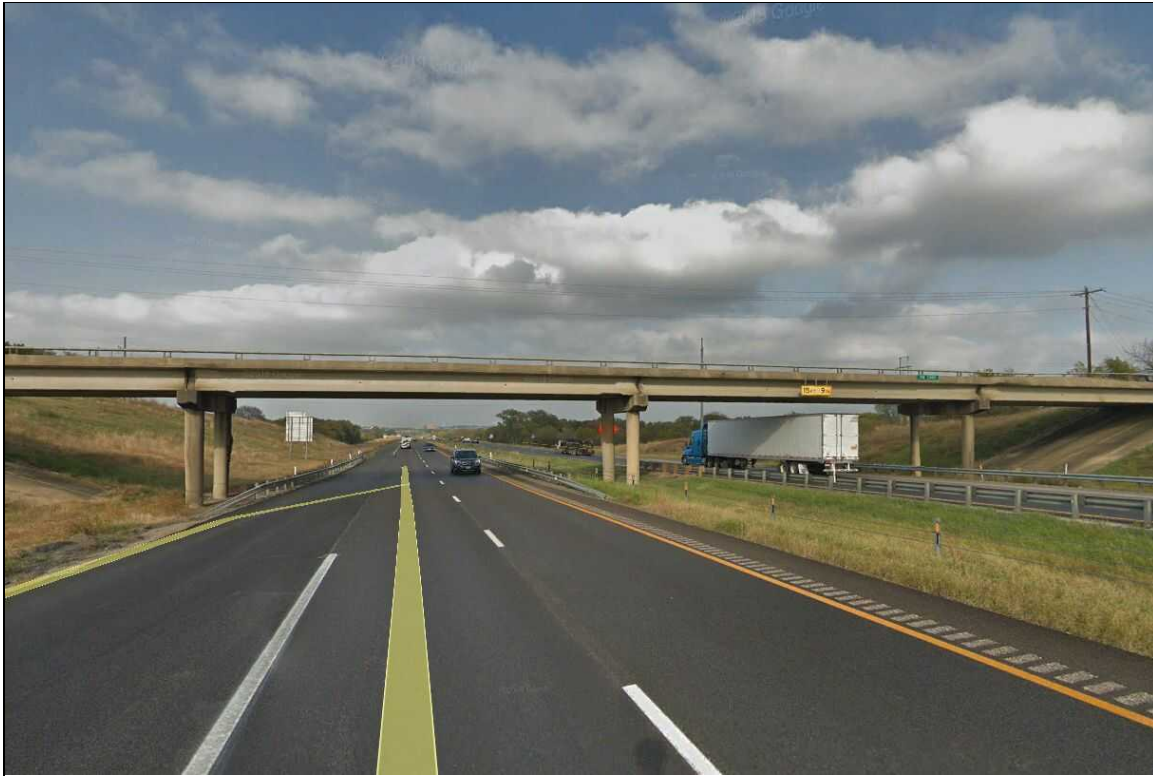
View of FM 2449 Bridge over IH 35W, facing southwest (Google Earth, July 2018).
